**KIP CARA AUGUSTA IZ ARHEOLOŠKOG
MUZEJA ZADAR:
KONZERVATORSKO-RESTAURATORSKA
ISTRAŽIVANJA I RADOVI**

U ovom članku opisani su konzervatorsko-restauratorski radovi i istraživanja provedena na rimskoj antičkoj mramornoj skulpturi koja postumno prikazuje cara Augusta. Kip datira u 1. stoljeće i isklesan je s namjerom da se promatra s prednje strane. Pronađen je 1768. godine, tijekom arheoloških istraživanja grada Nina koje je financirao zadarski liječnik i jedan od prvih dalmatinskih kolekcionara, Ante Danielli Tommasoni. Nakon njegove smrti dospio je u sjemenište u Udinama, a potom je prodan Talijanima. Nakon nekoliko godina dopisivanja između talijanskih i jugoslavenskih vlasti, kip cara Augusta donesen je u Zadar 1928. godine, prilikom izložbe u crkvi sv. Donata. Kip je bio postavljen ispred crkve do 1953. kad je premješten u zgradu tadašnjeg Filozofskog fakulteta (danasa Sveučilište u Zadru) – Liceja sv. Dimitrija. Godine 1973. premješten je na svoju sadašnju poziciju – u Arheološki muzej Zadar. U predvorju muzeja stajao je od 1991. godine, opasan metalnom cijevnom konstrukcijom (skelom) zbog sumnje u statiku. Demontaža kipa zahtijevala je veliki oprez te razrađen i precizan pla

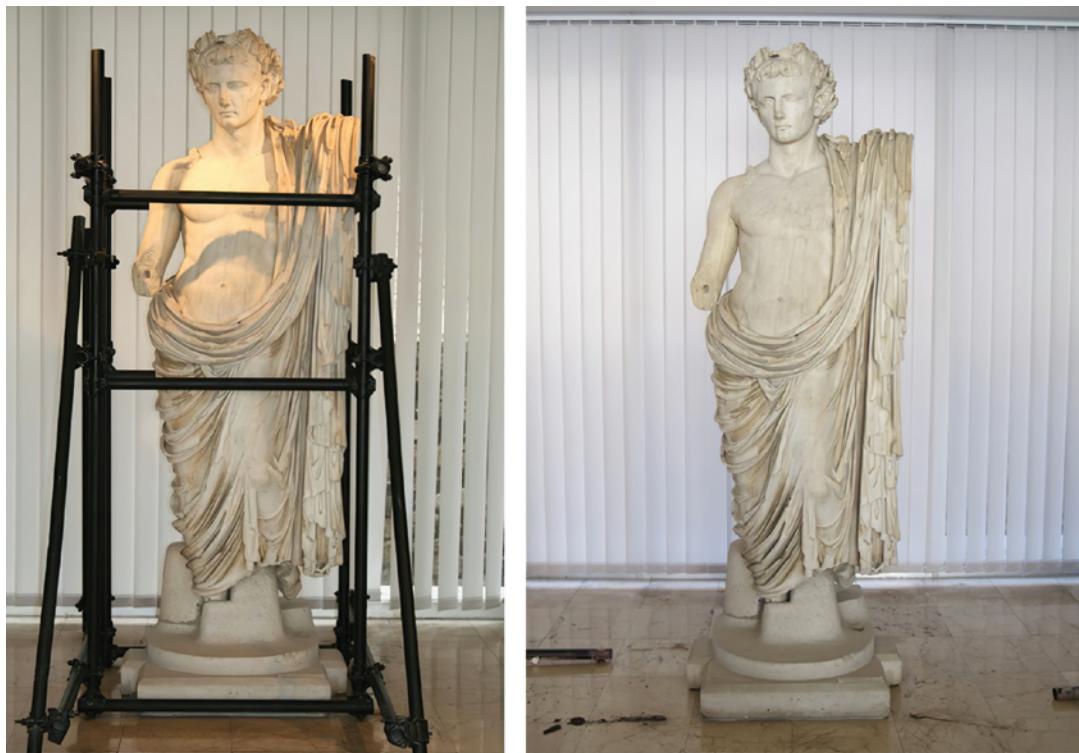
The statue stood in the vestibule of Archaeological Museum Zadar, girdled with a structure made of metal pipes and additionally fixed to the floor with Portland cement. After the earthquake of 1990, when cracks on the right foot were observed, the then Museum director Radomir Jurić assembled an expert team for repairs of the statue, which had been preventively enclosed in a wooden structure because of its dubious statics.²³ According to their report, the team established that the statue's statics had been threatened at the connection with the base.²⁴ Radiographic screening of the connection was carried out in March 1991, using radioactive isotope Cobalt-60 (^{60}Co).²⁵ Four screenings were made, from different angles and with different duration of shifting of γ -rays. The radiogram thus obtained indicated "that the statue is standing freely on the base and is not anchored; that there is a vertical hollow approx. 300 mm long and 50 mm wide in the center and bottom of the statue and another vertical hollow that was probably intended for fixing a part of the leg to the statue".²⁶ The plan for the conservation and restoration work was proposed on the basis of the radiographic screening report. It was concluded that "the X-ray shows that the existing hollow has been prepared and the wedge has never been embedded. The only connection between the statue and the base was a 'male-female groove' (also visible on the X-ray); we believe it is broken".²⁷ It is also suggested that wedges be embedded in the hollows and glued with epoxy resin. This is why, based on the drawing and the then team's proposal, a metal-pipe structure in the Museum was built, but wedges were not embedded and glued with epoxy resin – probably due to the outbreak of war in Croatia in 1991.

Figure 3. Statue's initial condition in Museum's vestibule, before and after removal of protective scaffold

After earlier documents had been studied and the expert team from the Conservation-Restoration Department of the Split Arts Academy had made its assessment, it was decided that the statue would be laid down horizontally and examined to detail from all sides. The plan and steps of the removal of the protection scaffold and installing a new one were prepared. The new scaffold was intended for dismantling of the statue and placing it into a horizontal position for safe transport to the workshop in Split. The dismantling required particular caution because the statue's massive weight and height hinder its handling. Before the protective structure would be removed in the Museum, a special metal and wooden structure of adequate size (onto which the statue would be laid) was made in the workshop of the Split Arts Academy on the basis of a detailed load analysis. By controlled tightening and slackening of chain hoisting devices, the possibility of the statue's fall was eliminated. The belts of the two hoisting devices were wrapped around the statue's base and pulled up simultaneously and the statue was elevated a few centimeters from the ground (Fig. 3). A pallet and two wooden beams were placed underneath the statue to stabilize it. By repeated simultaneous slackening of the hoisting belts and by using two palettes, the statue was carefully laid in a horizontal position and then transported to the Split workshop (Fig. 4). Soon upon the arrival, three metal wedges, each with a 30mm diameter, were seen sticking out on the bottom side of the limestone base. They were additionally fixed with a concrete matrix that was often used between the two world wars.

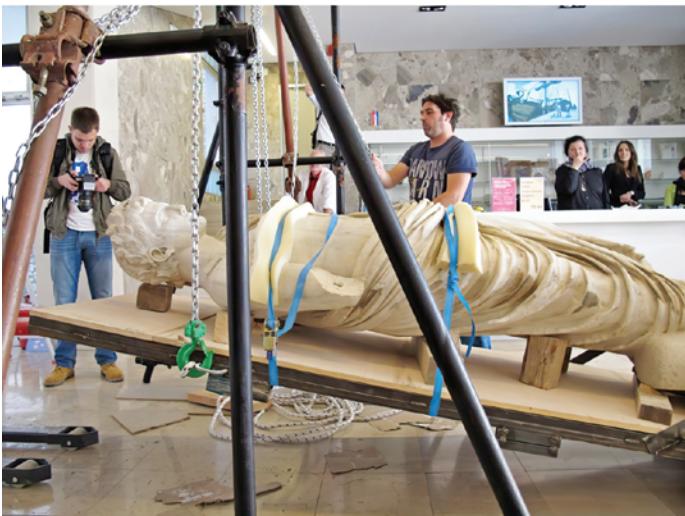
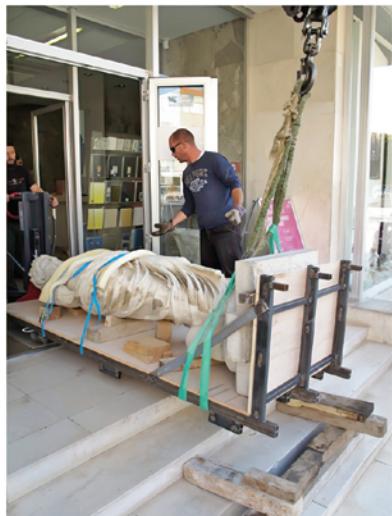
Slika 4. Spuštanje kipa u horizontalni položaj

Figure 4. Laying the statue in a horizontal position

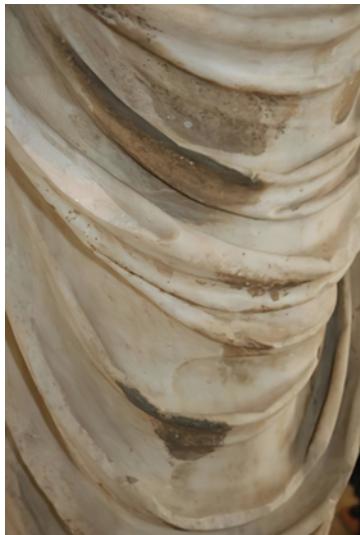
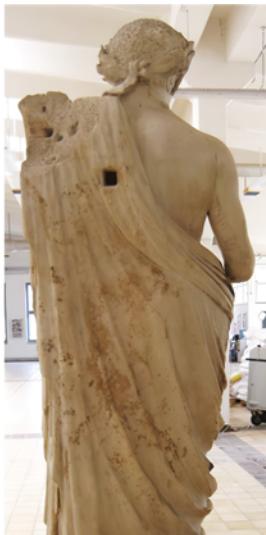
Several kinds of impurities were observed when a detailed visual overview of the marble surface was conducted. The black crusts on the drapery folds are probably a result of exposure to weathering factors.²⁸ The statue's back side is partly covered with ochre sediments.²⁹ On the rather coarsely and partially executed back side there is a symmetrical square groove which probably accommodated a wedge that supported the statue or fixed it to a wall (Fig. 5). The whole right arm with the back part of the left shoulder are missing, as well as the right arm from the elbow down and the lower edge of the drape. The legs are canted at the bottom: the right foot from the ankle to the toes is missing and the left leg is canted across the middle of its calf. The left leg is pulled back; its fragment (part of the heel with the ankle) was subsequently glued above the base. The connection of the marble and the limestone was pointed with Portland cement, which is harmful. As for the head, minor damage can be seen on the right side of the face, nose and chin; part of the left concha is missing. The leafed wreath around the head contains numerous irregularly distributed punctures. The strap attaching the wreath to the head is broken above the right shoulder. Minor recent damage can be seen on a number of places; they are probably a result of improper handling of the statue in recent past.

Slika 5. Zatećeno stanje: crna kora u području draperije i stražnja strana kipa

Figure 5. Statue's initial condition: black crust on drapery and statue's back side

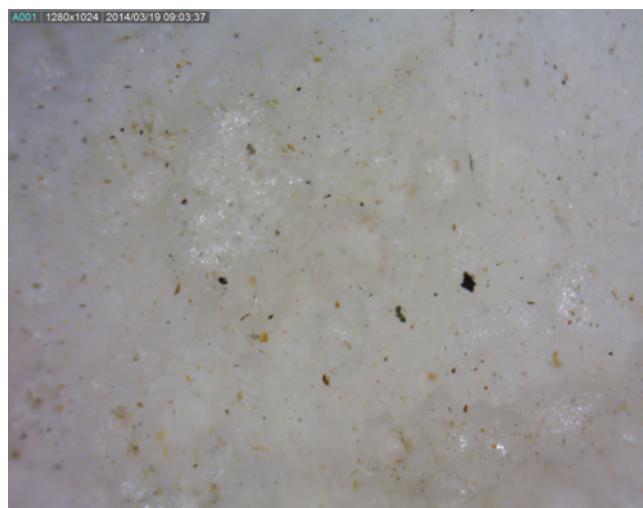
An analysis with a *Dino Capture Dino Lite* digital microscope showed that the material in question was Pentelic marble (Fig. 6).³⁰ That marble used to be quarried on Mount Pentelicus in Attica, 16 kilometers from Athens.³¹ Pentelic marble is white, with a pale-golden hue under sunlight. It was used by such ancient Greek sculptors as Phidias and Praxiteles.³² The metal the three wedges protruding from the bottom side of the base are made of was sampled. Part of the metal sawdust was analyzed and it was established that the metal in question was leaded brass of excellent quality.³³ It is very similar to modern C37710 alloys, very resistant to corrosion and suitable for cutting, forging, pressing and thermoforming. According to the interpretation of the results, it is obtained by pressing and hammering and is used for the making of precision-made pressed steel sections and as watchmaker's brass (Fig. 7). Based on the obtained results, it was concluded (among other things) that the presence of lead in the brass affected the radiographic examination and the radiograms of two hollows. Gamma rays get slightly diffracted at the connection of two different materials. They can penetrate very dense materials, but the depth of penetration depends on energy and the features of the matter they are passing through until they

Slika 6. Mikroskopska snimka mramora pod uvećanjem 1280 x 1024

Figure 6. Microscopic image of marble under magnification of 1280 x 1024

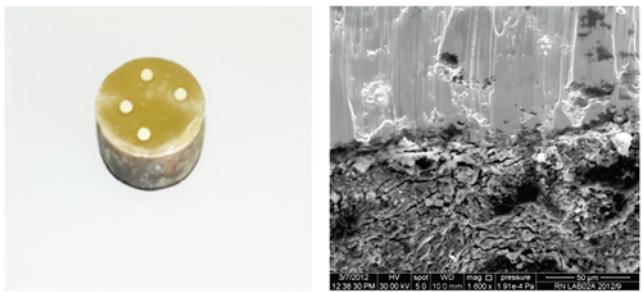
Slika 7. Uzorak mesinga i SEM fotografija uzorka pri uvećanju P = 800 ×

Figure 7. Brass sample and SEM photograph of sample under 800× magnification

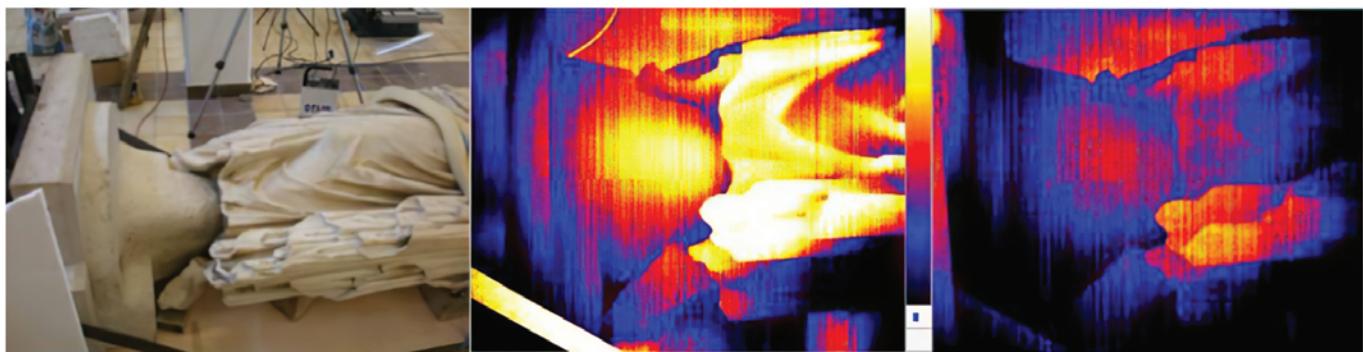
After considering all the available non-destructive methods, thermography was selected. It has a long history of use in conservation and restoration research and work. Thermography is best defined as a technique that registers IC radiation, which is different for every object with a temperature above absolute zero. Today, thermography is more than just registering temperature; it is a technique using sophisticated equipment and software for diagnosing the condition of objects based on their IC radiation. Hoping that this non-destructive method of measuring temperature and its distribution across an object's surface would locate the depth of the brass wedges, we had to heat them up. As metal heats up much faster than stone, the thermographic camera would record different temperatures.³⁶ We first heated them with an electric drier and then with a propane-butane burner. However, as they are deeply inserted in the stone, the metal wedges could not be located with thermography and a medium-wave cooled thermographic camera (with thermal sensitivity 0.02°C) (Fig. 8).³⁷

Slika 8. Snimke termografske kamere prije i nakon petominutnog grijanja propan-butan plamenikom

Figure 8. Thermographic images before and after 5-minute heating with propane-butane burner

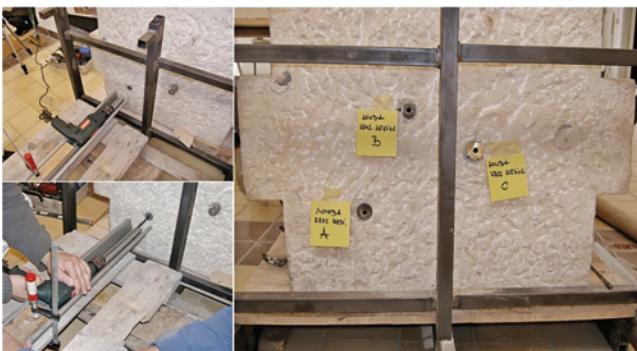
Slika 9. Sondiranje mesinganih trnova bušenjem

Figure 9. Probing brass wedges by drilling

Unfortunately, as the thermographic images failed to yield satisfactory results, the only way of establishing the depth of the brass wedges was to probe them by drilling them along their length, through their central section, and determine the depth with an endoscopic camera (Fig. 9). An 8 mm drill was used, which is a minimum diameter for an endoscopic camera. This “improvised” method required extreme precision because the brass wedge had to be drilled along its length without going off course into the marble. A guide for the drill was designed to prevent it from deviating from its course. At first, drills available in the market were used, but then longer drills were made in a workshop by welding an additional length to the commercially available drills. It was the only solution because no metal dills of such length are available in the market. The depth measured for the first wedge (probe A) was 50 cm. The endoscopic camera showed the depth of 70 cm for the second wedge (probe B) and 56 cm for the third wedge (probe C) (Fig. 10). After these results, a structural analysis confirmed that these three brass wedges were more than enough to ensure the statue’s unsupported standing – in

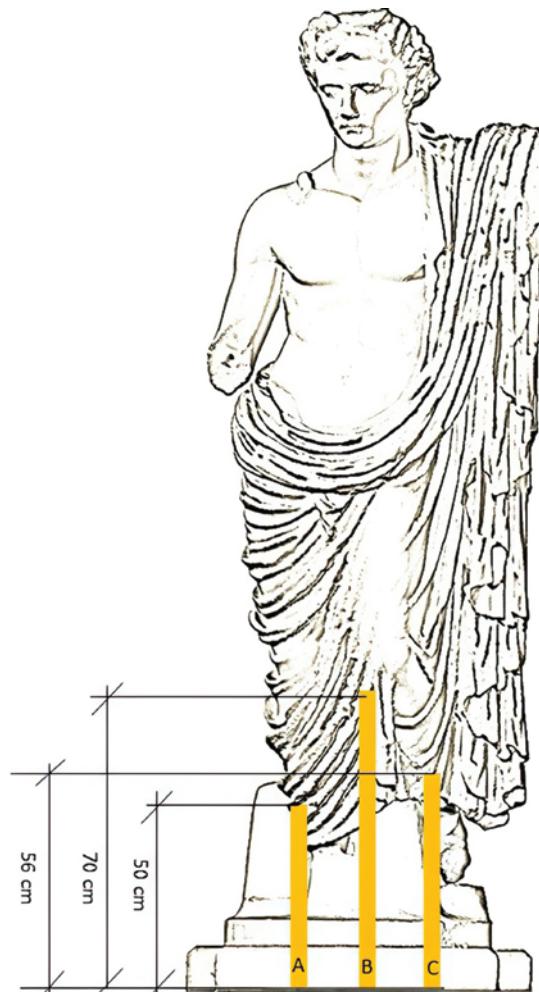
Slika 10. Prikaz visina mesinganih trnova

Figure 10. Heights of brass wedges

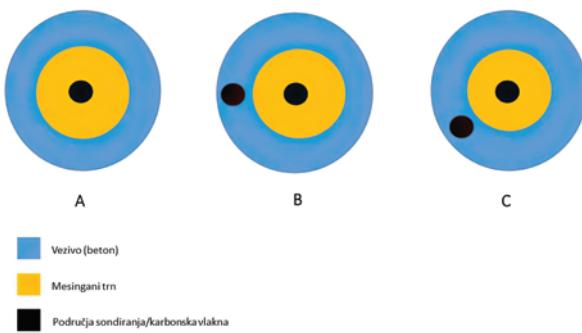
Slika 12. Presjek mesinganih trnova (sondi) A, B i C

Figure 12. Cross-sections of brass wedges (probes) A, B and C
