Restauriranje antičke carske skulpture iz Visa

Restoration of an ancient imperial sculpture from Vis

U restauratorsku radionicu Arheološkog muzeja u Splitu sredinom listopada 2019. godine stigle su dvije rimske carske skulpture iz Priručne zbirke *Issa* smještene u Gospinoj batariji u Visu. Skulpture je potrebno pripremiti za obljetničku izložbu *Vis-à-Vis 200. Arheološka baština otoka Visa*. Skulpture pripadaju skupini od pet carskih skulptura koje potječu s područja podno Gradine u Visu. Dvije skulpture nalaze se u fundusu Područne zbirke *Issa* na otoku Visu, jedna se čuva u Arheološkome muzeju u Splitu, jedna u Arheološkome muzeju u Zagrebu, a jedna u Beču.¹ Kako se skulptura u Beču sastoji od tijela i glave koji ne pripadaju jedno drugome, možda se može pretpostaviti da se radi o šest viških skulptura.² U ovom tekstu opisana je problematika prezentacije skulpture kojoj nedostaju nosivi dijelovi te su kronološki obrazloženi procesi koji su primijenjeni na skulpturi inv. br. AMS 74350.

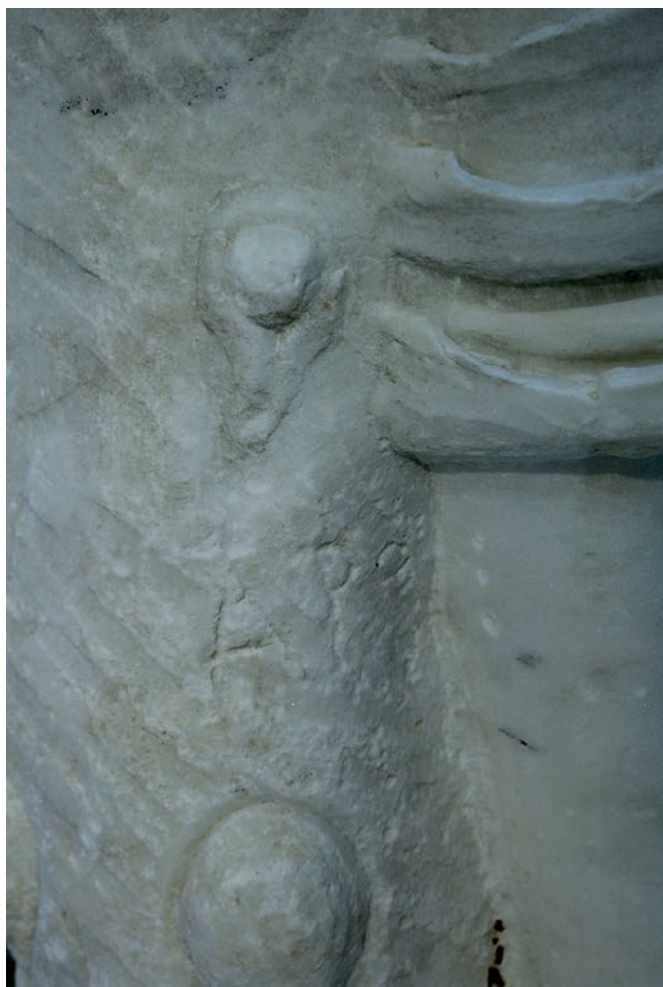
(sl. 2, 3), te se može pretpostaviti da je djelo istog kipara.⁶ Vidljivi su i metalni trnovi koji su držali ostale dijelove tijela i draperije; trnovi su korodirali i prouzročili oštećenja mramora. Površina skulpture mehanički je oštećena i erodirana zbog uvjeta u kojima se skulptura nalazila tijekom vremena. U površinu su urezani grafiti nastali u vrijeme kad je skulptura bila izložena u predvorju palače Dojmi u Visu, a zamijećena su i oštećenja površine nastala u vrijeme kad se skulptura nalazila u dvorištu Gospine batarije. Upravo je izloženost atmosferilijama u dvorištu Batarije pogodovala i nastanku organskog obraštaja (lišajevi i mahovina), koji je znatno utjecao na stanje sačuvano-sti skulpture.

leg below the knee, and a part of the base. The signature of the sculptor – APO (*Appolonios*) – located on the stump of the sculpture, is an interesting and rare detail. The same signature can be found on another sculpture, depicting Emperor Vespasian, exhibited in the *Kunsthistorisches Museum* in Vienna, Inv. No. I 669 (Figs. 2, 3). Therefore, it can be presumed to be the work of the same sculptor.⁶ Metal tangs holding other body parts and the drapery are also visible. They are corroded and hence damaged the marble. The surface of the sculpture is mechanically damaged and eroded due to the conditions in which it was kept. Graffiti was carved into the surface when the sculpture was exhibited in the entrance-hall of the Dojmi Palace in Vis. It also suffered surface damage when it was located in the bailey of Gospina batarija. It was the exposure to weather conditions in the Batarija bailey that facilitated the emergence of organic growth (lichens and moss), which significantly affected the state of preservation of the sculpture.

Figure 2.
Author's signature on the
sculpture Inv. No. AMS 74350
(photograph: D. Ordulj)

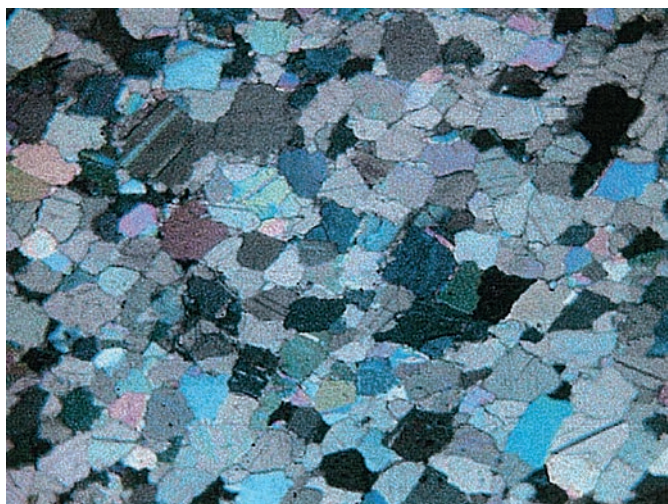
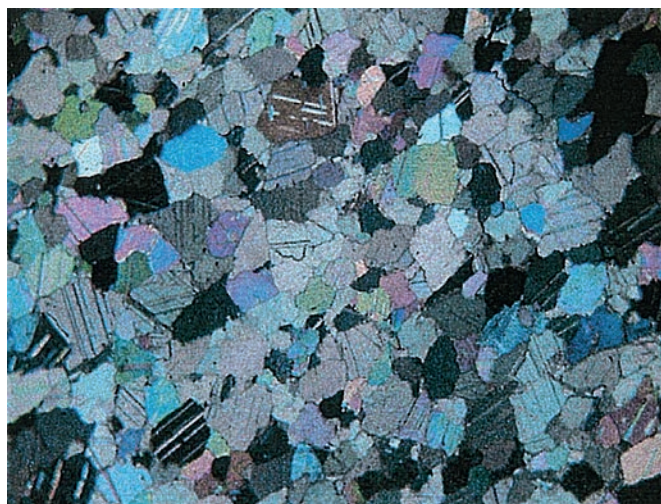
tiny grains of quartz of primary origin, very small in size (of a compact, fine-grained texture) and round in shape. For a comparative sample, we refer to previous reports in which sample of LEMLA 5097 was photographed, viz. material from the very quarries. With small variations in grain size and distribution, samples from fragments of Vis sculptures were undoubtedly identified as Pentelic marble (Figs. 4, 5).

Slika 4.
Mikrofotografija uzorka
iz gornjeg dijela skulpture,
Issa 3019 Pentelic (foto:
Laboratorij LEMLA)

Figure 4.
Microphotograph of a
sample from the upper part
of the sculpture, Issa 3019
Pentelic (photograph: LEMLA
Laboratory)

Slika 5.
Mikrofotografija uzorka
iz donjeg dijela skulpture,
Issa 3020 Pentelic (foto:
Laboratorij LEMLA)

Figure 5.
Microphotograph of a
sample from the lower part
of the sculpture, Issa 3020
Pentelic (photograph: LEMLA
Laboratory)

U elaboratu analize uzoraka navodi se da je uzorak viškog mramora intenzivne bijele boje, sitnog zrna kristala, izuzetno kompaktno i srednje proziran. Mikroskopskim pregledom zamijećene su male pahuljaste tvorevine kristala muskovita.⁸ Sastav ovog mramora je u velikom postotku vapnenački, s vrlo malo prisutnosti dolomita.⁹ Zrna imaju poligonalne oblike. Ponekad se pojave sitna zrna kvarca primarnog podrijetla, vrlo malih dimenzija (kompaktne, sitnozrne teksture) i zaobljenih oblika. Za usporedni uzorak pozivamo se na prethodna izvješća u kojima se fotografira uzorak LEMLA 5097, materijala iz samih kamenoloma. Uz male varijacije u veličini i raspodjeli zrna, uzorci iz ulomaka viških skulptura nedvojbeno su određeni kao pentelički mramor (sl. 4, 5).

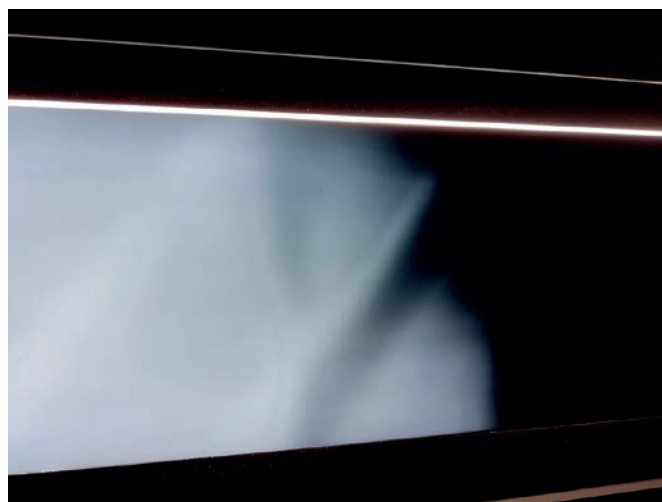
Nakon snimanja navedenih mjesta na skulpturama i obrade filmova u Laboratoriju *Brodosplita* pokazalo se da rezultati nisu zadovoljavajući (sl. 7). Razlozi nejasnih i nepotpunih rezultata prema tvrdnji stručnjaka za radiografska snimanja mogu se tražiti u gustoj strukturi mramornog materijala, zatim u neodgovarajućoj pokretnoj RTG opremi za tako zahtjevno snimanje te u filmovima i kemikalijama koji nisu bili dovoljno osjetljivi za takvu vrstu snimanja.¹¹

Figure 7.
Blurred image of an iron joint on radiographic film (photograph: S. Repanić)

according to radiographic imaging specialists, the reasons for the vague and incomplete results can be found in the dense structure of the marble, inadequacy of the mobile X-ray equipment for such demanding imaging, and in the films and chemicals that were not sensitive enough for this type of imaging."

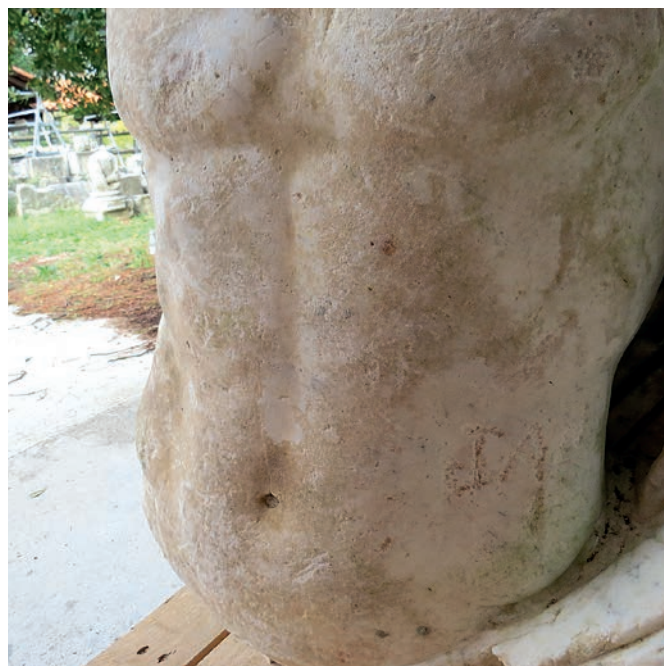
Figure 10.
Man-made damage to the
sculpture (photograph: B.
Vješnica)

176 cm, širina od 72 cm, debljina od 48 cm i težina od 510 kg. Daljnjim pregledom utvrđene su dimenzije oštećenja nastalih ljudskom rukom (sl. 10): uklesani potpisi, ogrebotine, ostaci cementne žbuke. Radi još boljeg uvida u stanje, mramorni ulomci podvrgnuti su metodi čišćenja visokotlačnim strojem na vrelu paru (sl. 11). Tim je postupkom s površine mramora pomno uklonjen višegodišnji sloj nečistoće, masnoće, tragova životinjskih nastambi, mahovine i mikrobioloških ostataka. Uklanjanjem prvog sloja naslaga na površini mramornih ulomaka mjestimično se ukazuju tvrdokornije kalcitne naslage. U cjelini, mramor je kompaktno, uz površinsku degradaciju nastalu zbog izloženosti atmosferilijama; nema tragova osoljavanja te još uvijek ima finu teksturu, ne računajući pritom na oštećenja nastala ljudskim djelovanjem. Relativno mekše kalcitne naslage uklanjaju se postupnim mehaničkim čišćenjem uz pomoć ultrazvučne igle ili ručno, skalpelima raznih profila. Svi preostali kalcifikati uklanjaju se s pomoću finih abraziva (stakleni ili kameni prah) metodom suhog pjeskarenja (sl. 12). Kako bi se različiti restauratorski postupci uopće mogli primijeniti, potrebna su posebna pomagala i alati, bez kojih rad ne bi bio moguć, a to su: automehaničarska dizalica, pomična stropna kolica za lančanu dizalicu, lančana dizalica, laserska libela, ručna auto-dizalica. Uz pomoć kliznih stropnih kolica i lančane dizalice skulptura je uspješno postavljena. Kad je donji ulomak skulpture uspravljen u izvorni položaj, na njega se više puta tijekom ukupnih radova montirao i demontirao torzo (sl. 13).

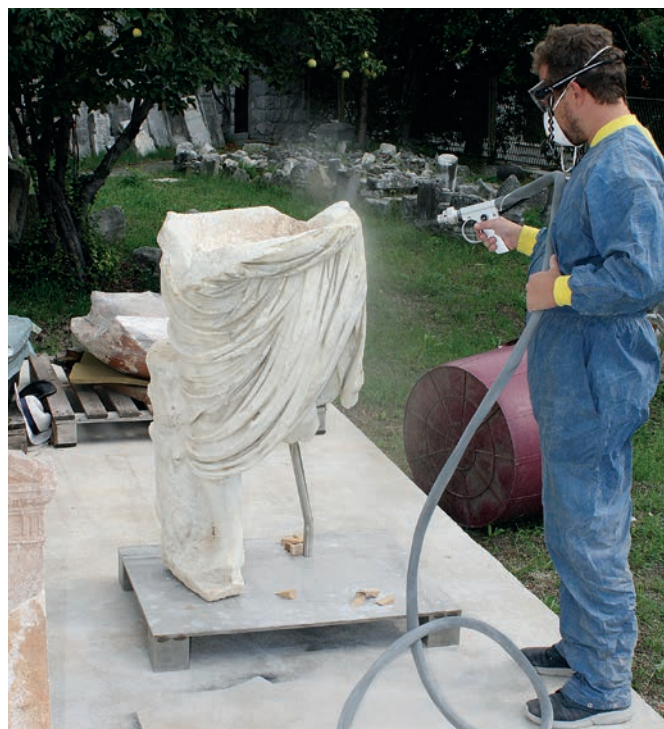
Figure 12.
Removal of thick calcite crust
layers by dry sandblasting with
fine abrasives (photograph: B.
Vješnica)

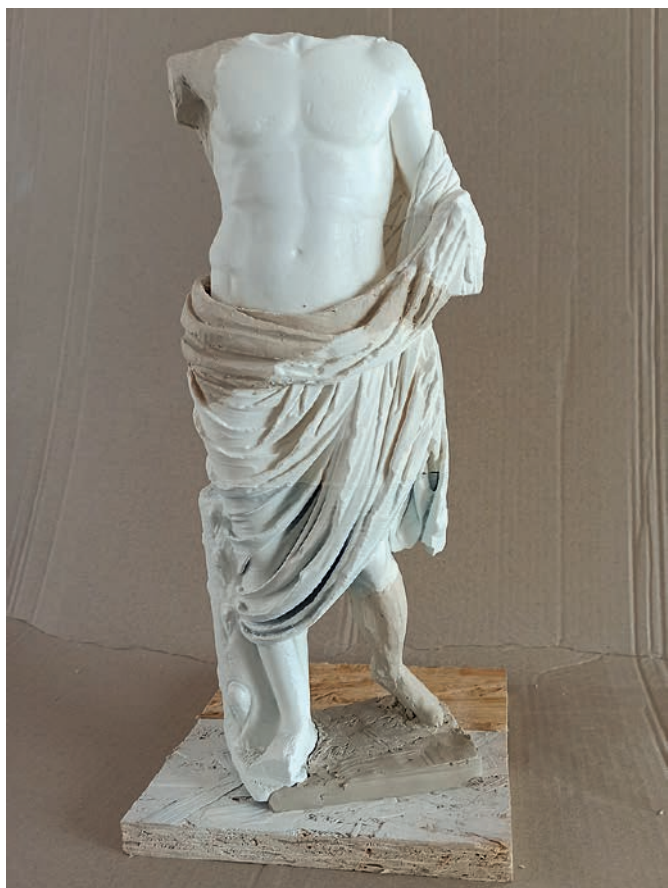
Figure 14.
Missing parts on the printed
model (photograph: D. Ordulj)

parts, although they can be reconstructed iconographically. The missing parts were first modelled on a scaled-down plastic model, and then served to model the original (Fig. 14). The reconstructions were formed of clay, and a silicone mould was made. The mould was made of two-component silicone rubber *Alpa Sil MF3*,¹⁹ which was applied to the clay. Due to the large dimensions of the reconstruction, it was necessary to make a plaster cap in order to harden the rubber mould. The mould was separated and prepared for casting in the composite ma-

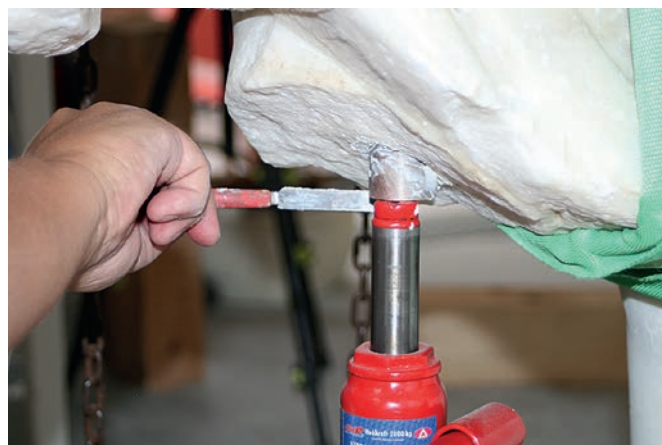
Figure 24.
Use of a small hydraulic jack while fixing a tin bronze pin (photograph: B. Vješnica)

A small technical aid was needed to fix the tin bronze pin (joint) successfully. Namely, in contrast to the original base, which pushed the pin into the perforation with the weight of the whole fragment on the support, the side of the lower leg fracture required building a wooden pedestal with a small hydraulic jack on top to push the tin bronze pin, and squeeze out excess adhesive (Fig. 24).
