ANALYSIS OF THE VEHICLE EXHAUST SYSTEM CORROSION AND ITS EFFECT ON THE ECO-TEST RESULT

Key words: vehicle, exhaust system, corrosion, eco-test, technical inspection

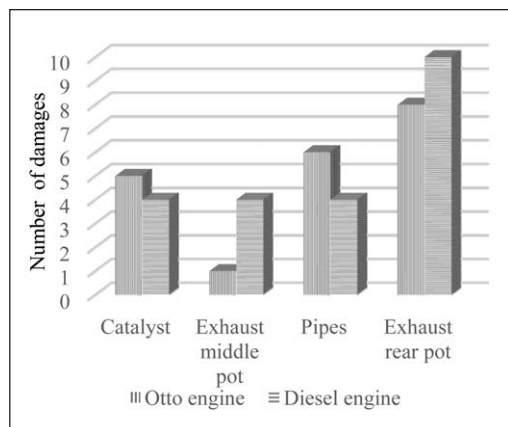
Figure 1 Locations of damages in exhaust systems of tested vehicles

Locations of damages are different if comparing the vehicles with Otto and with Diesel engines, yet the most damages are related to the exhaust rear pot in both types of vehicles, since it is a location where condensate and soot particles accumulate the most. The rest of damages is evenly distributed in Diesel engines, whereas in Otto engines, pipes and catalysts suffer more damages. This occurs because of the engine operation mode and because of the catalytic converter high temperature that damages pipes. Corrosion usually occurs on pipes because the exhaust system supporters are welded to pipes. Corrosion occurs because of defects in the structure caused by welding. The second most common cause of the exhaust system faults are pipe joints made without welding where the exhaust gases constantly come out of the exhaust system because the metal-metal

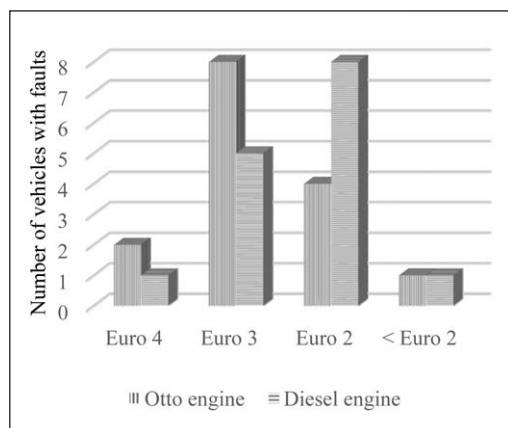
Figure 2 Vehicles with exhaust system faults according to the Euro standard categories

Vehicles of the Euro 5 and Euro 6 standard are free of faults in the exhaust system. The number of vehicles in the category lower than Euro 2 is very small due to their age. Most vehicles with exhaust system faults are in the Euro 2 and Euro 3 categories, although the exhaust systems have been repaired for several times, and the faults occur on welds that are not factory-made. In vehicles with Otto engine, catalytic converter is only rarely original. The Euro 4 engines are usually at the service life point when it is time for the first replacement of the catalytic converter or other parts of the exhaust system. The Figure 3 shows the number of vehicles with Otto and Diesel engines that would fulfill the eco-test requirements before repairing of the exhaust system.

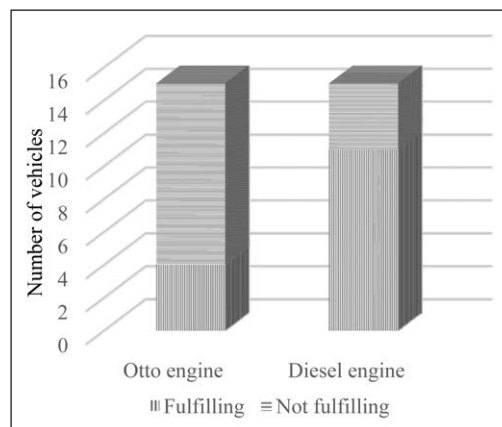
Figure 3 Vehicles with Otto and Diesel engines that would fulfill the eco-test requirements before repair

The number of vehicles that would fulfill the eco-test requirements is less than the number of vehicles with Otto engine that would not pass the eco-test. Such situation is reversed in vehicles with Diesel engine, because damages in the exhaust system have a more favorable effect on the eco-test results. The Figure 4 pre-

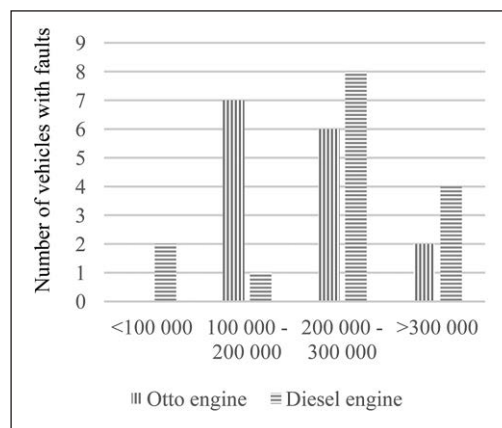
Figure 4 Number of vehicles with faults in relation to the vehicle kilometers travelled

According to the research results, majority of vehicles with Otto engine travel less kilometers during their service life, but factors such as vehicle standing, exposure to adverse weather conditions and exhaust gases during service still lead to more faults in the exhaust system. Illogicality with two vehicles of the Euro 2 category, older than 20 years with less than 100,000 kilometers travelled, can be explained by resetting of vehicle odometer.
