MATRIX REPLICA-BASED ASSESSMENT OF THE MICROSTRUCTURE OF PRIMARY STEAM PIPING ELBOWS AFTER LONG-TERM OPERATION

Preliminary Note – Prethodno priopćenje

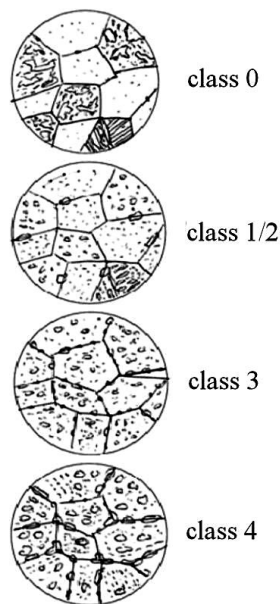
Figure 1 Microstructure patterns with classes assigned according to [12].

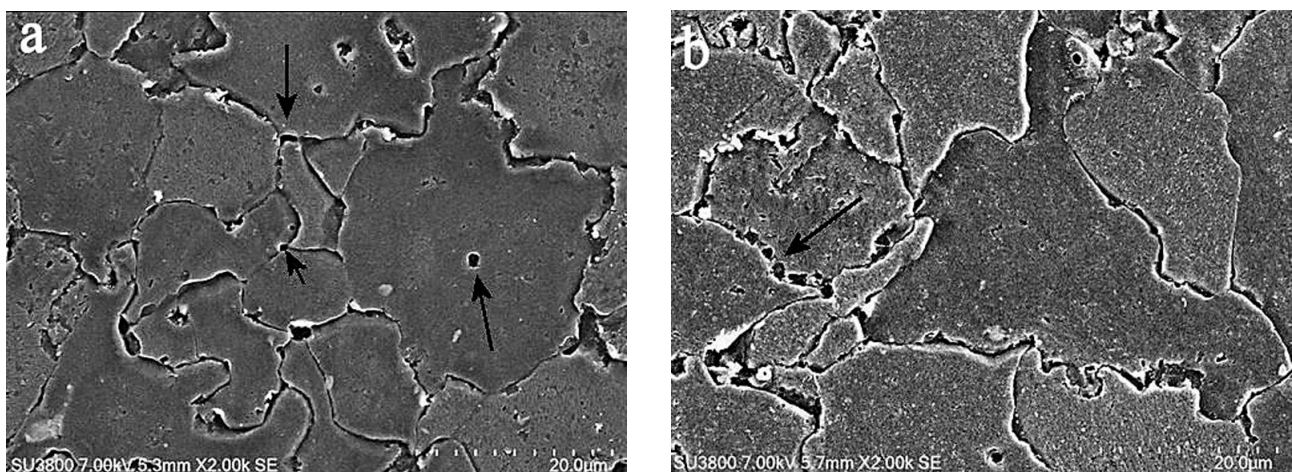
Qualitative analysis of microstructure images on the matrix replicas showed a significant degree of degradation of the primary material with the ferritic-perlitic initial microstructure. Pearlite disappeared after 245 000 operating hours (Figure 2a, b). Numerous voids were observed at the grain boundaries and inside the grains, proving the occurrence of precipitation processes (Figure 2a). The released carbides also formed “chains” of the precipitates along the grain boundaries (Figure 2b).

Figure 2 Example of a 13HMF steel microstructure after long term in service, replicas, SEM
