Carbon Mast Structural Damage Detection Using Ultrasonic NDT Method

Abstract

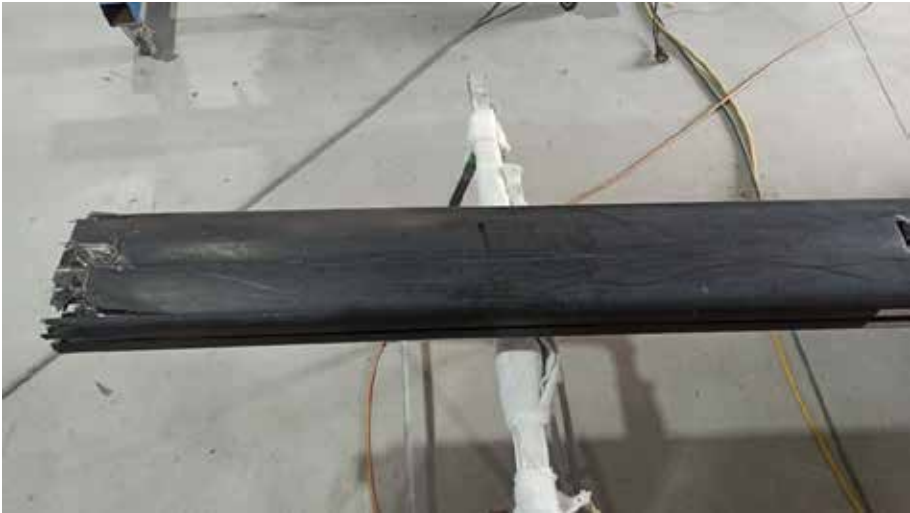
Figure 10. Mast damage

The analyzed mast is the mast of a Melges 32 class sailboat. It is a two-part mast made of carbon fiber. The reason why the mast is designed in two parts is primarily to make it easier to transport. Damage was caused to the upper part of the mast during sailing in strong winds. At the time of sailing downwind there was damage in the rigging which caused a short-term torsional load of the mast and shortly after the rupture of the upper section of the mast into two parts.

Masts are generally not designed to withstand torsional loading because it almost never occurs under normal conditions.

At first glance, the damage to the mast is only near the site of the section rupture. However, as mentioned earlier, the problem with composite materials is that most often internal damage is many times greater than it is apparent.

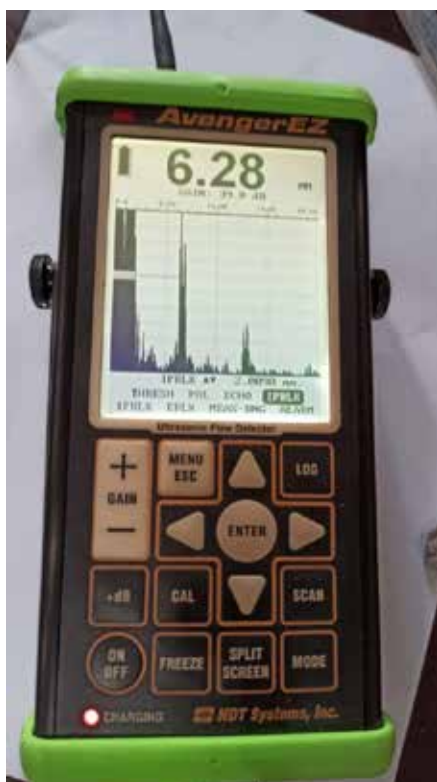
Figure 11. Result 1

Figure 11 shows the three signals received. The first and most pronounced signal is a transmitted wave that bounced off the surface of the mast wall without entering the material itself. This wave needs to be filtered out of the measurement for the reason that otherwise the device will show the wrong wall thickness and later the wrong place and size of the imperfection in the material. The second signal shows a wave bounced off the inner surface of the mast wall to a depth of 6.28 mm. This is the signal that needs to be recorded on the mast to know the exact position where the damage does not exist. The third and smallest signal is not common, but occurs if the laminate is well made and it shows a wave that has already bounced off the inner surface of the mast

wall and once again made its way all the way through the mast wall again and once again bounced off the inner surface of the mast and back into the ultrasonic probe. The obtained value is approximately twice the mast wall thickness.

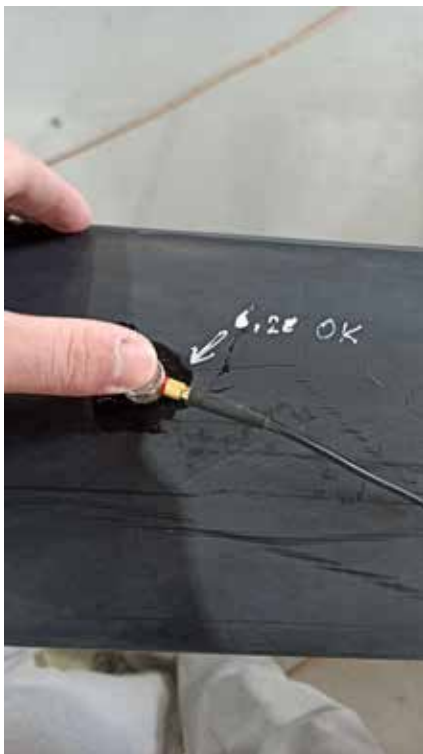
Figure 12. Position 1

Figure 11 and figure 12 show ideal conditions where damage does not exist and only the thickness of the mast wall is measured. Figure 13 shows a situation where the damage in the wall of the mast is close to the surface from which we are measuring. Ultrasound no longer shows at what depth the inner surface of the wall is but only shows the location of the damage. It can be concluded that it is a case of delamination. The layers of laminate are separated from each other and between them there is a layer of air that does not allow sound to travel freely through the material.

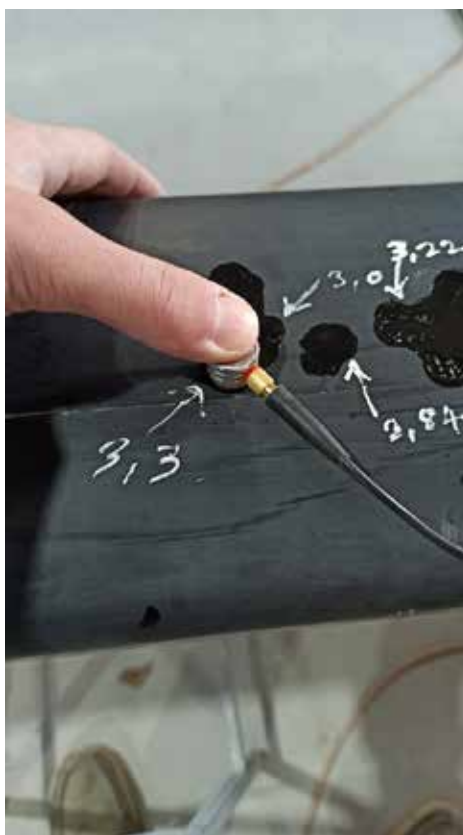
Figure 14. Position 2

The measuring position as well as the obtained value are marked on the surface of the mast in order to finally get a detailed picture of the magnitude of the damage to the mast.

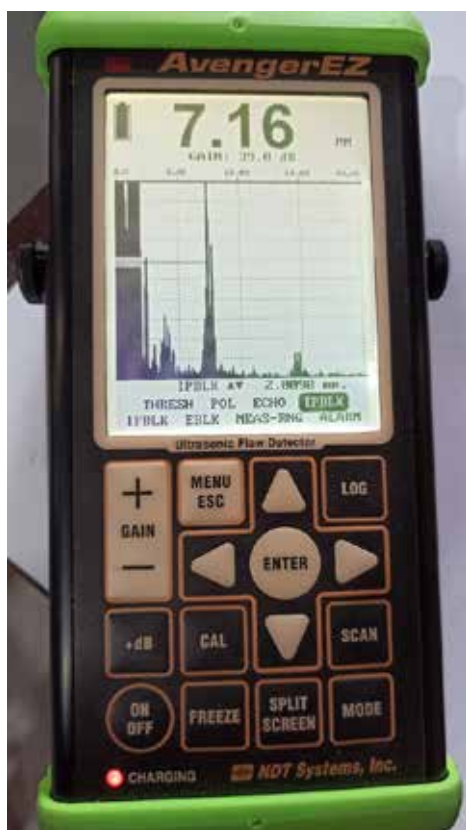
Figure 15. Result 3

In certain situations, the measurement result was not completely clear at first. As shown in figure 15, the feedback signal from the inner surface of the mast wall is clearly visible at 7.16 mm but there are two signals also visible near the outer surface of the mast wall.

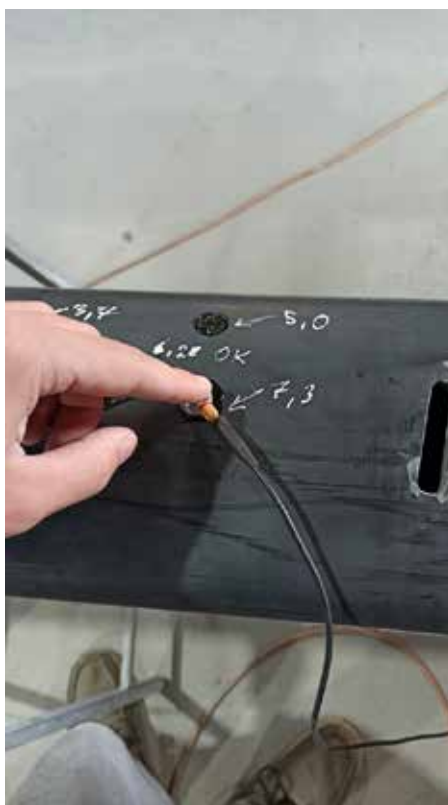
Figure 16. Position 3

The measuring point was marked on the mast in order to get a detailed picture of the condition of the mast and to determine later during the repair what kind of irregularity it is, considering that the ultrasonic examination did not give a concrete result. During the repair, that place on the mast was sanded and it was determined that it was an imperfection that occurred during the production of the mast in the factory, and that imperfection was filled with some kind of epoxy filler.

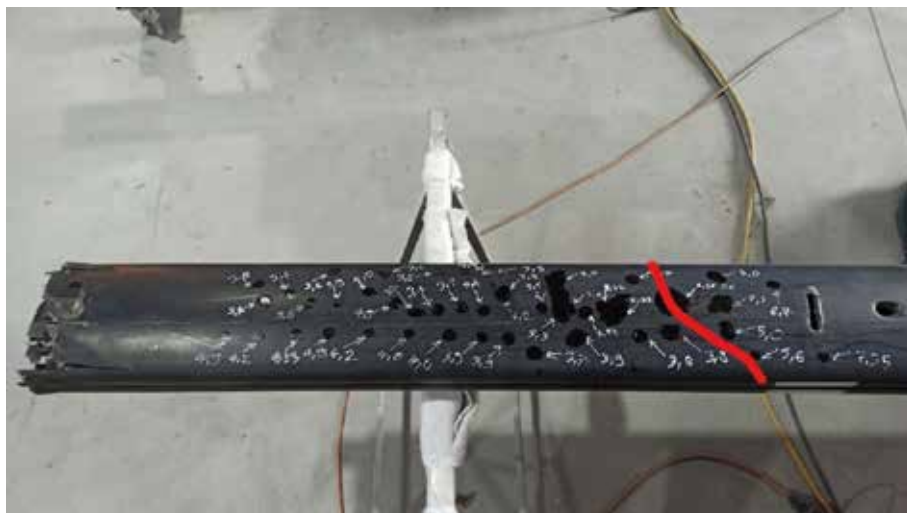
Figure 17 Magnitude of damage 1

After the mast was examined in a number of positions, an insight was gained into the magnitude of the damage itself. The damage, which at first glance seemed to be localized only around the rupture site, actually extends approximately 60 cm above the rupture site. The test was also performed on the lower part of the broken section and the obtained results indicated that the internal damage on the lower part is much less than on the upper part of that mast section. Figure 17 shows the amount of damage at the top of that mast section. All to the left of the red line is a wall that has layer delamination.

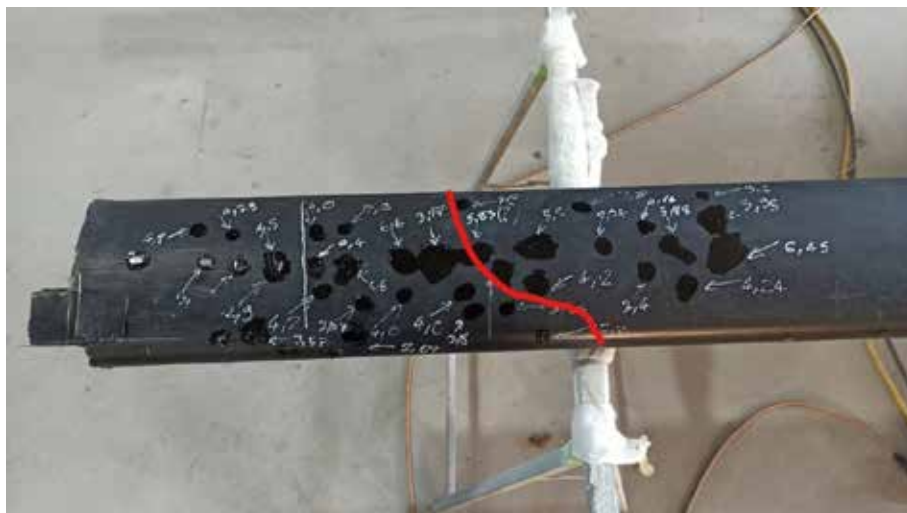
Figure 18 Magnitude of damage 2

The lower part of this section of the mast shows slightly less damage, but it is interesting to note that the place where the internal damage ends is not a straight line but in both parts of the mast is a curved line, which could indicate that it is indeed damage caused by torsional load on the mast. Figure 18 shows the lower part of that mast section. Anything to the left of the red line is damage.
