## Root cause analysis of the corrosion-related coiled tubing failure

Coiled tubing (CT) is widely used in the oil and gas industry. However, corrosion-related failures are frequently reported. Research into the causes of failures leads to improvement in the design of components and processes. In this study, a new CT sample and a CT sample with perforated wall that had failed after a few acidizing operations were selected for analysis. Scanning electron microscope (SEM) images at the fracture site showed that CT damage was caused by the low cycle fatigue. In addition, light and scanning electron microscopy (SEM) showed that a corrosion pit acted as the initiator of the crack. Elemental analysis using energy dispersive X-ray spectroscopy (EDS) indicated the presence of an iron oxide layer and a layer associated with the Sb containing inhibitor. The corrosion damage investigation showed that the internal CT wall pits likely formed during storage due to the acidizing operations in the areas where the remaining liquid was still at the tube bottom.

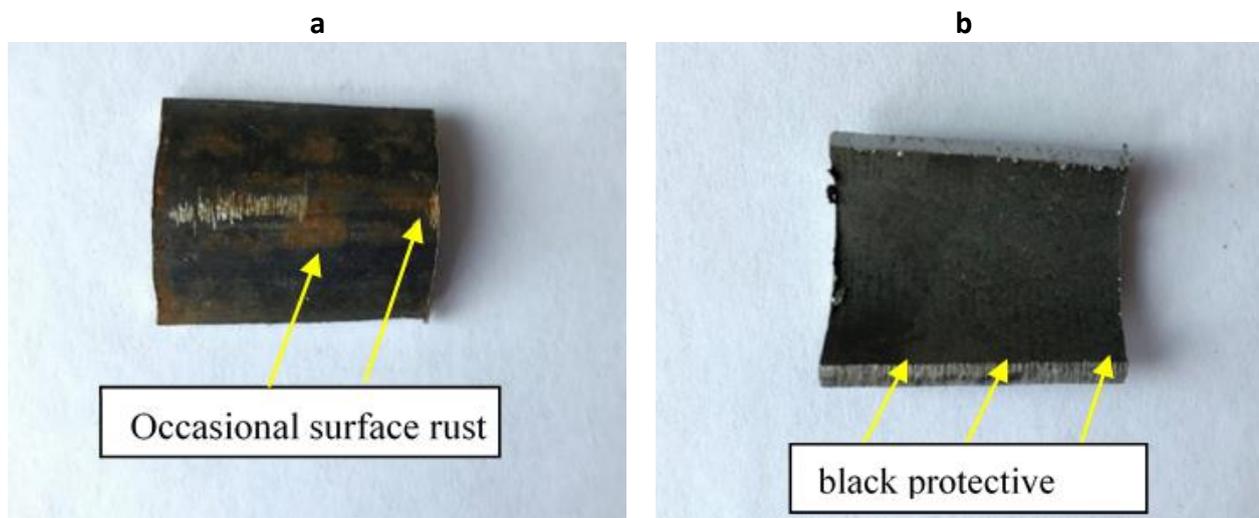
Visual examination of a new CT sample revealed no corrosion damage to the tubing, as shown in Figure 1. A uniform black coating, visually consistent with the corrosion protection applied by the CT manufacturer, was visible on both sides of the CT wall. In addition, surface rust is visible on the exterior wall of CT (Figure 1a) where the black coating is likely mechanically damaged. No rust was observed on the interior wall of CT (Figure 1b). The black coating was not damaged because the interior wall is protected from mechanical impact.

**Figure 1.** New coiled tubing: a - outer surface and b - inner surface

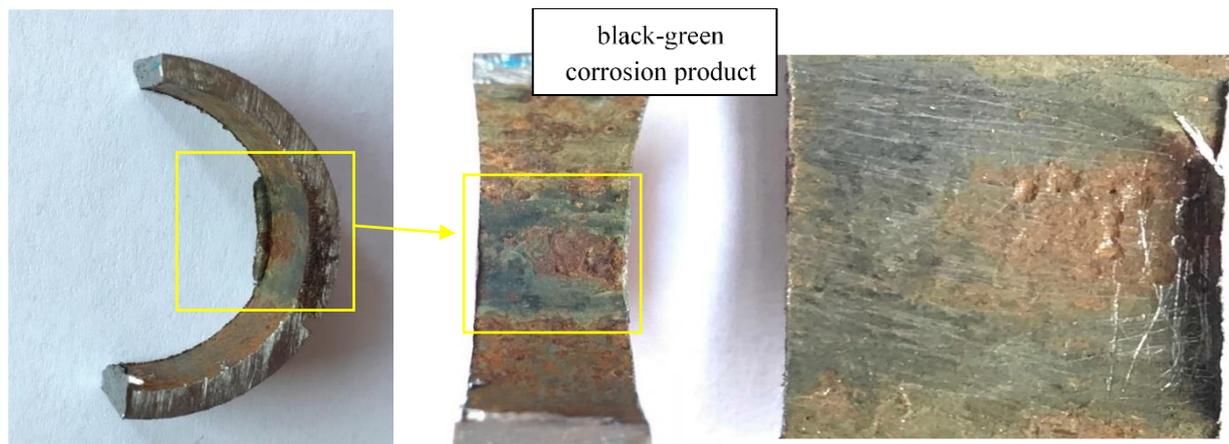
The used CT sample from the well had a metallic appearance on the outside with no visible corrosion products. On the inside, the sample was covered by a layer of brown corrosion products (Figure 2). A black-green corrosion product streak was observed longitudinally across approximately 20 % of the inner diameter.

Figure 2. Black-green corrosion product streak on a coiled tubing sample from the well

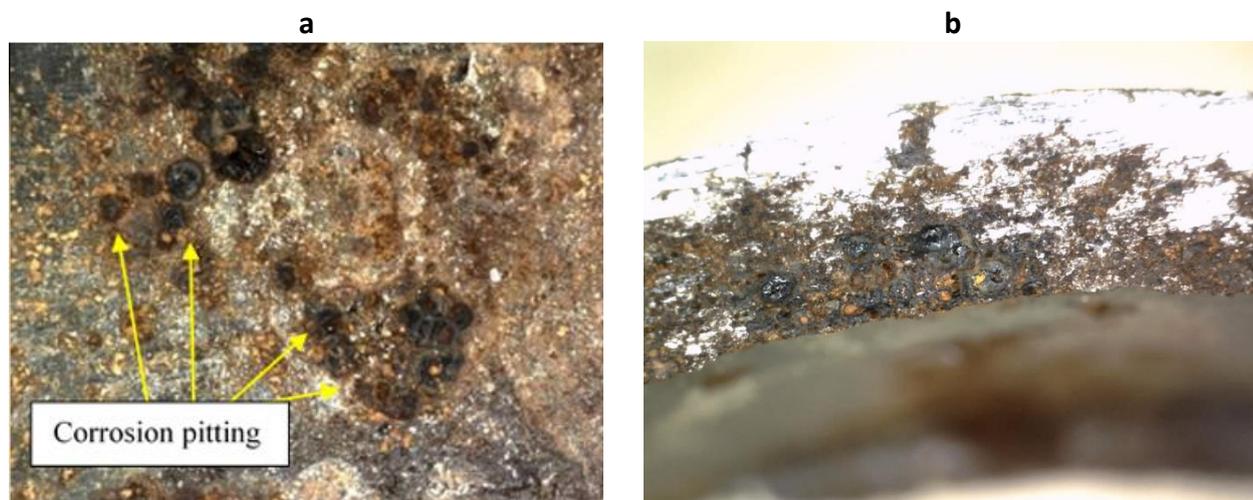
Figure 3 shows the corrosion pits and Figure 4a shows the cracks, both of which occur only within a black-green area. One of the cracks observed on the inside protruded through the wall of CT and was visible on the outside surface, as shown in Figure 4b.

Figure 3. Corrosion pits on the inner wall of the coiled tubing

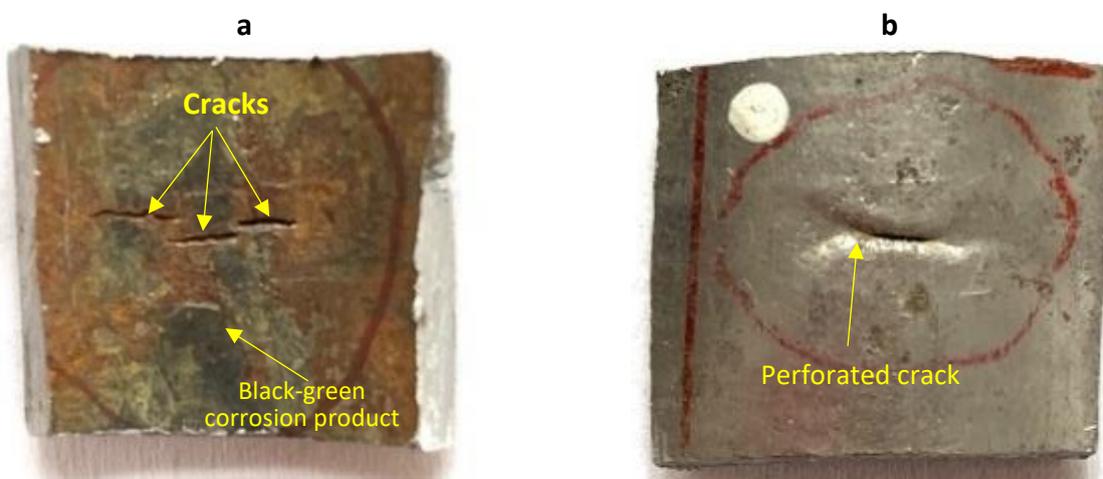
Figure 4. Cracks on a - the inner surface and b - the outer surface

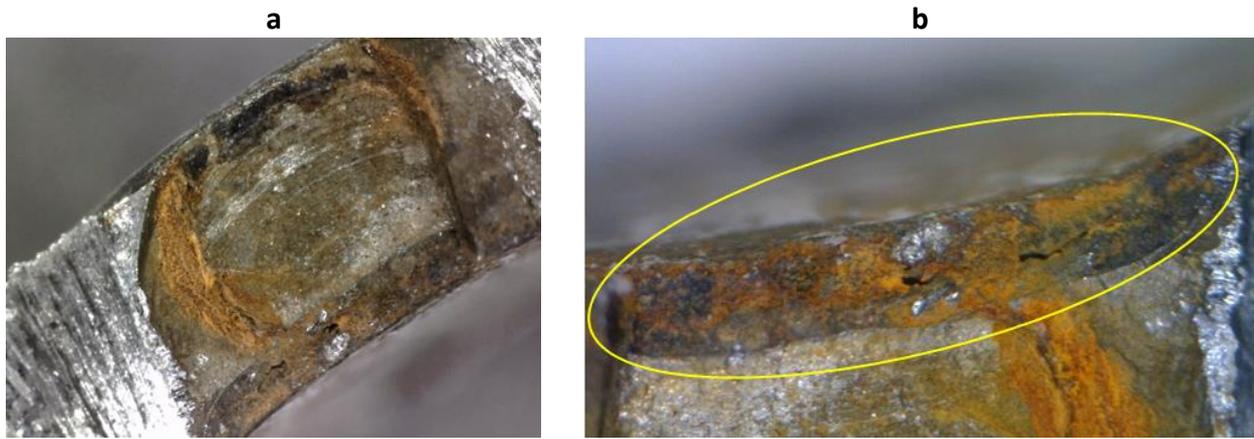
For close observation and examination, the sample was cut open to expose the fracture surface (Figure 5a). The edge of the corrosion damage in Figure 5b is the source of the striation marks and therefore likely served as the fracture origin. In the central part of the wall, a large area of striation marks perpendicular to the fracture direction was observed. The striations represent the propagation front of the fatigue crack and indicate that the fracture was caused by material fatigue. The Y-shaped crack ends shown in Figure 4b, also support the fatigue hypothesis. In addition, ridges have formed along the inner edge of the fracture parallel to the direction of fracture propagation, which can be

attributed to micro-cracking outside the central fracture plane. Terraces (stepped structures) are formed along the edges of the fracture, which are due to the initial development of the fracture in different planes.

**Figure 5.** Light microscope photographs of a - fracture surface and b - fracture initiation site

The number of striations is greater than the number of tube straightening and bending cycles, which may indicate a corrosion-related fatigue fracture. As the tip region of the fracture is repeatedly covered with a layer of corrosion products, the growth of the striation mark slows down. It can be argued that the numerous striation marks are due to the acceleration and deceleration of the growth of a fracture during each cycle. Becker and Lampman [12] reported that under many loading conditions, the pre-existing macroscopic crack-like defect blunts with increasing load and a new crack form by ductile tearing, creating a striation zone. Consequently, continued increase in loading causes the crack propagation mechanism to change to cleavage or quasi-cleavage.

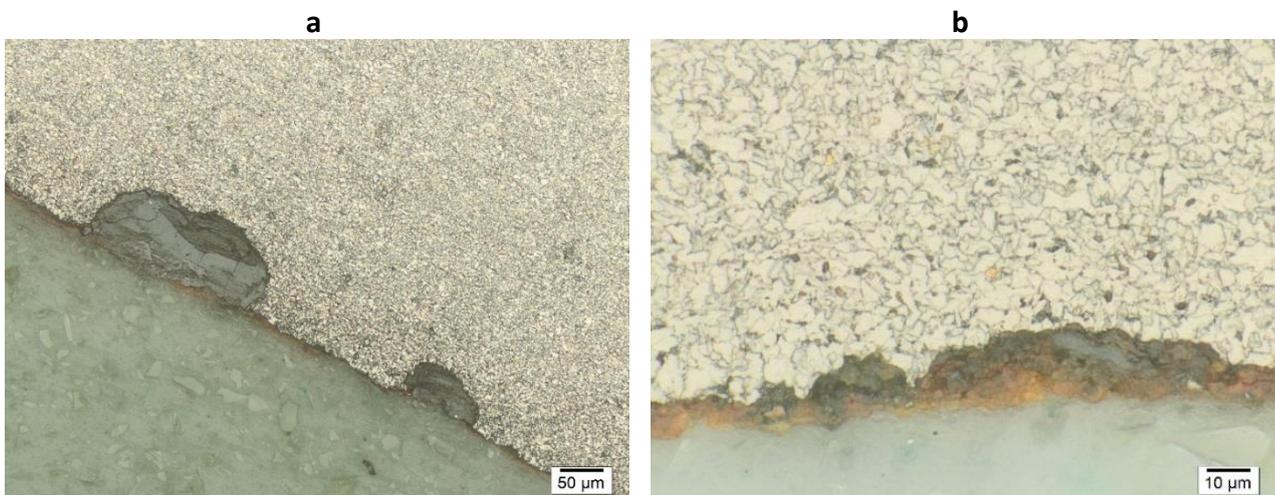
The internal surface shown in Figure 3a was examined under a metallographic microscope (Figure 6) and the corrosion pits contained a black corrosion product. Brown-orange corrosion product was seen above the black one on the surface of the shallower defects. The appearance of the corrosion damage suggests atmospheric corrosion of the steel with unobstructed oxygen flow outside the pit and a de-aerated space at the bottom of the pit. The corrosion, more pronounced on the inner diameter, is in good agreement with Still and Rolovic [13].

**Figure 6.** The corroded inner surface at different zones

- To prevent storage corrosion, it is necessary to properly maintain the tubing between acidizing operations by the following procedures:
  - nitrogen purging, preferably using a polyurethane ball to expel electrolytes from the tubing and subsequent capping the tubing ends,

- application of vapor phase corrosion inhibitors.

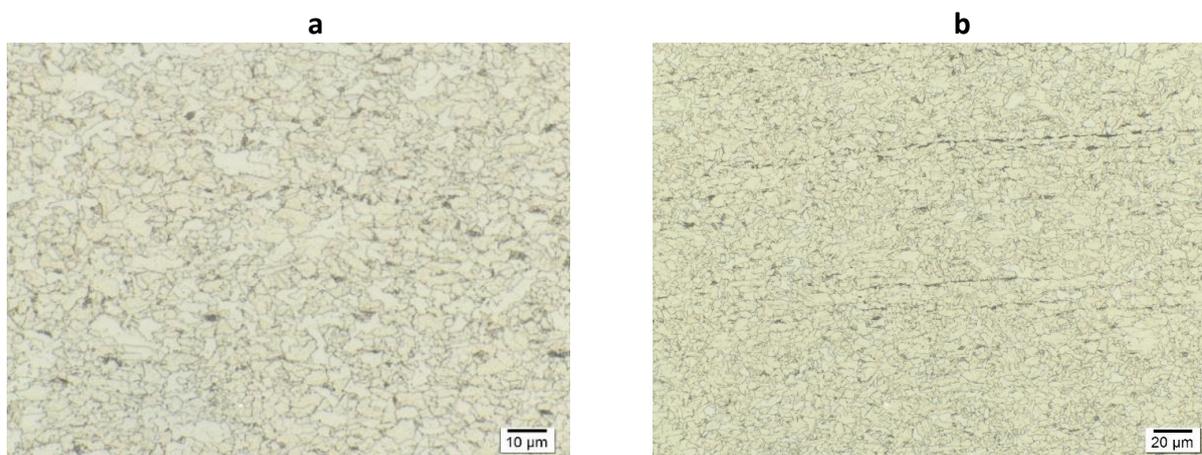
The polished and etched used CT had a fine-grained microstructure (ASTM sizes 13 to 14) with evenly distributed areas of ferrite and pearlite and some bainite, as shown in Figure 7a. Short banded structures of pearlite are observed in some places in the centre of the wall section (Figure 7b). No cracks are visible on the metallographic samples.

Figure 7. Fine-grained structure of quasi-polygonal ferrite with uniformly distributed areas of pearlite and bainite

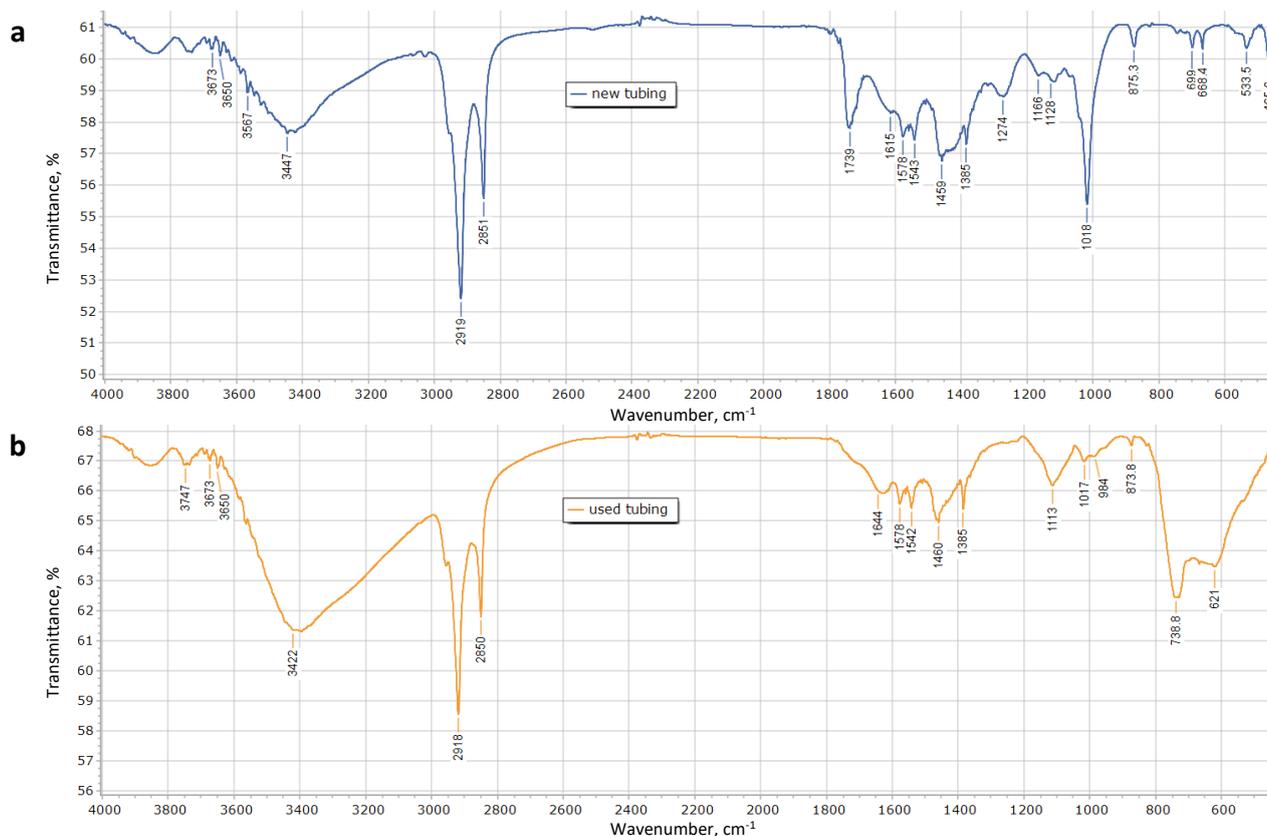
The layers on the inner surfaces of the new and used CT samples were rubbed with KBr, which was later pressed into pellets for FTIR analysis. The FTIR spectrum of the new CT sample, Figure 8a, shows no clear bands of iron oxides, confirming the absence of corrosion on the inner diameter of the new CT sample. The observed bands indicate the presence of an organic corrosion inhibitor used by the manufacturer of the CT. The FTIR spectrum of the used sample CT is shown in Figure 8b and indicates the presence of antimony oxide. Antimony salts were used as a component of the acidizing corrosion inhibitor and the inner surface of CT is partially covered with deposited metallic antimony, which oxidizes to antimony oxide when exposed to air.

Figure 8. FTIR spectra for a - new tubing and b - used tubing from the well

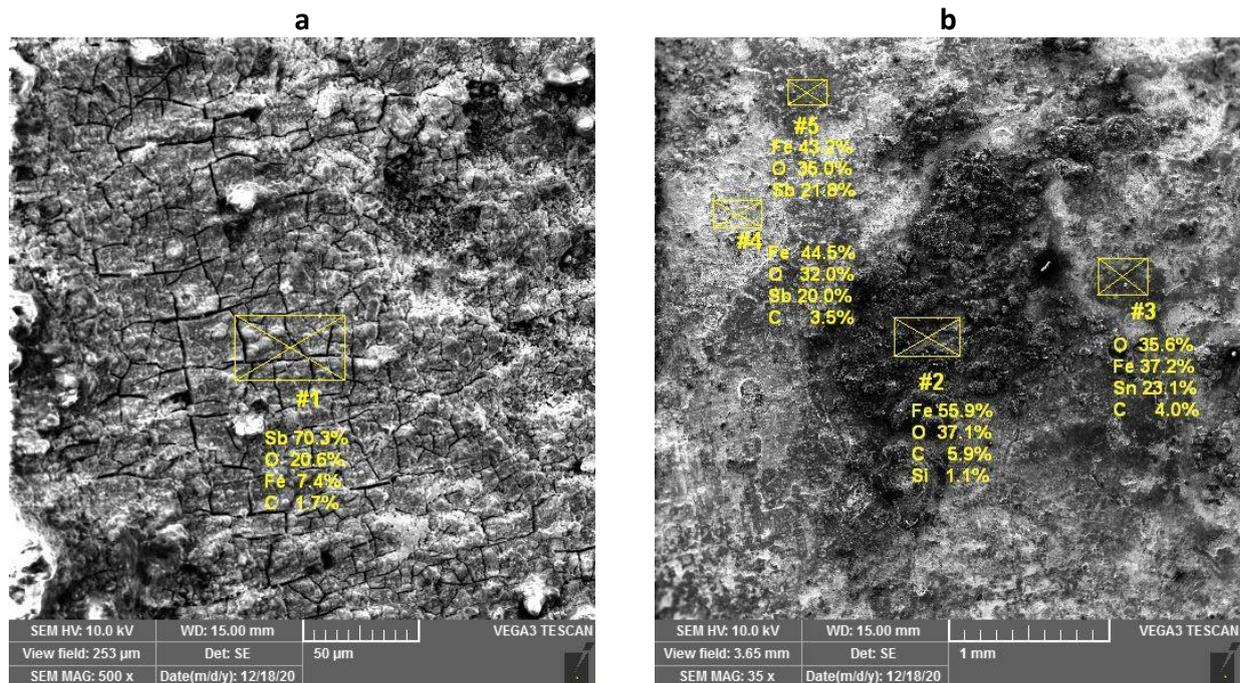
Figure 9a shows a cracked but layer of antimony at the inner surface of the used CT (measurement point #1), located away from the analysed crack. The inner surface near the crack in

Figure 9b shows that no continuous antimony layer is present (measurement points #3 to #5), and in particular, no antimony is found within the pit (measurement point #2)

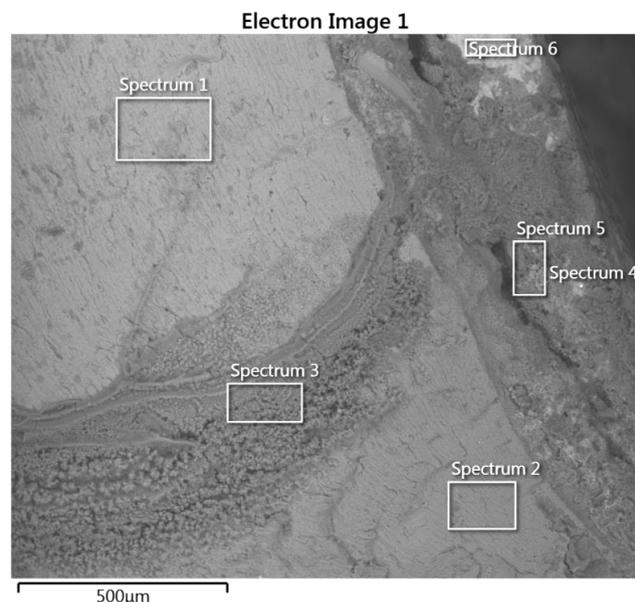
The EDS was performed at different locations on the fracture surface (Figure 10). Representative EDS spectra are shown in Figure 11, and the results are summarized in Table 2. The EDS elemental analysis of the fracture indicates elements that can originate from the metal substrate (Fe, Cr, Si, C) or the environment (O, C, S, Si, Cl, Sb). Carbon can originate from the organic component of the corrosion inhibitor. Small amounts of sulfur were detected during the test. The sulfur could be from  $H_2S$  from the environment and/or microbiological corrosion induced by sulfate-reducing bacteria (SRB). However, the amount of sulfur is minimal and the source of the sulfur could not be clearly determined from this analysis. The presence of sulfides was not detected by the lead acetate paper test.

**Figure 10.** EDS spectra locations at the fracture surface of the perforated sample

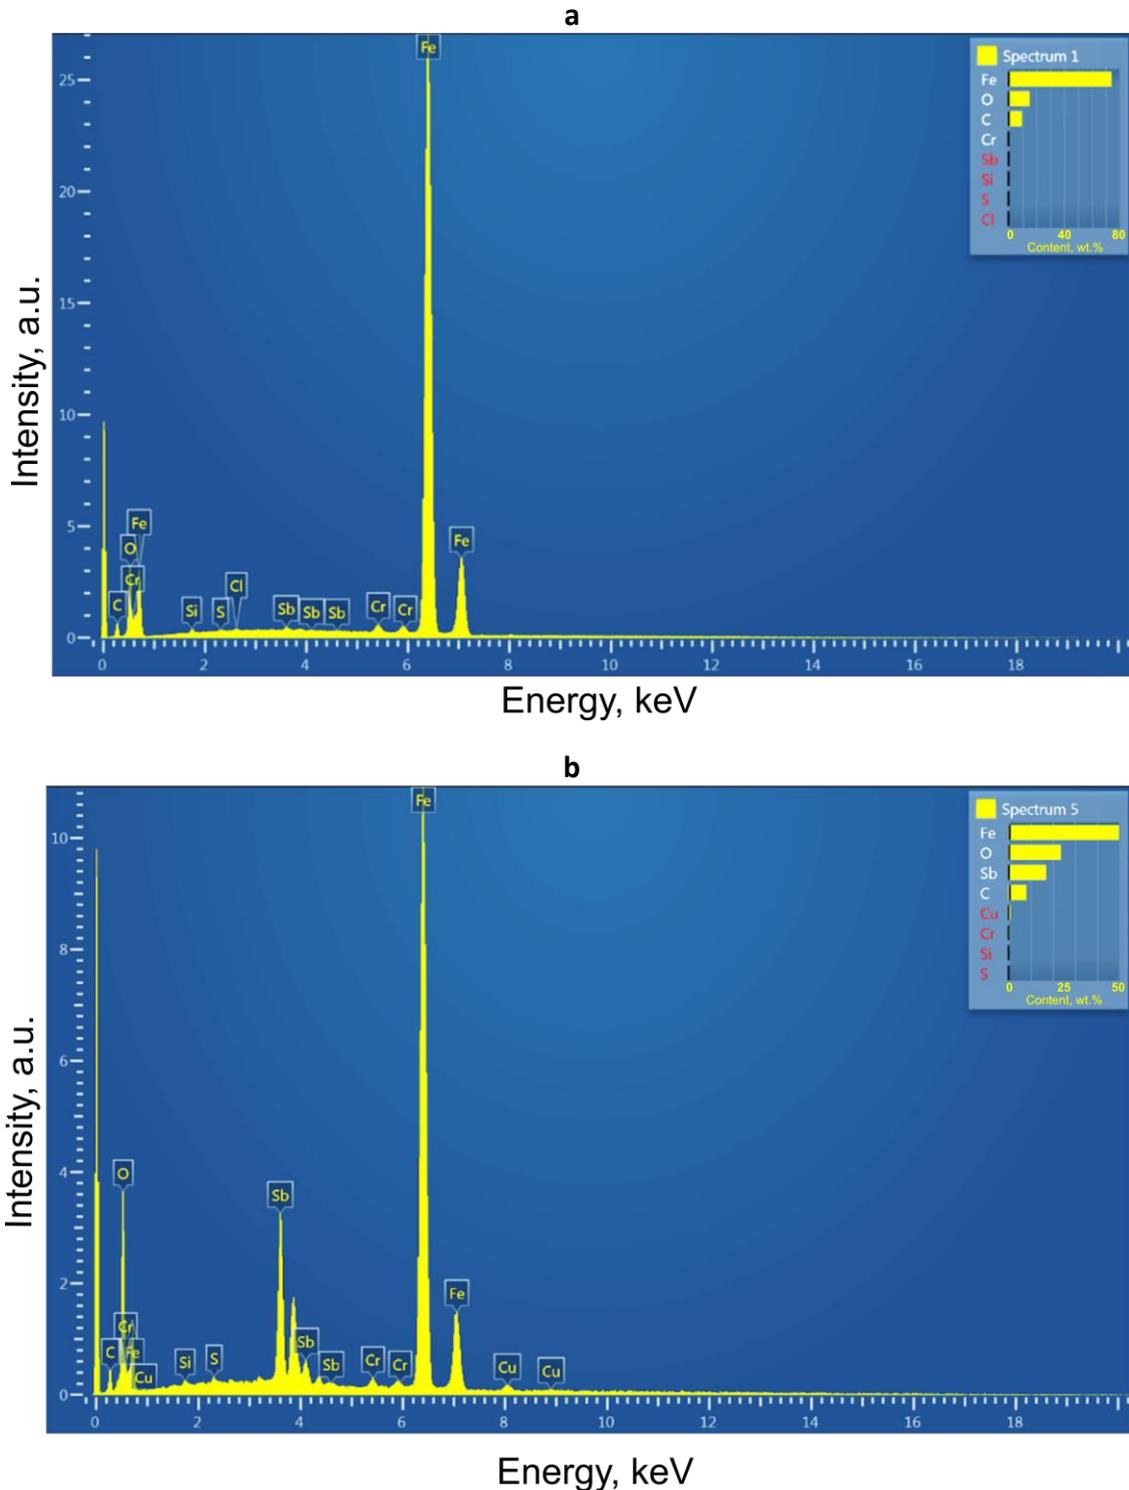
**Figure 11.** Representative EDS spectra of the fracture surface in Figure 10 at different locations: **a** -location 1 and **b** - location 5

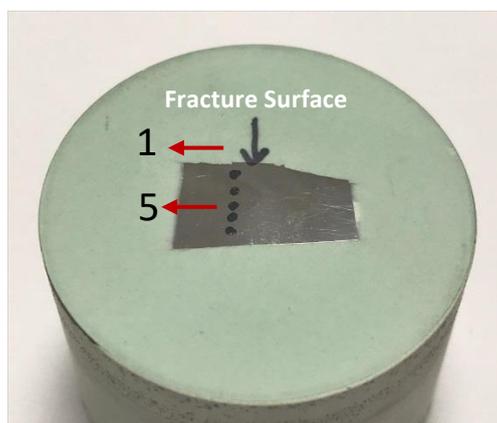
Figure 12 shows the locations where the hardness measurements were made, and the results are summarized in Table 3. The hardness values were relatively consistent and agreed well with the declared value of 91.87 HRB (190 HV) of the CT-80 tubing parent material. Given the relatively small grain size (ASTM 13 to 14) and the fact that hardness decreases with decreasing grain size, this is the expected value of the measured hardness. H. Ghiasi [14] reported that the microstructure affects the improvement of properties and fatigue life. By decreasing the grain size, the mechanical properties and fatigue life increased.

**Figure 12.** Vickers microhardness examination sites**Table 3.** Vickers hardness values near the fracture at different locations

Location	HV	Location	HV
1	204	4	201
2	203	5	199
3	206	$\bar{x} \pm \sigma$	$202.6 \pm 2.7$
