CRACK ANALYSIS OF CRANKSHAFT FOR DIESEL ENGINE

The cause of crankshaft fracture crack of a certain vehicle has been analyzed through macroscopic analysis, microstructure analysis, mechanical properties test and dimension inspection. The analysis results show that: the fatigue strength of the crankshaft is reduced due to spheroidization recession, low strength and shallow nitriding layer of the fillets.

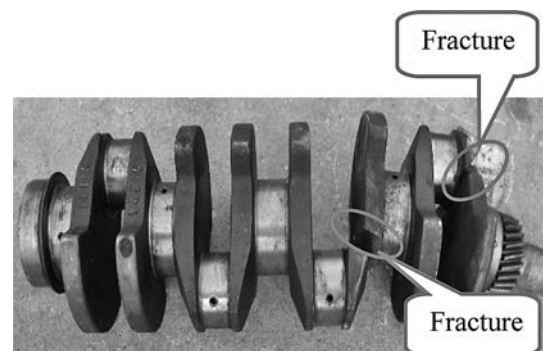
The crankshaft is an important part of the engine and the key part of engine power transmission. It can be said that the quality of the crankshaft determines the service life of the engine. So it plays an important role in improving crankshaft processing technology and improving crankshaft performance to study the crankshaft fracture crack. There are three broken crankshafts made of qt900-3 in an engine company. The strengthening process of crankshaft is ion nitriding. The fracture diagram of one crankshaft is shown in Figure 1.

Figure 1 The fracture diagram of crankshaft

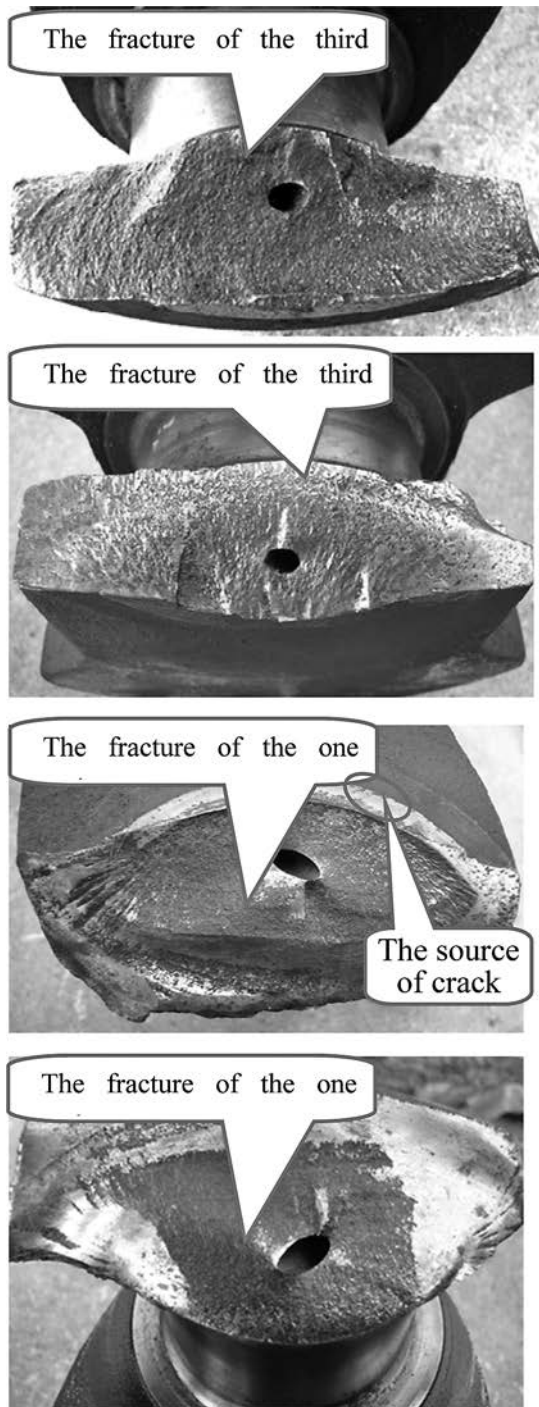
The three crankshafts were broken all at the one and three cranks of the crankshafts. By observing the fracture crack areas of the crankshafts, the crack sources of the three crankshafts are all at the connecting rod fillets. The fracture surface of the first two crankshafts are rough, with a small amount of radial fatigue cracks, showing brittle cleavage fracture. The fracture surface of the third crankshaft is relatively fine, with obvious fatigue striation, and the surface of the fracture sources is severely worn, which is a typical fatigue fracture. Therefore, of crack source by using wire cutting. Both of these two cracks are fatigue fracture. The macroscopic fracture diagram of crankshaft is shown in Figure 2.

Figure 2 The macroscopic fracture diagram of crankshaft

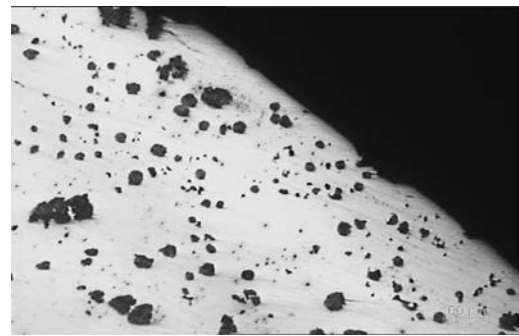
The results showed that the graphite spheroidization level near the fracture of the crankshaft was level 5. The diameter of graphite ball was 5 grades. The diameter content was 95 %. There is no cementite phosphorus eutectic at the fracture crack location. The nitriding infiltration layer of the fillets was 0,1 and the nitriding infiltration layer of the journal was 0,2 as shown in Figures 3, 4,5,6 and Table 1.

From the microstructural picture and detection value, Spheroidization of the crankshaft is not uniform, the graphite ball is larger, the nitriding infiltration layer of the rounded corner is shallow, lower than the technical requirements.

Figure 3 Graphite morphology on the surface of the fracture site.

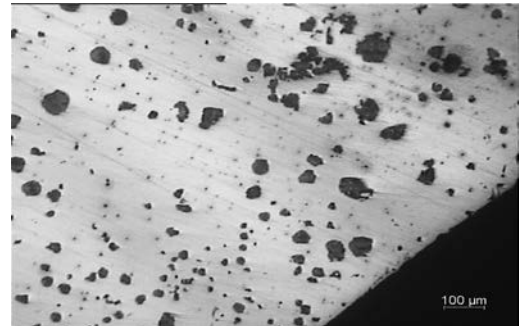
Figure 4 Graphite morphology on the surface of the fillet

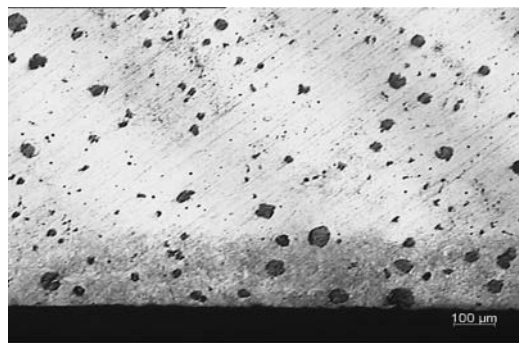
Figure 5 The nitriding layer of the journal

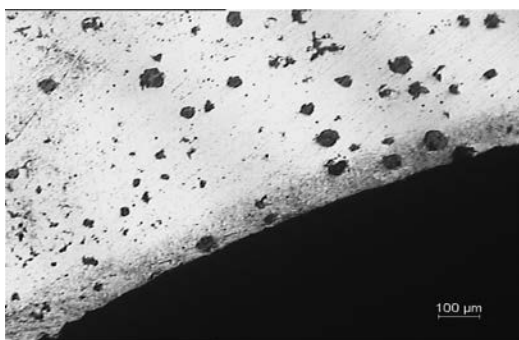
Figure 6 The nitriding layer of the fillet
