The SDIPF reliability curve of old EHV power transformers

A historical review for utilities when developing specifications for new transformers - Part III

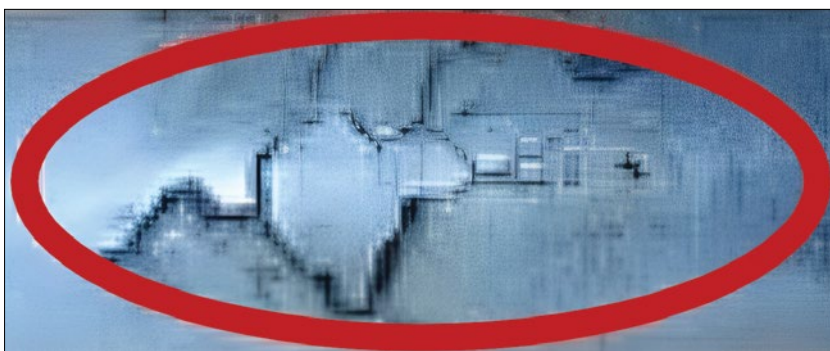
In total, *polzuchy razryad* damaged several dozens of ATs and GSUTs 330–500 kV and several units of 220 kV transformers (damage to interfacial insulation). The damage of 330 kV transformers was about an order of magnitude greater than that of 500 kV transformers. For both voltages of 330 and 500 kV, the damage of ATs was higher than that of GSUTs. The authors failed to restore the true number of damaged transformers. At that time, only ZTZ produced 330–500 kV transformers. But this period is not reflected in the reference list of this plant, which includes transformers starting only from 1970 [4].

Figure 1. The *polzuchy razryad*

To eliminate *polzuchy razryad* problem, ZTZ underwent restructuring with improvements made in design, production processes, insulation drying methods, testing, and equipment

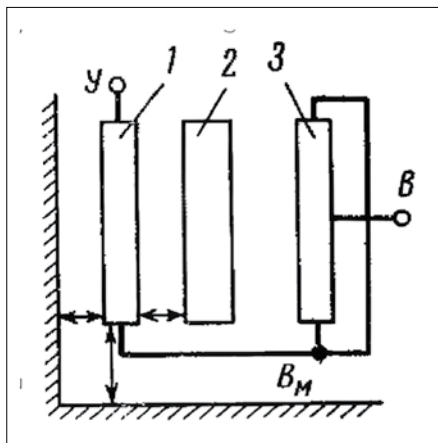
Five 330 kV transformers failed due to a breakdown in the connection of two parts of the HV winding to the ground (Fig. 2). Usually, the number of turns in the Y-Bm section is 50 % of the total number of turns of the HV winding. Insulating gaps indicated by arrows in Fig. 2 are rated for 50 % ACSD applied to the HV terminal. In addition, these gaps must withstand the impulse voltage that occurs at the Vm point with 100% LI applied to the HV terminal. These failures were caused by the poor design of the isolation of these gaps (the design was later changed). Perhaps there was also an accumulation of water at the bottom of the tank, which penetrated through the upper seals of the bushings and caused a sharp decrease in the electrical strength of the insulation [5].

Figure 2. The layout of the windings in the GSUT in the case of a double concentric HV winding (1 - the inner part of the HV winding, 2 - LV winding, 3 - the outer part of the HV winding)

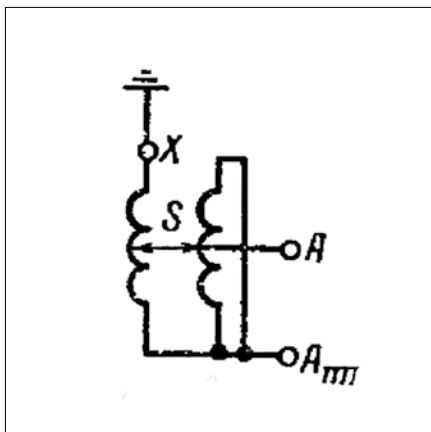
Similar damage occurred in autotransformers (Fig. 3). In these cases, the voltage value in the lower part of the windings depends on the ratio ACSD, and LI applied to the HV and MV terminals (330/110, 330/150, 330/220, 500/110 kV).

Figure 3. A typical AT winding connection diagram.

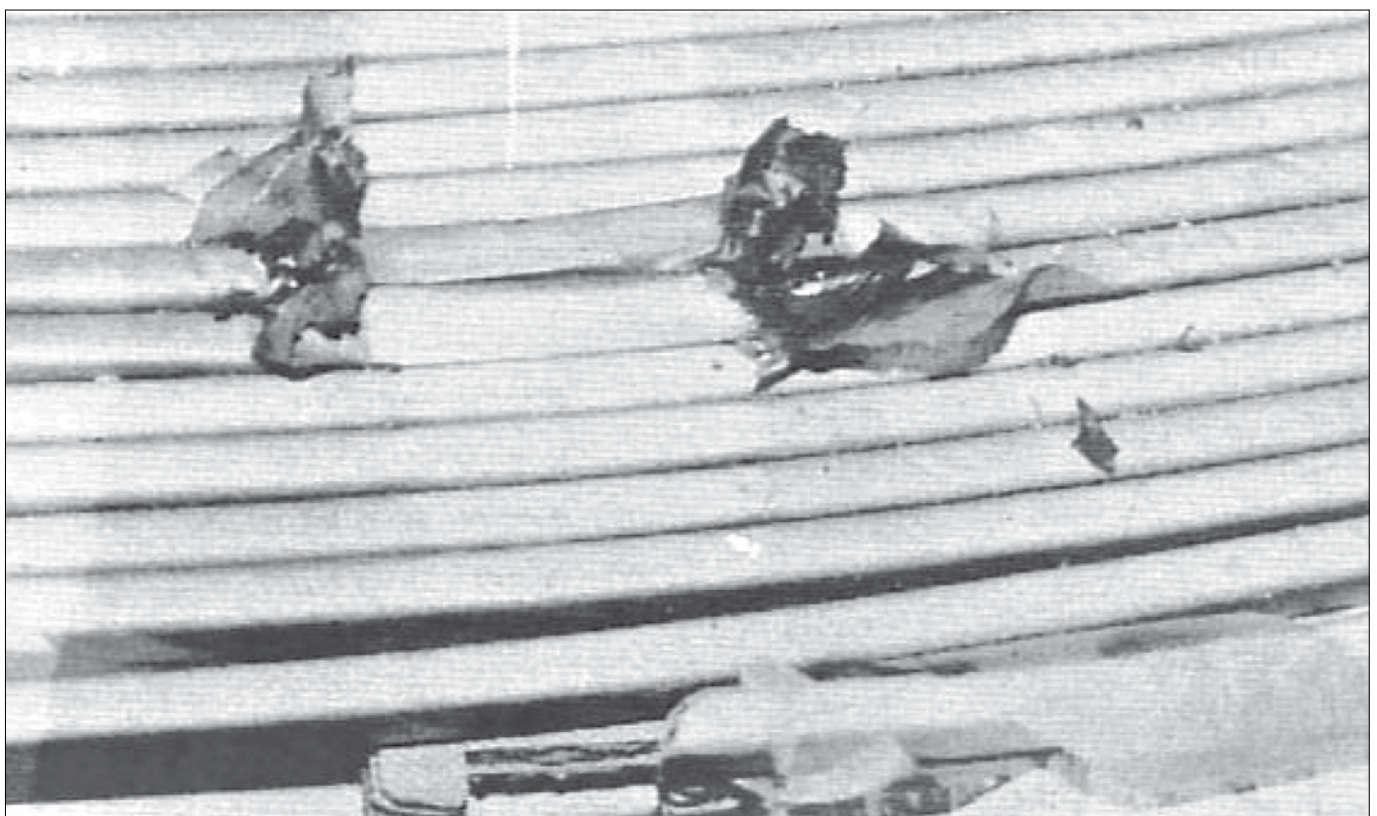
tion”. Fig. 6 shows one of the types of faults in the HV winding.

Figure 6. Turn-to-turn punctures found in the discs adjacent to the site of the fault of the main insulation [13]

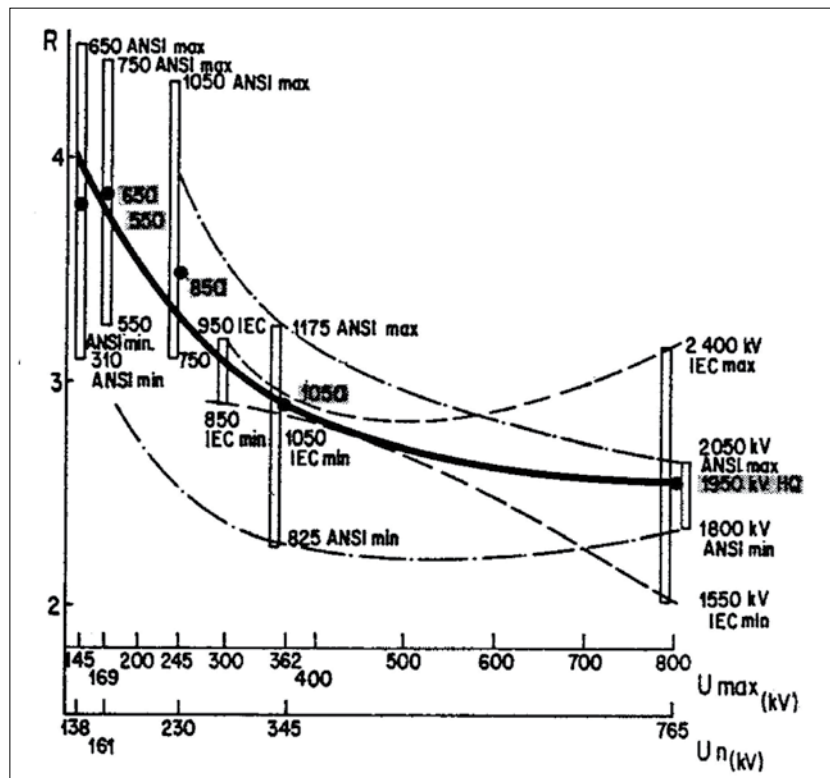
in the customer's specification. This tolerance and the ratio R of the standard test voltage to the operating voltage for different transmission levels are shown in Fig. 7.

- Insulation strength margins of 735 kV transformers are significantly lower than those of transformers of lower voltage classes. This is due to the lower test voltage levels of 735 kV transformers.
- Switching overvoltages generated by circuit breakers can reach

Figure 7. Ratio R of the impulse test voltage (BIL) to the rated system voltage U_n plotted against the maximum system operating voltage U_m . The limits of the BIL voltage Specified by IEC and ANSI are indicated together with the levels Specified by Hydro-Quebec (Source: [12])

- The highest level of transients occurs during the shutdown of autotransformer 735/345 kV on the 345 kV side. This procedure should be excluded.
- Even in cases where the generated transients in the system do not exceed the protection level and the arrester does not operate, steep overvoltages can cause dangerous internal resonant oscillations in the HV windings.
- It is necessary to update the technical specifications for new EHV transformers.
