A site survey of damaged RC buildings in İzmir after the Aegean sea earthquake on October 30, 2020

Research Paper

Halit Cenan Mertol, Gokhan Tunc, Tolga Akis

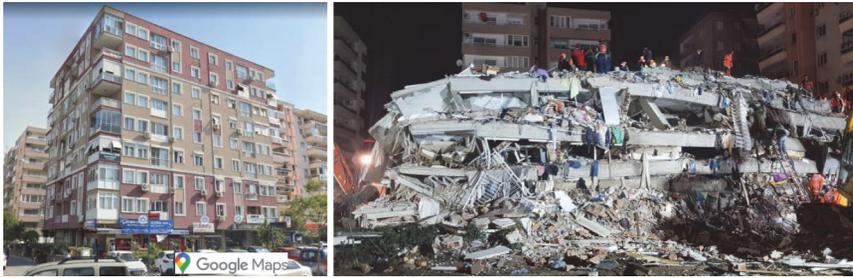
A nine-story building, the Rıza Bey Apartment, collapsed fully during the earthquake. The building construction was completed in 1994. The building consisted of 32 separate apartments and five shops at the ground-story level. Based on videos shot during the collapse, the collapse of this building started with the failure of the ground story columns. After the remainder of the building shifted one story

Figure 21. Photographs of the Riza Bey Apartment Building before and after the earthquake

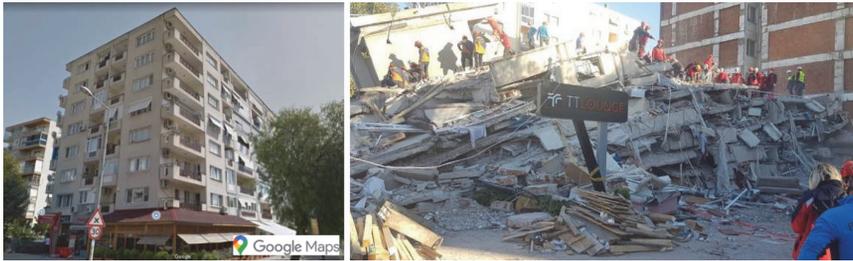
The Doğanlar Apartment Building, with its 21 apartments and four shops at the entrance level, collapsed approximately 1 min after the earthquake. Construction of this eight-story building was completed in 1992. One side of the building was adjacent to the other, with a small gap between them. During its collapse, the Doğanlar Apartment Building shifted away from the adjacent building. Photographs of the buildings before and after the earthquake are shown in Figure 22.

Figure 22. Photographs of the Doğanlar Apartment Building before and after the earthquake

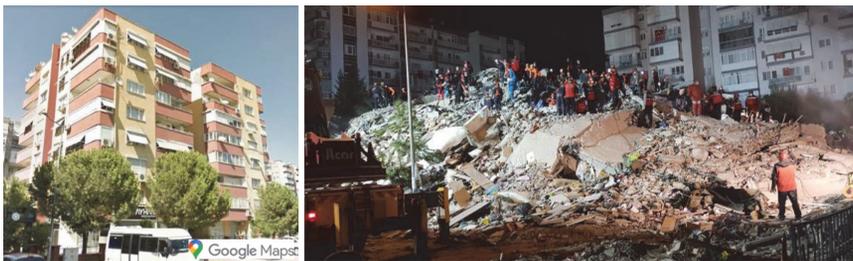
Figure 23. Photographs of the Emrah Apartment Building before and after the earthquake

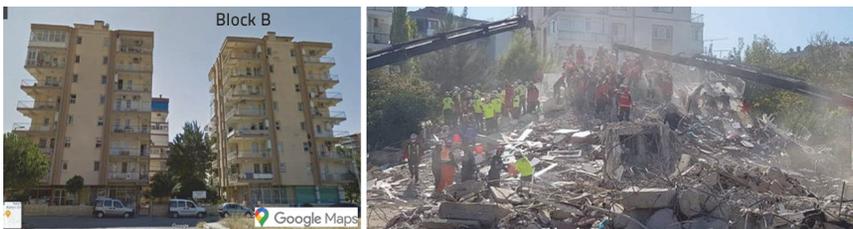
Figure 24. Photographs of Block B of the Yağcıoğlu Apartment Complex before and after the earthquake

Block B of the Yağcıoğlu Apartment Complex collapsed fully after the earthquake, whereas Block A survived the earthquake with heavy damage. Each block of this apartment complex consisted of an 8 story building with 14 separate apartments and four shops located at ground level. Both the buildings were constructed in 1993. Photographs of the buildings before and after the earthquake are shown in Figure 24.

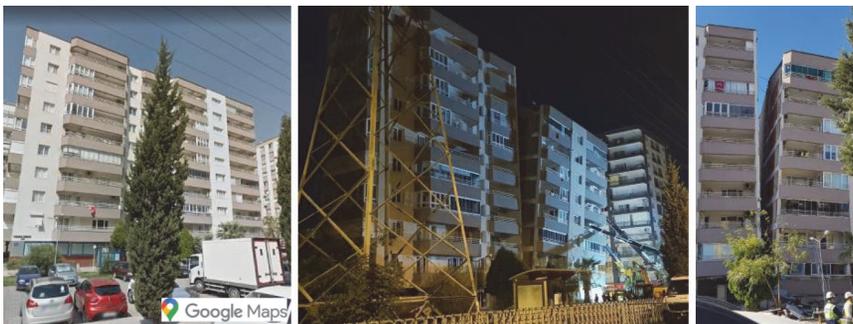
Figure 25. Photographs of the Yılmaz Erbek Apartment Complex before and after the earthquake

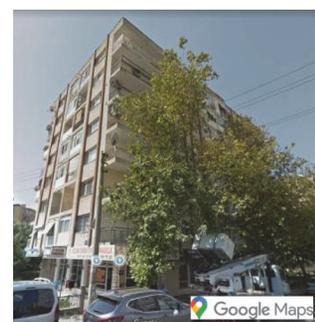
The eight-story Karagül Apartment Building, with 28 separate apartments and shops at ground level, was heavily damaged during the earthquake. The building was constructed in the early 1990s. Each residential story consisted of four apartments, and only one-fourth of the building area (corresponding to one apartment) partially collapsed a few minutes after the earthquake. Photographs of the building before and after the earthquake are shown in Figure 26.

Figure 26. Photographs of the Karagül Apartment Building before and after the earthquake

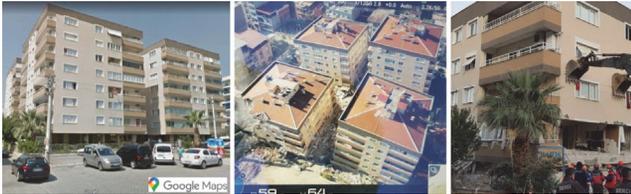
The Barış Apartment Complex, which was comprised of four blocks with eight stories each, was constructed in 1992. Three of these buildings partially collapsed, and one experienced extensive damage without collapse. The first four stories of the two blocks and the first three stories of the other block collapsed on top of each other. The stories over the collapsed portions of the buildings survived the earthquake by leaning towards one side of the buildings. Photographs of the Barış Apartment Complex before and after the earthquake are shown in Figure 27.

Figure 27. Photographs of the Barış Apartment Complex before and after the earthquake

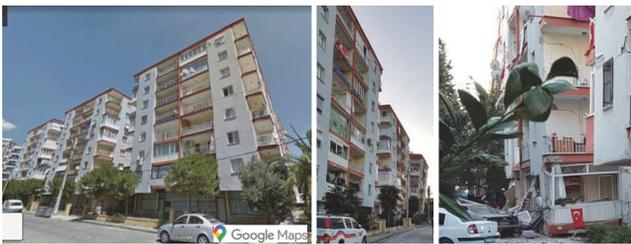
A similar failure mode was observed in the Cumhuriyet Apartment Complex constructed in the early 1990s. The complex consisted of three blocks of eight stories each. One block survived the earthquake with heavy damage; however, the first stories of the other two blocks collapsed, causing the uncollapsed sections of the buildings to shift by one story. Photographs of the Cumhuriyet Apartment Complex before and after the earthquake are shown in Figure 28.

Figure 28. Photographs of the Cumhuriyet Apartment Complex before and after the earthquake

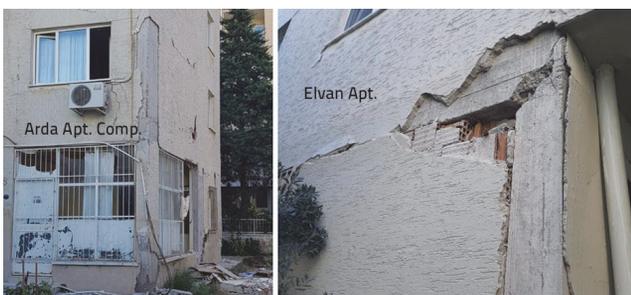
There were numerous severely damaged buildings in the city of İzmir during the Aegean Sea earthquake. A typical damage type was diagonal cracking on structural (beams, columns, and shear walls) and non-structural (partition walls) elements, as shown in Figure 29.

Figure 29. Diagonal cracks on structural and non-structural elements

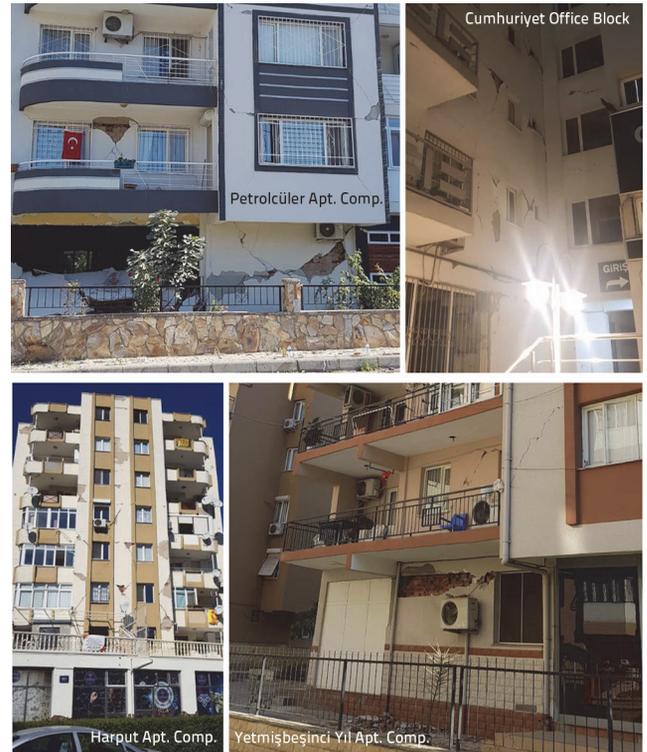
Structural damage to the columns was also significant in some of the buildings, as shown in Figure 30. However, some of the buildings constructed side-by-side were separated because of the collision (hammering effect) of these buildings moving in opposite directions during the earthquake. This type of motion damages the structural elements of buildings. An example of this behaviour is shown in Figure 31.

Figure 30. Severe column damage

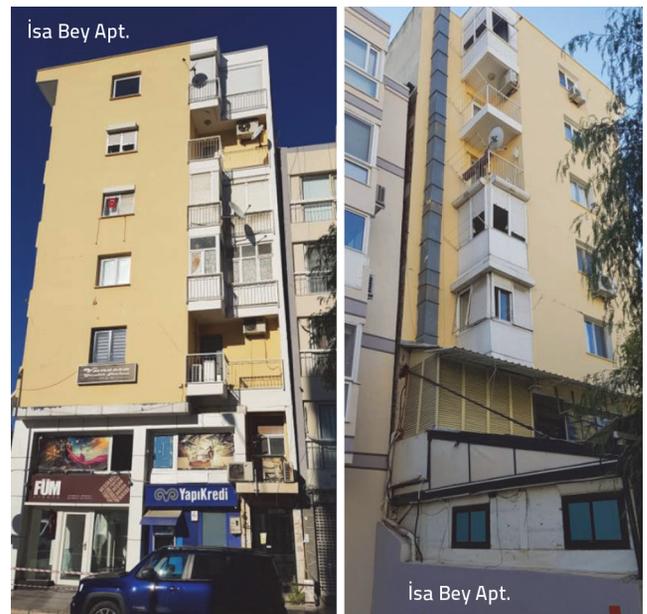
Figure 31. Separated buildings constructed side by side

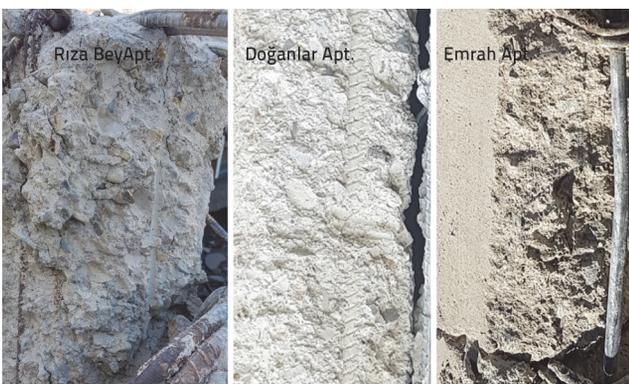
Based on site observations of the concrete members of the collapsed buildings, it was determined that the concrete used in these buildings consisted of round coarse aggregates of 30–50 mm in diameter. Round and large aggregates would result in poor interlocking behaviour and weak bond strength between the concrete and steel reinforcement. Photographs of some of the concrete samples are shown in Figure 33.

Figure 33. Concrete quality in various collapsed buildings

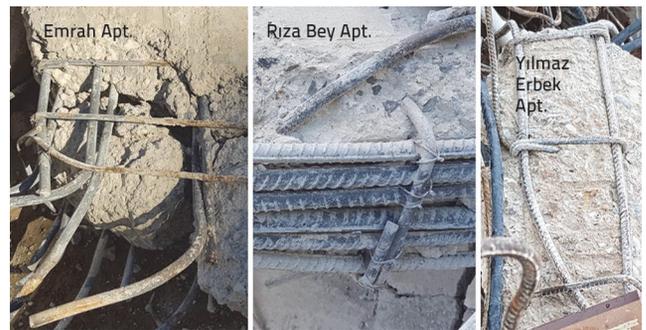
TEC (1975) [55] did not specify the type of steel reinforcement that should be used in RC buildings. Only plain longitudinal and transverse reinforcing bars were available in Turkey during the early 1990s. The steel-reinforcing bars exhibited a minimum yield strength of 220 MPa. Deformed reinforcing bars have been available since the mid-1990s. Visual observations of the collapsed buildings confirmed that combinations of these reinforcements were used during construction. For example, plain bars were used in the construction of the Emrah Apartment, both as longitudinal and transverse reinforcements. The longitudinal and transverse reinforcements used in the Rıza Bey Apartment were deformed and plain, respectively. In the Yılmaz Erbek Apartment, only deformed bars were used as reinforcement. Photographs of the reinforcements are shown in Figure 34.

Figure 34. Reinforcement types in various collapsed buildings

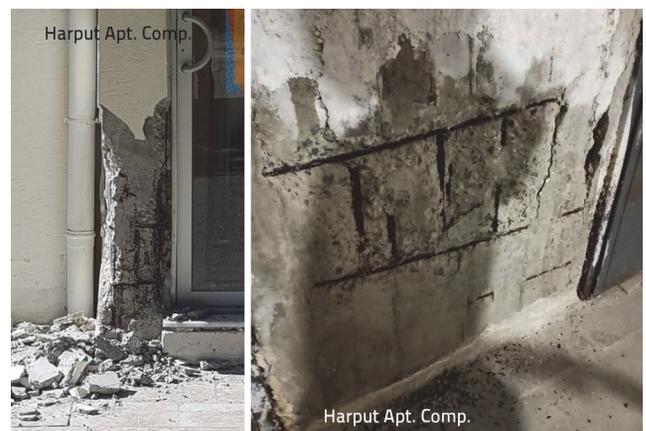
Most of the buildings in the area had moisture problems owing to the humid climate, high water table level, and insufficient water insulation, particularly at the ground level. Therefore, the reinforcements of the structural members of these buildings corroded extensively, resulting in a significant reduction in the cross-sectional area of the reinforcements. Examples of the corroded reinforcements are shown in Figure 35. It is important to note that these mistakes are repeated when building damage is investigated during most earthquakes. For instance, the field observations recorded after the Sivrice, Elazığ, Turkey earthquake on 24 January 2020 are an example of this [63].

Figure 35. Corrosion of reinforcements due to moisture

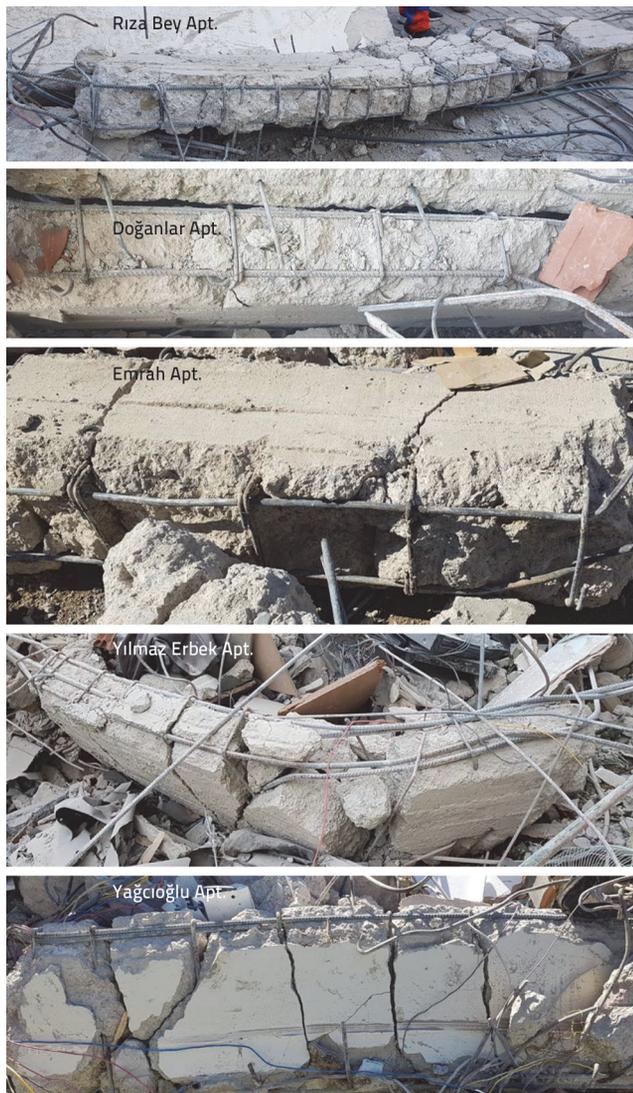
As stated previously, TEC (1975) [55] required closely spaced stirrups (confinements) to be used at the end regions (confinement zones) of the beams and columns. The length of this region was a minimum of one-sixth of the column height, or 450 mm for the columns. TEC (1975) [55] also specified the maximum distance between the two stirrups in this region as 100 mm. Site observations indicated that no confinement was used at the ends of the beams and columns. Examples of the reinforcement configurations of the columns and beams of collapsed buildings are shown in Figure 36. This finding was also supported by various SER [58, 59] prepared for these collapsed buildings.

Figure 36. Reinforcement configurations of the columns and beams of the collapsed buildings

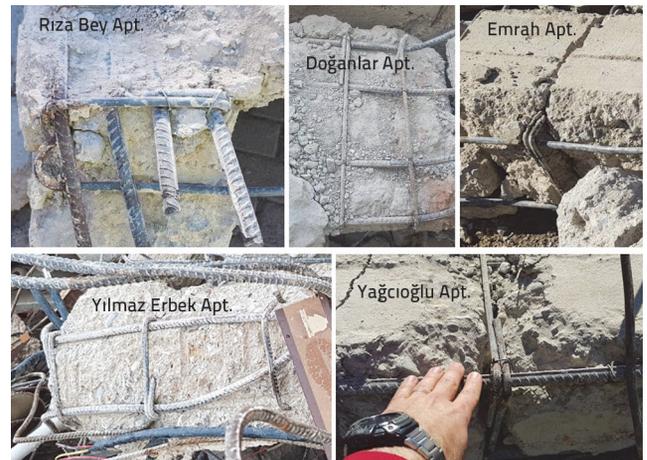
Although TEC (1975) [55] required bending the ends of the stirrups into the concrete core (135° hooks), the ends of the stirrups were only bent by 90°, resulting in the opening of the stirrups after the spalling of the cover concrete in the beams and columns. Photographs of

these stirrups in various collapsed buildings are shown in Figure 37. As with the observations made in the materials section, problems related to the reinforcement configuration have been frequently observed in Turkey following an earthquake.

Figure 37. Ends of the stirrups (bent 90°) of the collapsed buildings

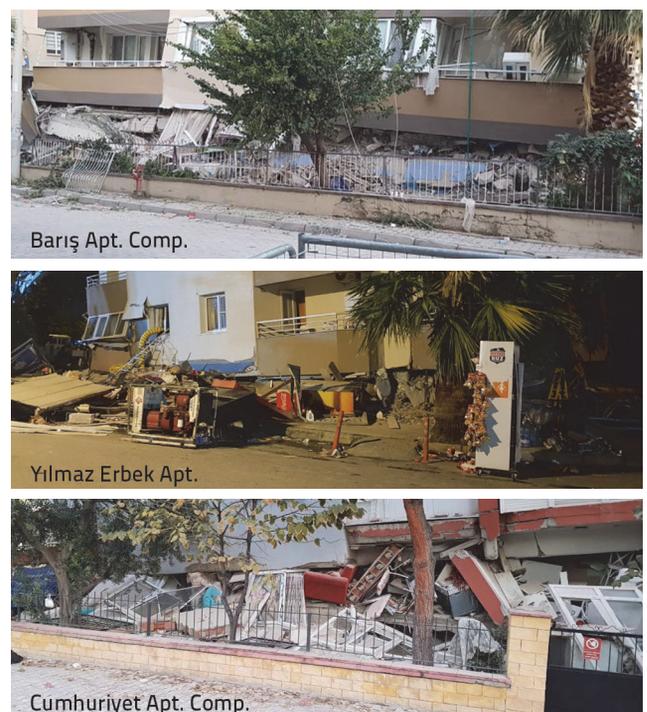
TEC (1975) [55] did not define irregularities based on story stiffness. The effects of this type of irregularity were first introduced into the 1998 earthquake code [56]. The strong beam–stronger column requirement first appeared in TEC (1998) [56]. The first few stories of some of the buildings collapsed like a sandwich during the earthquake. These buildings had story stiffness irregularities at the ground-story level which likely played a major role in their collapse. Photographs of these buildings are shown in Figure 38.

Figure 38. Collapsed buildings due to the failure of first story columns

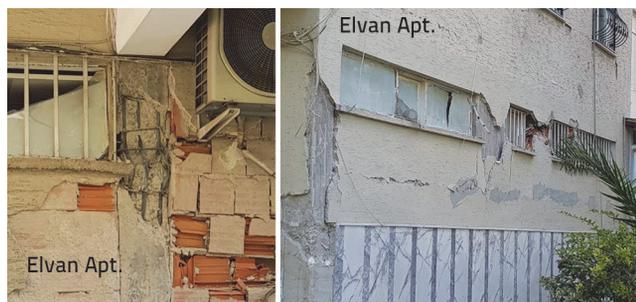
According to TEC (1975) [55], the transverse reinforcement was confined along the length of the short columns. An example of the damage caused to short columns after the earthquake is shown in Figure 39. Reinforcement confinement was not observed in the short columns.

Figure 39. Short column formation in a severely damaged building

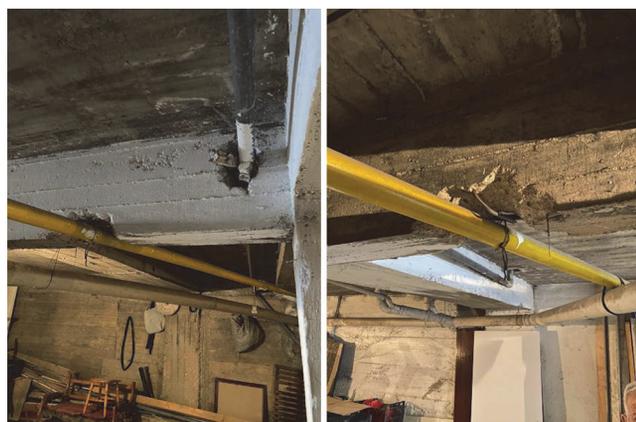
Before the beginning of the millennium, construction work in Turkey had not been properly inspected. Reports related to soil investigations and structural designs were not always reviewed by an institution. During construction, the strength of the materials (concrete and steel) used was not tested, and the correct application of the structural drawings in terms of the reinforcement configuration and dimensions of the structural members was not confirmed. In some collapsed and severely damaged buildings, the SER prepared before the earthquake indicated that the reinforcement configuration of the structural drawings differed from that of the constructed buildings. Furthermore, the sizes of the constructed structural members did not match those in the structural drawings of some buildings [58, 59]. For example, a column of 250 × 800 mm in size in structural drawings was constructed in 1988 as 250 × 500 mm along the height of a 9-story building.

Figure 40. Beam damaged for plumbing (Karşıyaka, İzmir)
