The SDIPF reliability curve of old EHV power transformers

A historical review for utilities when developing specifications for new transformers - Part IV

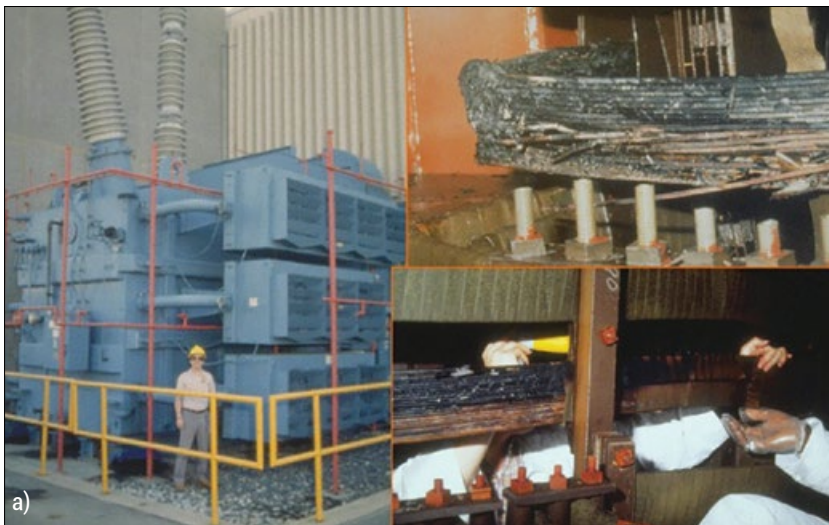
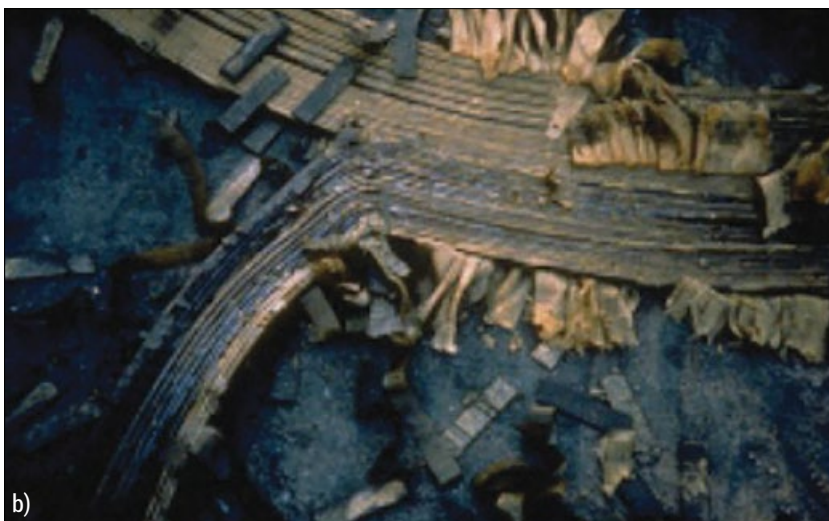
- charred winding series connections between two parallel low-voltage windings
- the degree of burning varied for different series connections
- phases A and C had burnt connections, but phase B was clean

This damage was inflicted because of the high levels of stray magnetic flux and circulating currents that were occurring outside the transformer core due to the half-cycle saturation. When these fluxes concentrate and impinge on regions of the transformer, such as windings and internal structural or tank members not expected to receive such exposure for normal operation, they can lead to almost immediate and severe hot-spot heating insults to exposed internal windings and structures of the transformer (Fig. 1).

Figure 1. Damaged transformer at the Salem Nuclear Plant. The insulation burned, and the 24 kV LV winding rated for 3000 A melted [1].

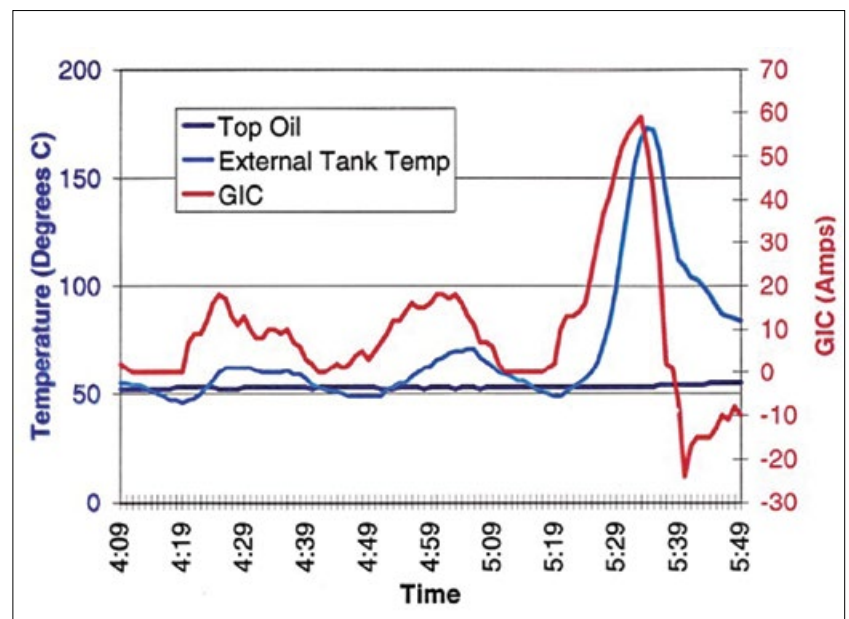
APS experienced an additional GMD event on 10 May 1992. Fig. 2 demonstrates the correlated rise of GIC with tank and oil temperature captured during the event. During the course of the storm, GIC flow in the neutral of the transformer reached a level of approximately 60 A DC (20 A per phase) in about 15 minutes, with a corresponding steady increase in temperature on the exterior of the tank (see Fig. 2). The peak temperature measurement on the exterior of the tank was 173 °C (internal hot-spot temperatures would have been even higher), and this happened approximately 1–2 minutes after the GIC peak. There weren't any significant changes with regard to the oil temperature.

The peak temperature measurement on the exterior of the tank was 173 °C (internal hot-spot temperatures would have been even higher), and this happened approximately 1–2 minutes after the GIC peak

Figure 2. Autotransformer at the Meadowbrook Substation. GIC and transformer tank temperature for the 10 May 1992 geomagnetic storm [1].

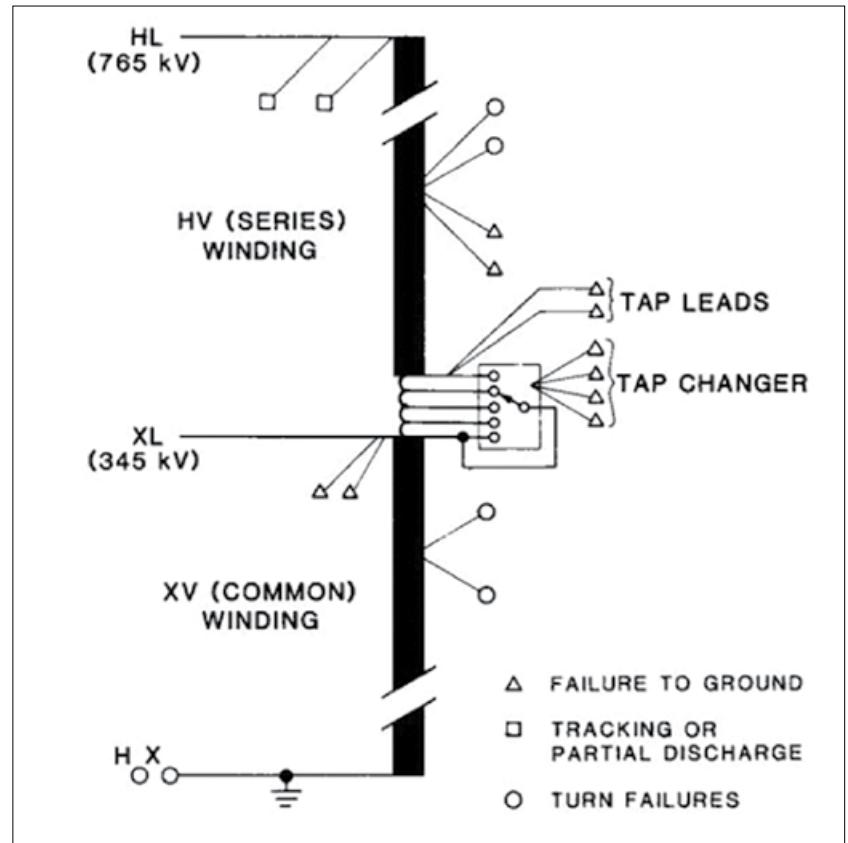
A particularly problematic situation has developed with 765/345 kV 500 MVA autotransformers. In a sample of 72 pieces, 54 failures occurred (several ATs were damaged again after repair). The locations or types of failures are shown in Fig. 3.

Figure 3. Approximate locations or types of failures for 765/345 kV, 500 MVA autotransformers [11]

To improve the reliability of 765 kV transformers, AEP increased the insulation level in the new specification by 13–15 % compared to the requirements of the previous one (Table 1), and a higher level of collaboration with manufacturers was adopted.
