Diagnosics of the condition of the Tabija tower in Mostar

Abstract: Based on measurements and research, diagnostics of the condition of a structure aims to provide an answer to the question of what the condition of the structure is, and the necessary steps for reconstruction or rehabilitation. Masonry stone construction is one of the oldest methods of construction of building structures. In spite of that, this type of structures does not have fully defined parameters that influence its behavior. The reason for this is the fact that the properties of masonry stone structures differ depending on the basic material (stone) and binding material (mortar), as well as their combination. The paper presents diagnostics of the condition of masonry structures on the Tabija tower building. Tabija, a low tower for cannons, is a fortification structure from the Ottoman period that is the most completely preserved and was registered for the first time in the city plan from 1717. The structure is in poor condition due to a large number of natural and human factors. The paper will present a detailed visual inspection of the structure, as well as tests conducted in the laboratory and in-situ, the c

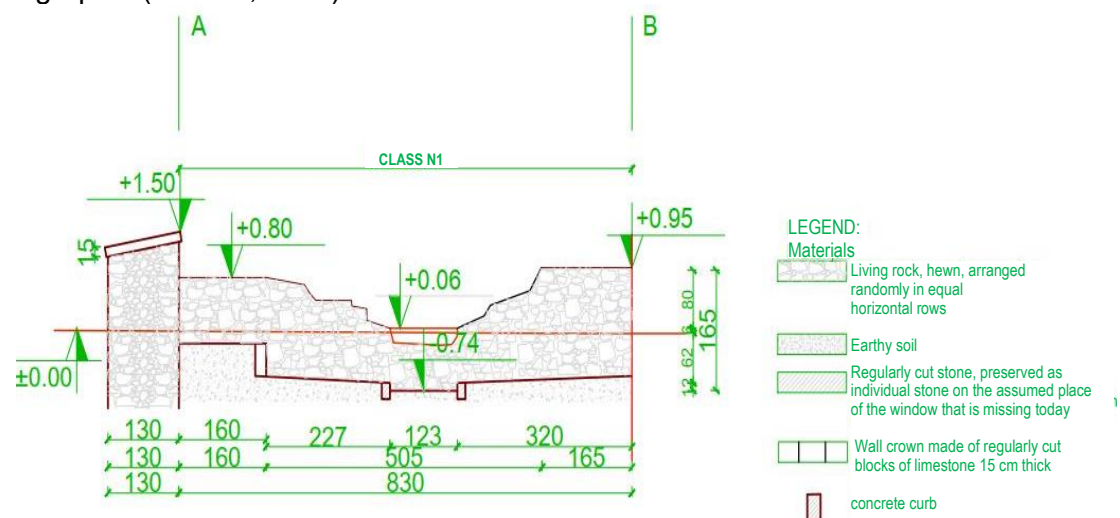
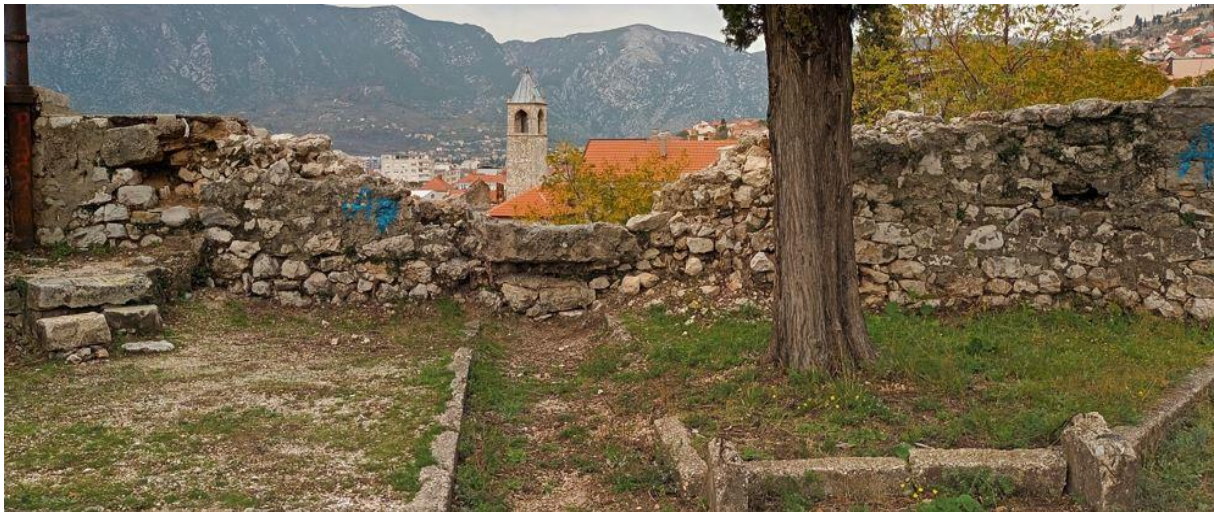
Figure 2. Sketch and photo of internal wall AB, (Kukrica, 2022)

Drawings of the current condition of the wall structure of the Tabija tower were made through visual inspections of the geometry and measurements. Figures 2, 3 and 4 show parts of the walls of Tabija through drawings, which are accompanied by corresponding photographs. (Kukrica, 2022).

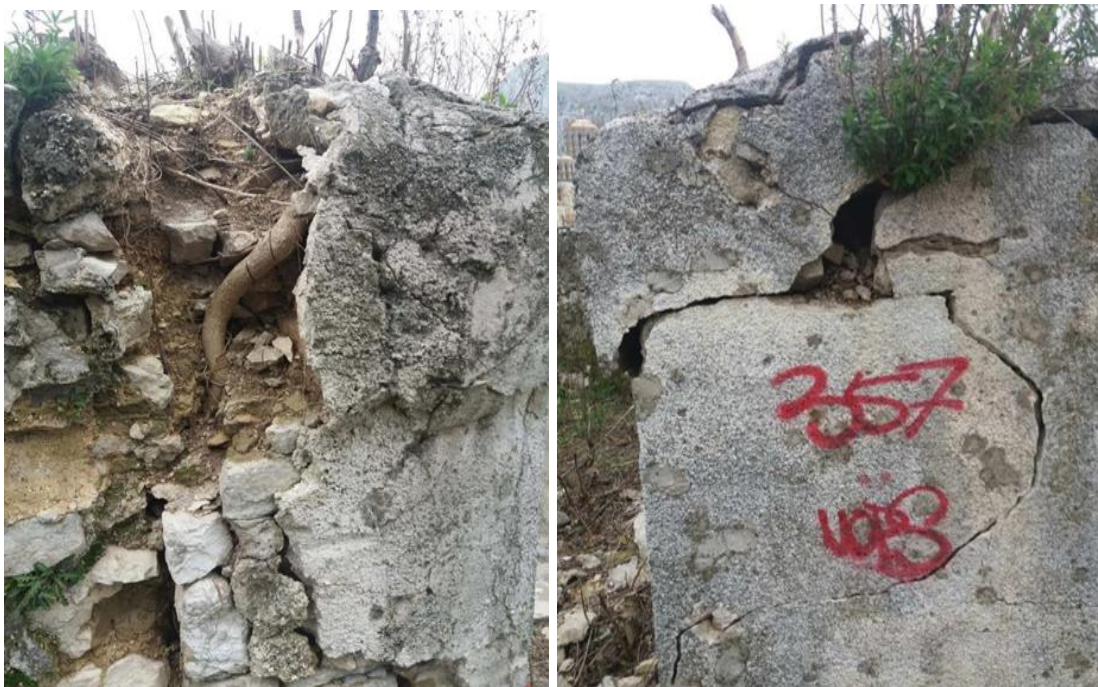
Biological action has substantially damaged the durability of the Tabija tower. Vegetation covering a large part of the walls, especially on the outside, has appeared due to long-term neglect. Vegetation has also caused the wall to crack and the mortar to break, some parts of the wall to collapse during the extraction of the same, the beams to lift (the roots of wild plants in this area are quite strong and difficult to clear). We distinguish between vegetation that we can control and that which we cannot control due to the inaccessibility of the terrain. Vegetation has caused the following (Figure 5 and 6):

Figure 6. Damage caused by root action

- It is necessary to remove vegetation that impairs the appearance and function of the structure. The roots that compromise the walls must be permanently removed with permitted biochemical means so that reconstruction of the damaged parts of the wall can be carried out on these parts.

- After carrying out the permanent removal of the roots, it is necessary to decompose the parts of the wall that have been destroyed by vegetation while marking all the stone blocks and then recombine and reconstruct them using material of the same type (stone and mortar, for the mortar use one based on natural hydraulic lime (NHL) intended for historical buildings). On the entire surface of the wall, it is necessary to clean the joints and repoint them using NHL mortar.

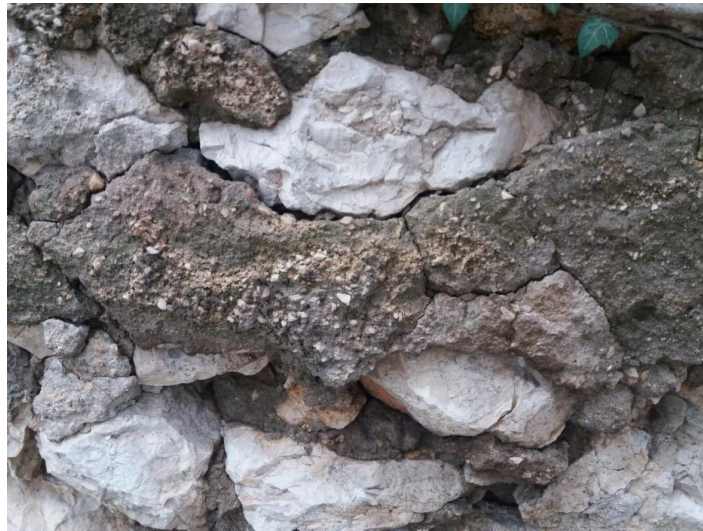
of the mortar to the wall element occur as a result. In the process of conservation, the structure was repaired with cement mortar on several occasions in the past, in which process it was not properly pointed and, as evident in the figure (Figure 7), the mortar separated.

Figure 7. Separation of mortar

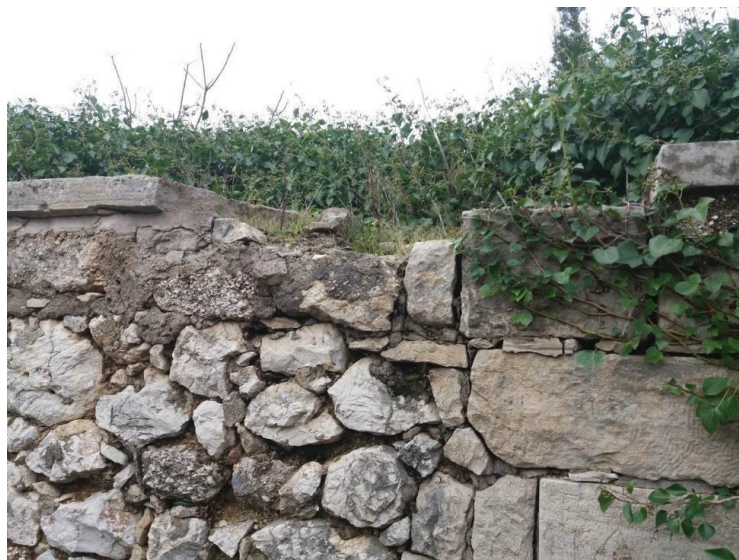
The concrete cap is destroyed in several places due to washing or the action of vegetation during the past years (Figure 8).

Figure 8. Absence of concrete cap

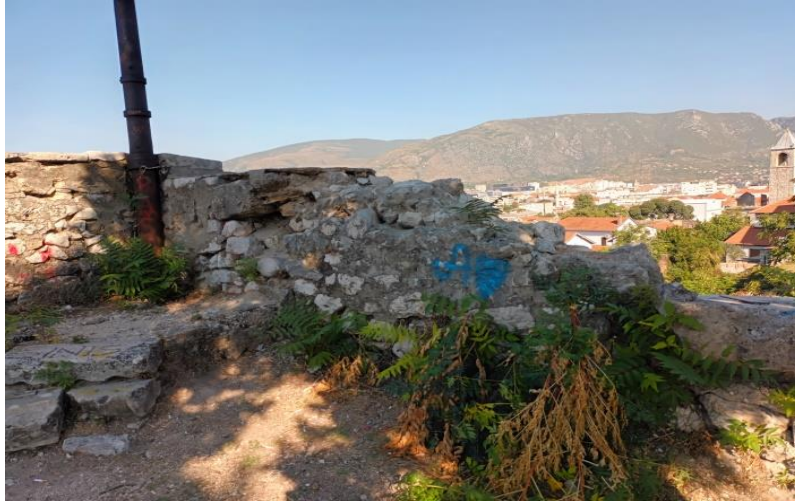
As the tower is a completely exposed structure, both the internal and external walls are constantly under climate effects. The climate of Mostar in winter is quite distinct, with low temperatures and heavy precipitation, so that the structure itself has been subjected to the effects of wind and rain over the years. The absence of a concrete cap in several places makes

it easier for the wind to have a more pronounced effect on the structure and on the peeling of the stone (Figure 9).

Figure 9. Stone separation

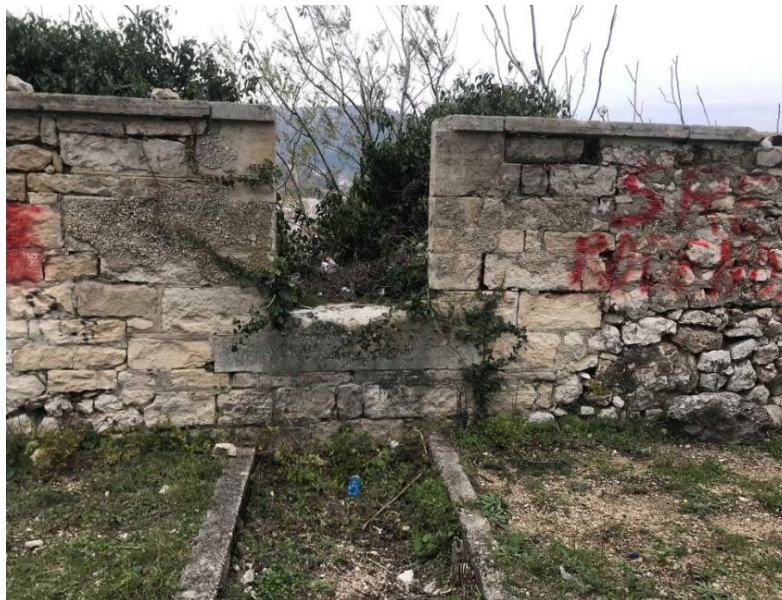
The immediate surroundings of Tabija are used for waste disposal, its walls are often a surface for graffiti, and access points for parking (Figure 10).

Figure 10. Graffiti on the structure
