CUT STABILIZATION ON THE HIGHWAY E-763 MADE IN ROCK MASS WITH UNFAVORABLY ORIENTED DISCONTINUITIES

Miodrag Pisarević^{1*}, Dragana Slavković², Vladimir Filipović³

¹Institute of Transportation CIP d.o.o. Nemanjina 6/IV, 11000 Belgrade, Serbia

Abstract: During the construction of the highway "Miloš Veliki" E-763 through Serbia, in addition to many challenges, it was necessary to stabilize the cut at the section km 81+250 to km 81+650. The cut was supposed to be constructed in the soft layered rocks of the Ljiški flysch complex, made of sandstone, marl stone and shales. The orientation of the rupture assembly of the rock mass as well as the spatial position of the slope led to a series of instabilities on the left side of the cut, while at the same time they had a positive effect on the stability of the right side. All occurrences of instability were accompanied by a dip direction of bedding, which on the left side of the cut had a dominant negative impact on the strength of the rock mass. For the purposes of geotechnical modeling and determination of remedial measures, the parameters of the rock mass were obtained using classifications of the rock mass, while the parameters of roc

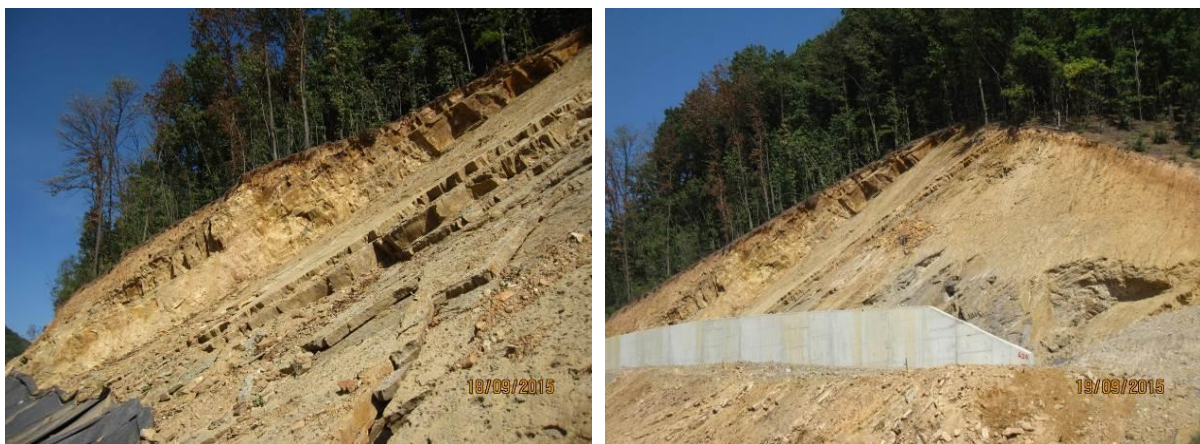
For the construction of the highway E-763 and the local road, section 1: Ljig (Donji Banjani) - Boljakovci from km 77+118.23 to km 87+839.44, extensive geotechnical investigations were carried out in several phases. These geotechnical investigations included the section of the cut from km 81+250 to km 81+650, which is the subject of this paper. The terrain in the cut zone was slightly undulating, covered with Quaternary sediments, without open outcrops of rock mass. During the mapping of the terrain and exploratory drilling, in the first phase of design, it was determined that the terrain is built of soft layered rocks of the Ljiški flysch complex, i.e. sandstone, marl stone and shales, which are covered by Quaternary deposits with a thickness of 2.0 to 7.0 m. During the field investigations, it was not possible to determine with certainty the rupture assembly of the rock mass, as well as the potential phenomena that would arise because of the most unfavorable type of instability in the rock mass. Problems appeared immediately at the beginning of the excavation, i.e., there was a planar fallout of larger blocks of rock mass and the formation of a landslide on the left side of the cut (**Figures 1 - 6**).

Figure 1. and 2. Planar sliding of rock blocks above a local road

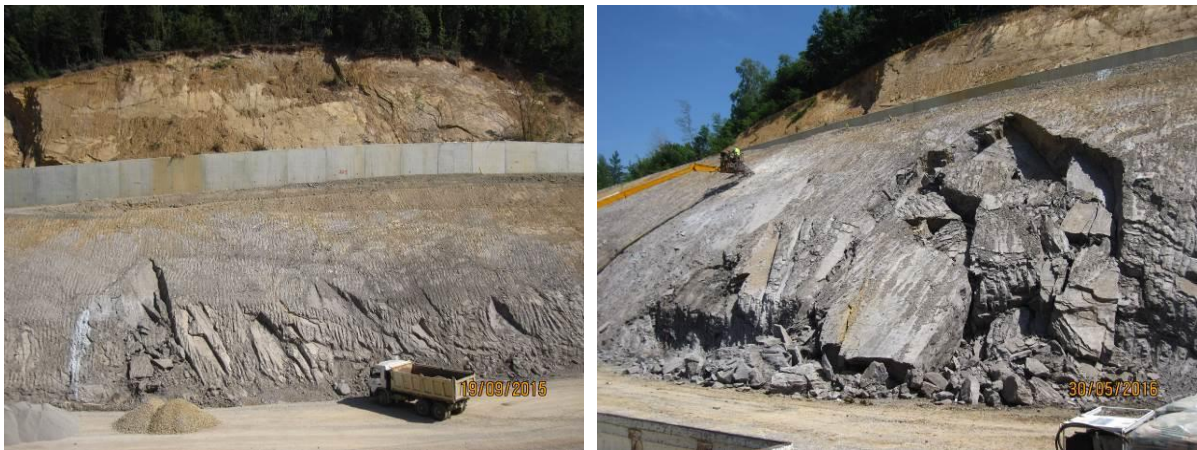
Figure 3. and 4. Planar sliding of rock blocks in the highway area

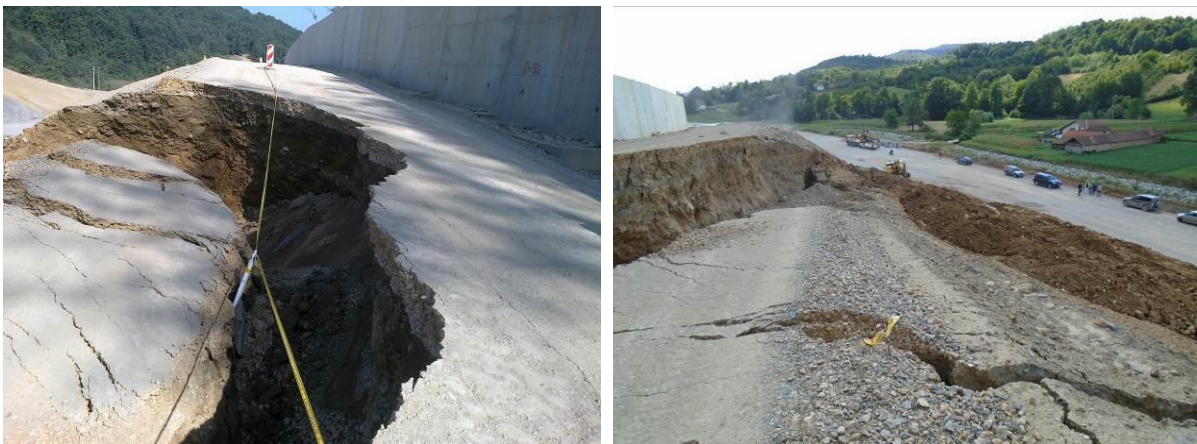
Figure 5. and 6. Sliding of Quaternary sediments in the local road

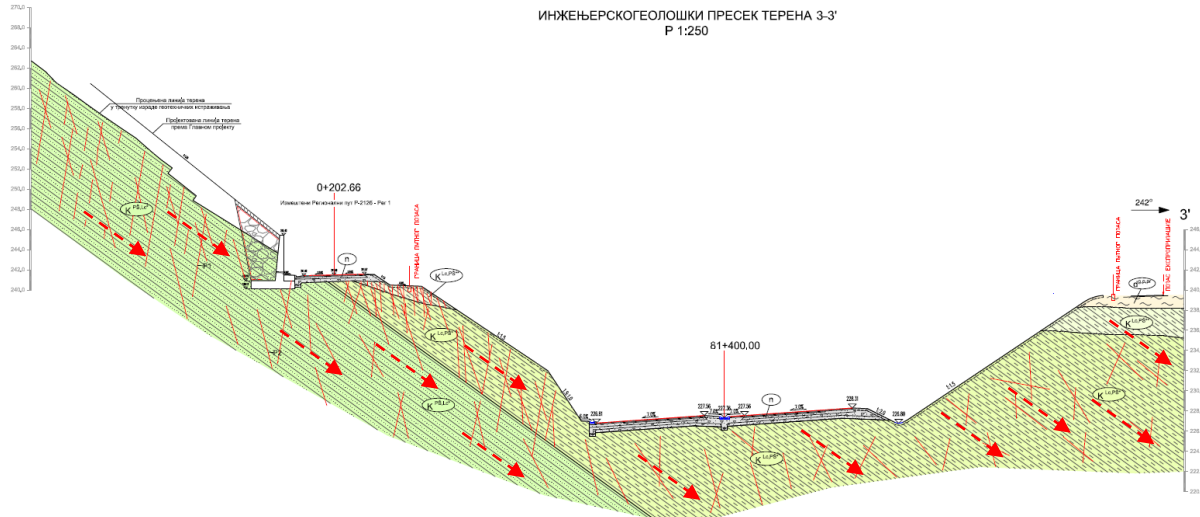
Within the Ljiški flysch complex, two zones of the rocks are determined according to the representation of lithological members (**Figure 9**), which can then be further divided into two subzones based on the physical and chemical degradation (weathering) of the rock mass, as follows:

Figure 9. Characteristic engineering geological section of the terrain in the cut zone of the E-763 highway at km 81+400.00

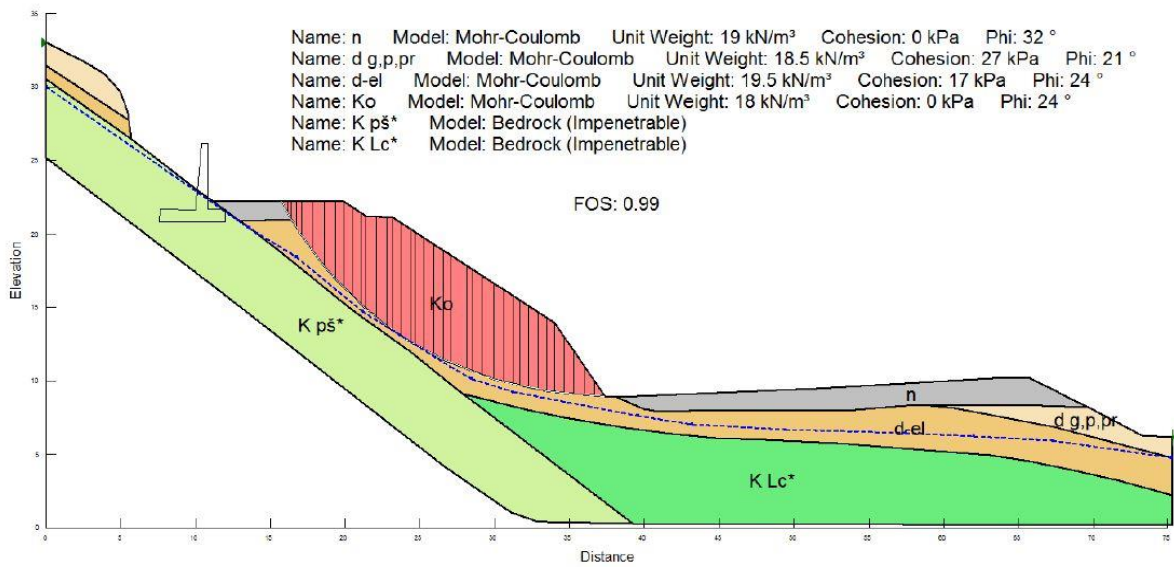
The parameters of the rock mass along the discontinuities and sliding surfaces (obtained by classification) were checked by back analysis of slipped rock blocks or slipped debris material (**Table 2**, **Figure 10** and **Figure 11**). All the conditions that prevailed in the terrain at the time of the instability, such as the geometry of the terrain before the sliding, the dimensions of the sliding body, the groundwater conditions, defining the position of the sliding surface, and position of lithological members, were simulated in the back analyses.

Figure 10. Determination of shear strength parameters along the sliding surface in diluvial-eluvial sediments using back analysis

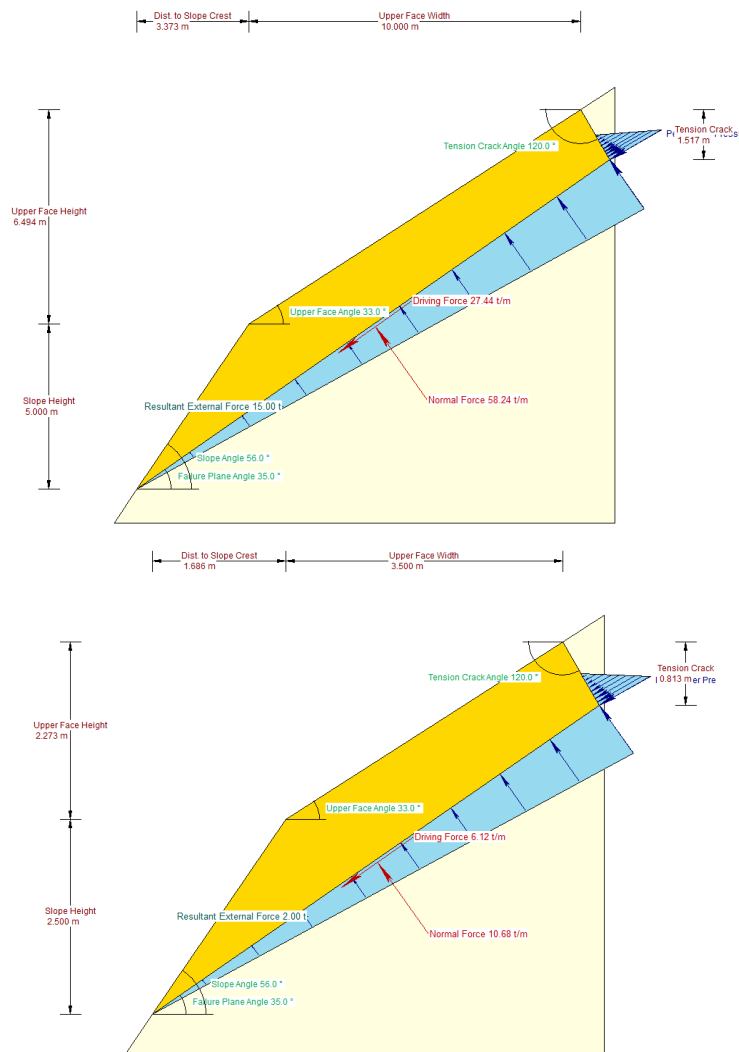
Figure 11. Dimensions of unstable blocks for calculation models 1 (up, block with larger dimensions) and model 2 (down, block with smaller dimensions)

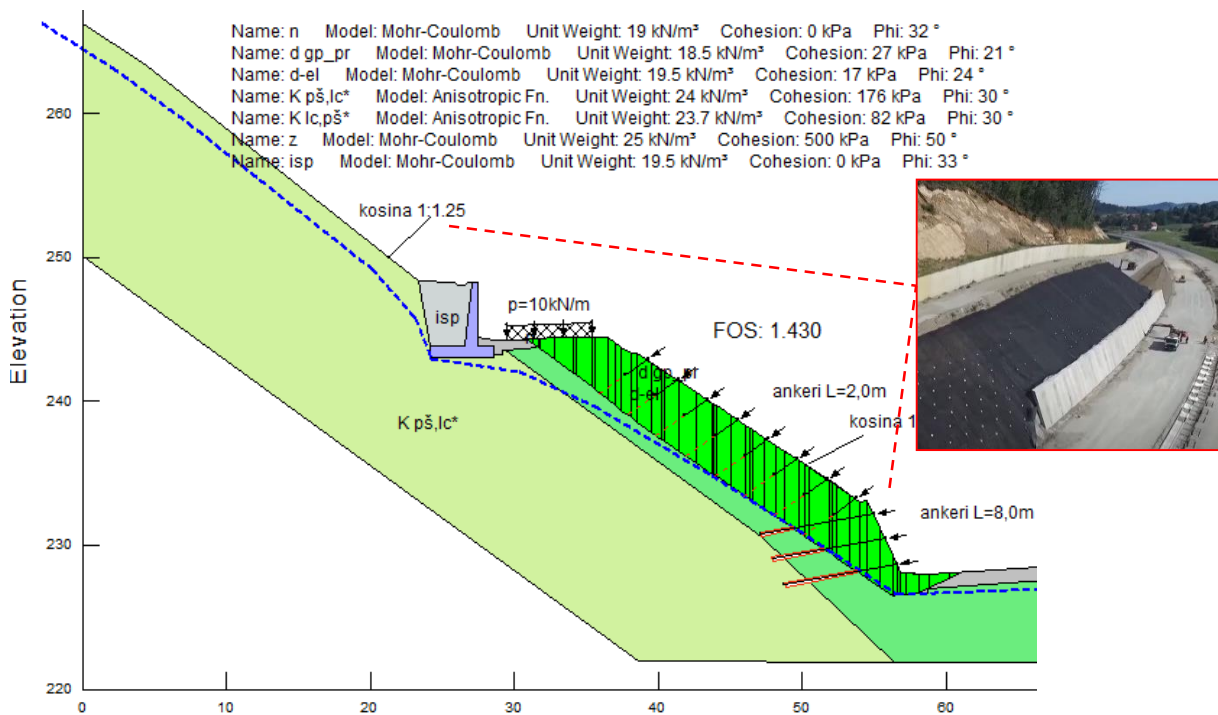
The first model, with applied remedial measures, represents the central part of the left side of the cut, where the planar sliding of the rock mass blocks along the "negatively" oriented beddings occurred.

Figure 13. Geostatic calculation of slope stability (in zone 1, see Figure 16) with applied remedial measures

After a series of performed analyses, a solution was given for the stabilization of this part of the cut, which contained the following remedial measures (**Figure 13**):

- Construction of a cut above the regional road at an inclination of 34-38°, which corresponds to the bedding inclination, with covering with a double-twisted wire mesh.
- Construction of the slope between the regional road and the highway in a dual slope of 1:1.5 and 2:1 with the application of passive self-drilling IBO anchors (Ø32mm) 2 m long (on the flatter part of the slope) and 8.0 m (on the steeper part of the slope), at a pattern of 3x3m (on the flatter part of the slope) and 2x2 m (on the steeper part of the slope), construction of drainage channels, installation of subhorizontal tubular drains (Ø50mm) 6 m long, protection of the face of the slope from weathering, covering the face

of the slope with a road network with the installation of geocomposite, and protection of the face of the slope from surface erosion by hydro-seeding (on the flatter part of the slope), while the steep part is protected by a facing RC wall.

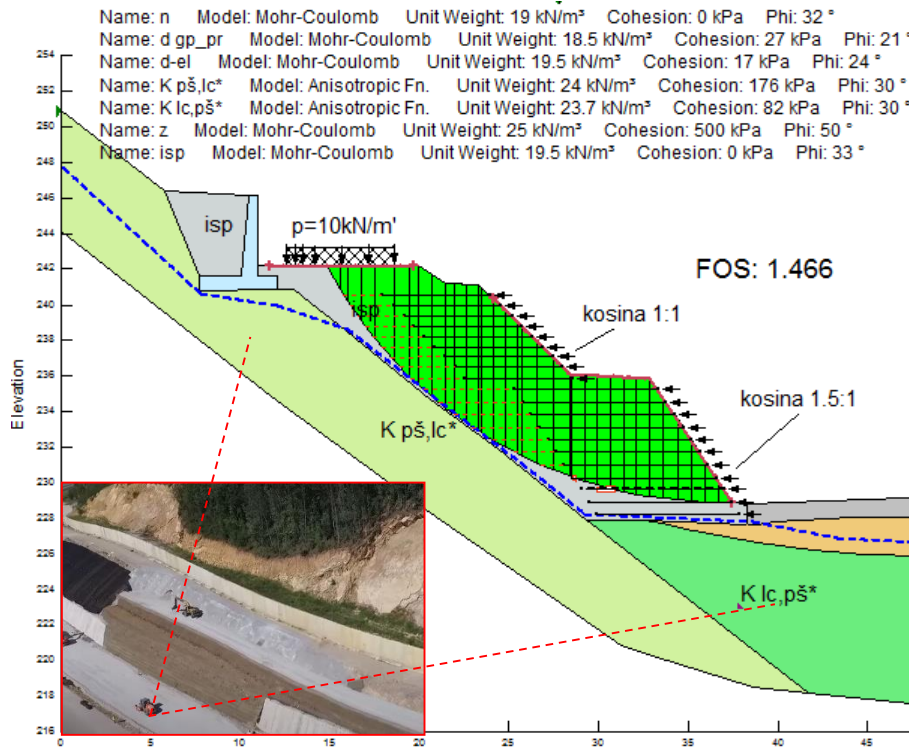
The second model (Figure 14), with applied remedial measures, represents the central part of the left side of the cut, where diluvial - eluvial sediments slide over the rock mass.

Figure 14. Geostatic calculation of slope stability (in zone 2, see Figure 16) with applied remedial measures

- Construction of a cut above the regional road at an inclination of 35-38°, which corresponds to the bedding inclination, with facing by double-twisted wire mesh.
- Replacement of the sliding body by embankment, constructed of reinforced soil from a combination of "teramesh" mesh and crushed stone filling (0-63 mm), under the slope of 1:1, making a drainage system to drain the slope, adequate protection of the face of the slope with hydro-seeding.
- For the temporary protection of the slope during the excavation (for the replacement of material in the sliding body and the creation of reinforced soil), passive anchors with shotcrete were used.

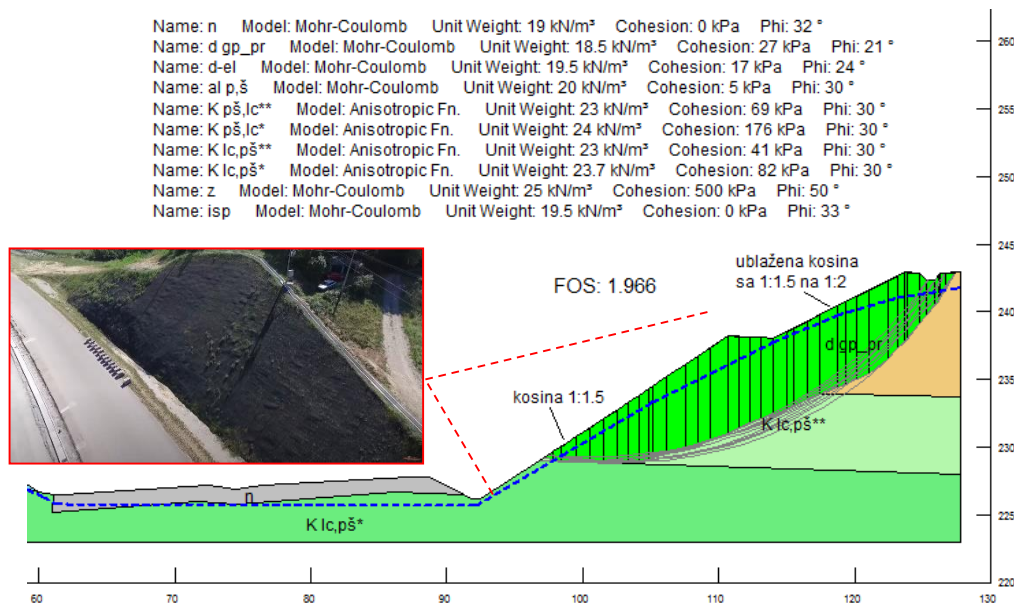
The third model (Figure 15) represents the central part of the right side of the cut, where due to the "favourably" oriented bedding "into the rock mass" instability did not occur. After a series of performed analyses, a solution was given for the stabilization of this part of the slope, which contained the following remedial measures:

Figure 15. Geostatic calculation of slope stability (in zone 3, see Figure 16) with applied remedial measures

- Construction of cut in the projected inclination of 1:1.5
- Creation of a drainage channel to drain the slope and adequate protection of the face of the slope with geocomposite and hydro-seeding.

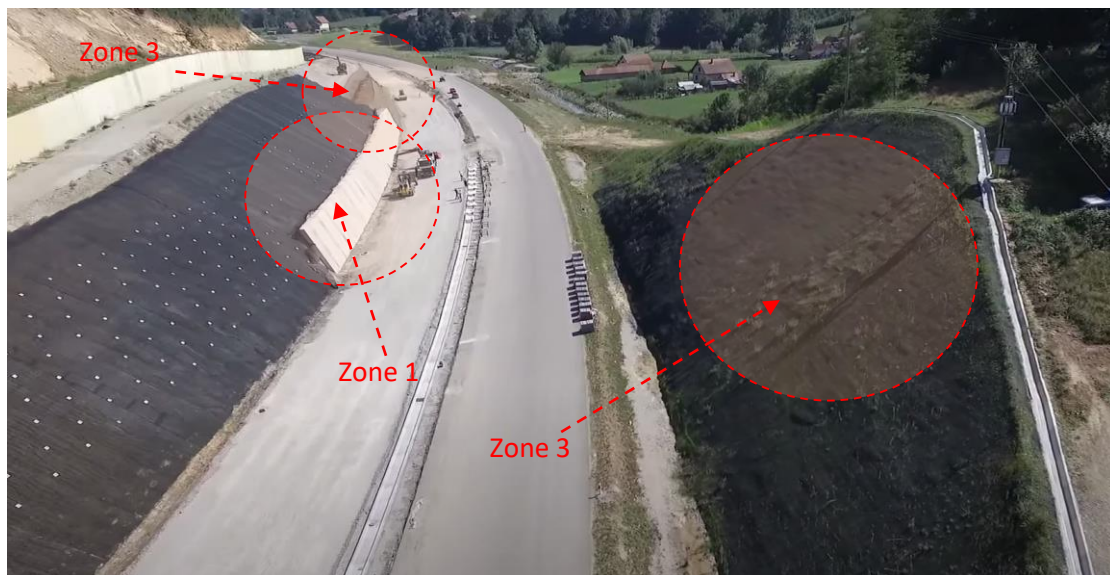
Figure 16. Left and right side of the cut after rehabilitation (with marked position of characteristic zones)
