António Arêde, Esmeralda Paupério, Xavier Romão

Lessons from the 2020 earthquakes in Croatia to improve the seismic performance of cultural heritage structures

António Arêde
Esmeralda Paupério
Xavier Romão
CONSTRUCT-LESE
(Laboratory of Earthquake and Structural Engineering)
Faculty of Engineering
University of Porto
PT – 4200-465 Porto, Rua Dr. Roberto Frias s/n

UDK: 72.025.1(497.5)"2020":550.34
72.025.4(497.5)"202":624
Review paper / Pregledni članak
Received / Primljeno: 11. 8. 2022.

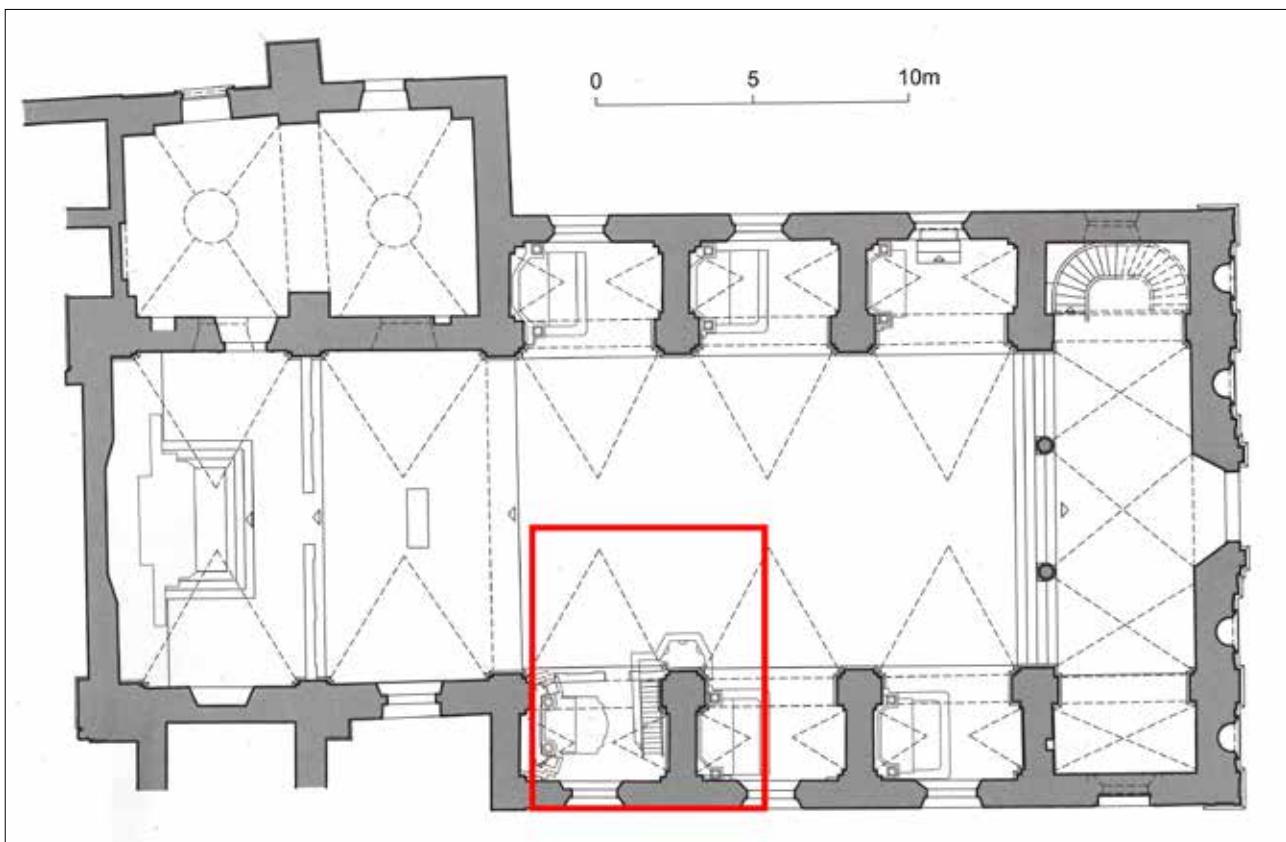
5 Floor plan of the Church of St. Catherine of Alexandria, with the identification of the zone where the partial collapse of the vault and the triumphal arch occurred (red line). (adapted from HORVAT-LEVAJ et al., 2011)

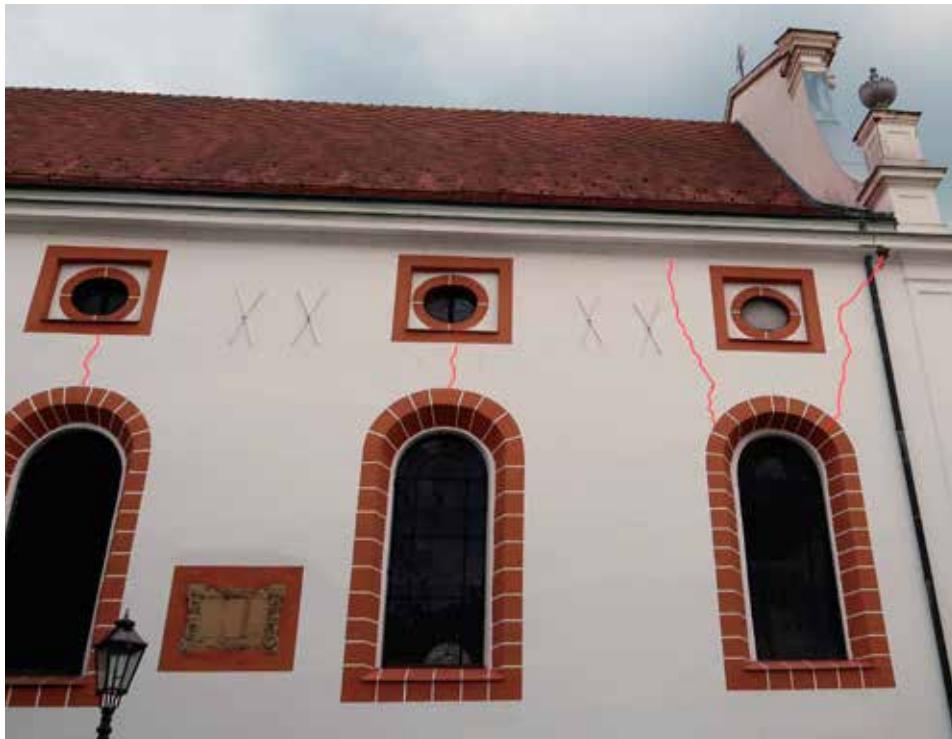
6 General view of the external damage of the church, where there is no evidence of masonry crushing at the anchorage zones of the tie rods (photo: X. Romão, July 2021)
Opći pogled na vanjsko oštećenje crkve, gdje nema tragova drobljenja zidane konstrukcije na mjestima sidrenja zatega (foto: X. Romão, srpanj 2021.)

The damage to the church that could be observed from the outside was not very expressive. The main façade did not present relevant damage while the lateral load-bearing walls exhibited light vertical cracking. The observation of the anchoring points of the tie rods from the outside of the church showed that none of the tie rods along the lateral walls of the nave exhibited signs of anchorage crushing. This means that the structure was able to accommodate the displacements imposed by the earthquake along the transversal direction (Fig. 6). However, the only tie rod visible from the outside along the alignment of the triumphal arch showed signs of anchorage crushing at the anchoring point located on the left lateral wall (Fig. 7). Finally, the observation of the roof from the exterior allowed concluding that it should be in a good condition since no evidence of bulging or missing tiles was seen.

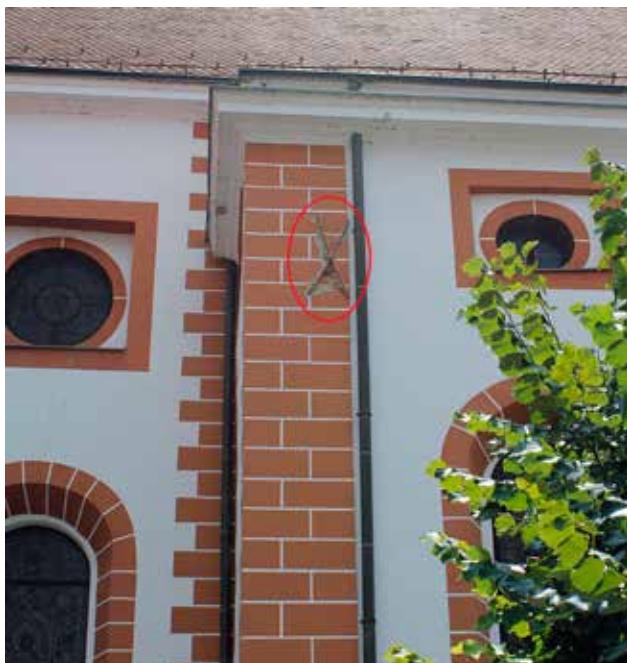
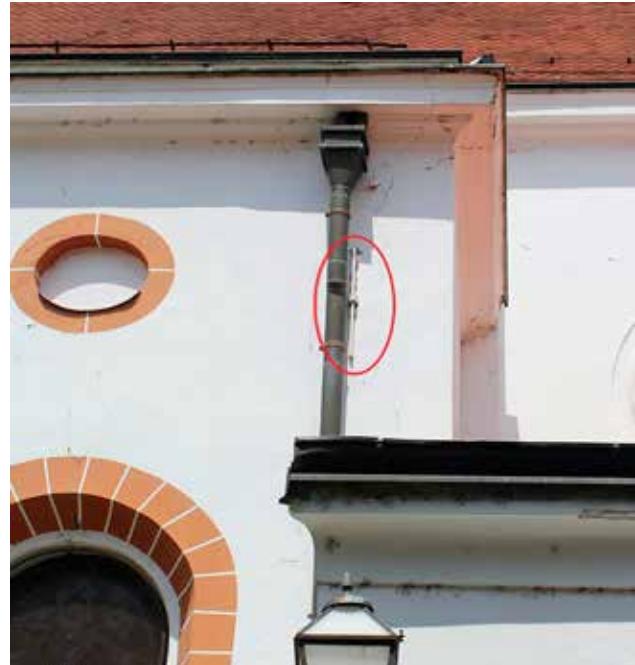
7 Anchorage points of one of the tie rods of the triumphal arch seen from the outside a) view of the left lateral wall where masonry crushing can be seen and, b) view of the right lateral wall where there are no signs of masonry crushing (photo: X. Romão, July 2021)

level of the imposts of the nave vault. Aside from these tie rods, another metallic tie rod (that seemed older) was also seen along the alignment of the upper choir and at a higher level. The anchoring point of some of these tie rods is not visible from the outside, namely that of the tie rod along the alignment of the upper choir and of one of the two existing tie rods along the triumphal arch.

Repositioning/replacement of the triumphal arch tie rods ensuring they are adequately anchored to the external face of the nave longitudinal walls.

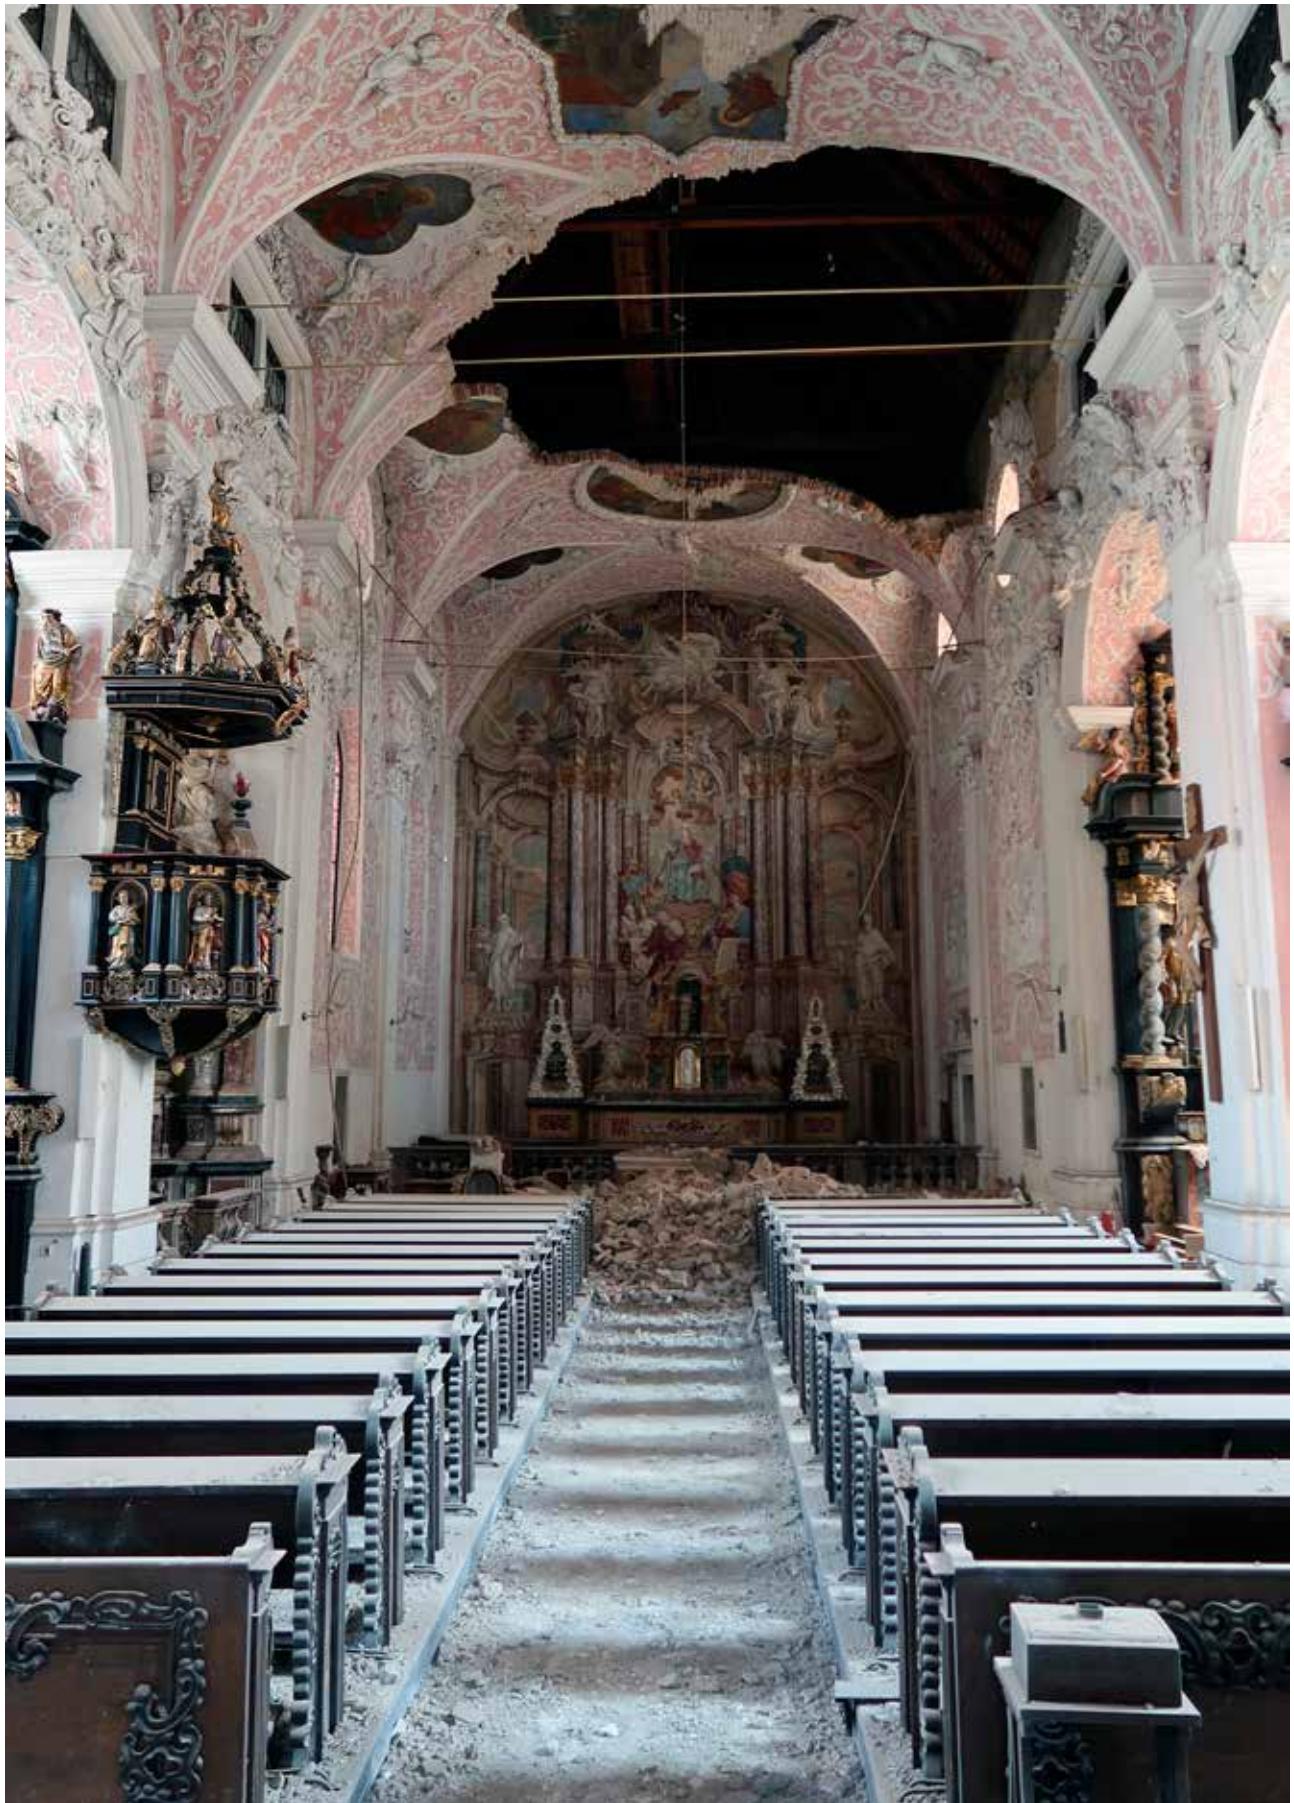
8 General view of the collapsed areas from the inside of the church (photo: X. Romão, July 2021)

The damage observed on the interior of the church is much more severe than the one observed from the outside due to the partial collapse of the vault in the triumphal arch area and the almost full collapse of the actual triumphal arch (Fig. 8) – the zone where the partial collapse of the nave vault occurred is also identified in red in Figure 5. From the inside, it was also possible to see that the triumphal arch had two tie-rods and that one of them (the one visible from the outside) broke near its tightening device located between the arch imposts (Fig. 9). Additionally, cracking was also observed in several locations of the vault, namely longitudinal cracks along the vault crown (Fig. 10), as well as the generalized detachment of parts of the painted finishing of the nave vault (Fig. 11). The observation of transversal cracking of the vault along the upper choir arch suggests the previous existence of a constructive joint that might have been created by possible reconstruction works or an expansion of the building in the past (Fig. 12). Finally, it was possible to see the wooden truss structure of the roof through the collapsed area of the vault, but no damage was able to be identified.

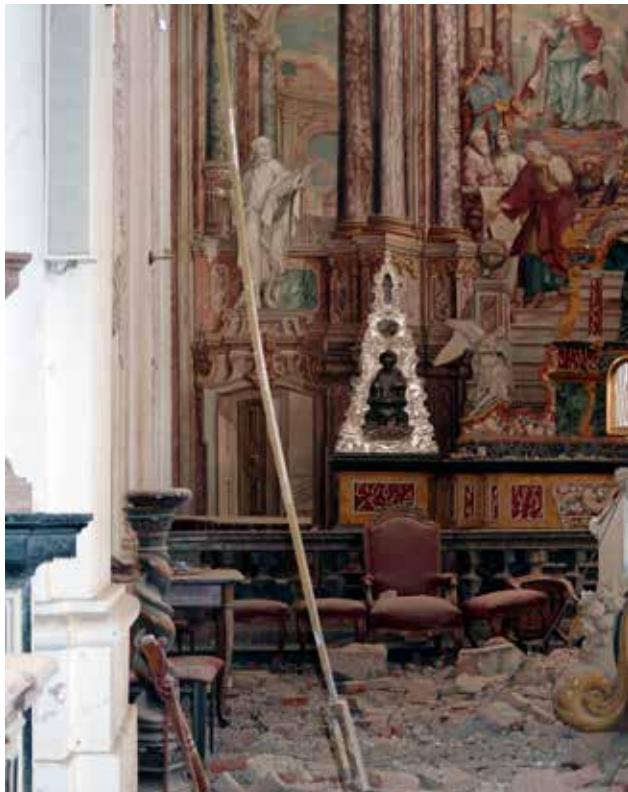
9 Detail of the failure of the triumphal arch tie rod (photo: X. Romão, July 2021)

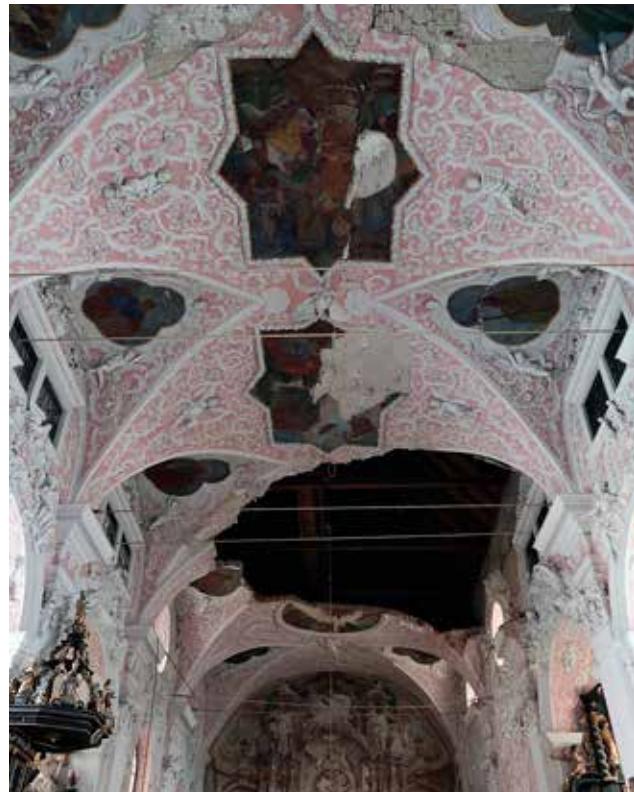
10 Longitudinal cracking along the vault crown line (photo: X. Romão, July 2021)

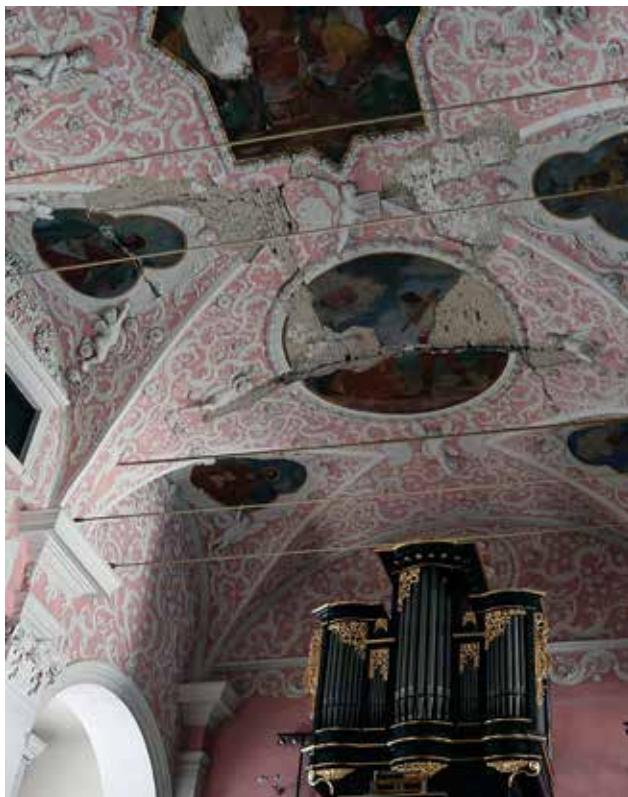
11 Detachment of finishing plasters of the nave vault (photo: X. Romão, July 2021)

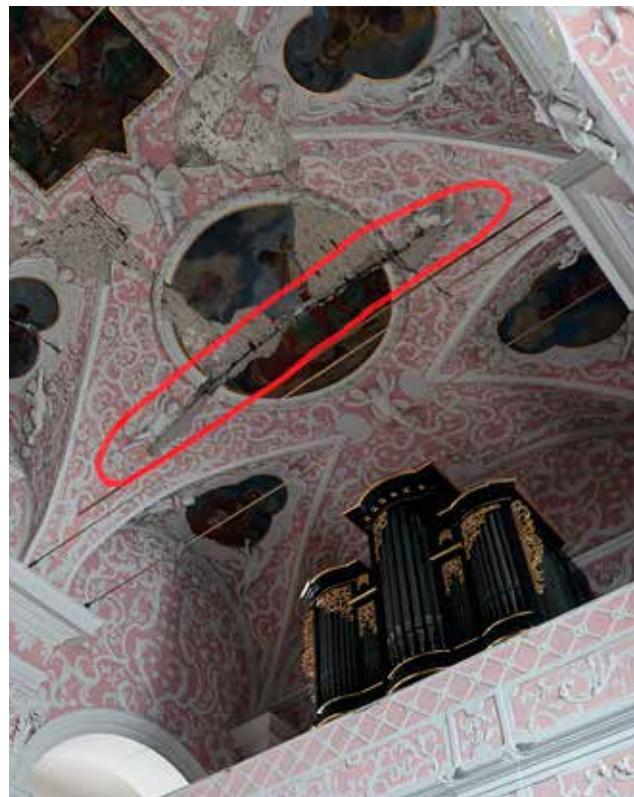
12 Possible constructive joint running along the upper choir arch (photo: X. Romão, July 2021)

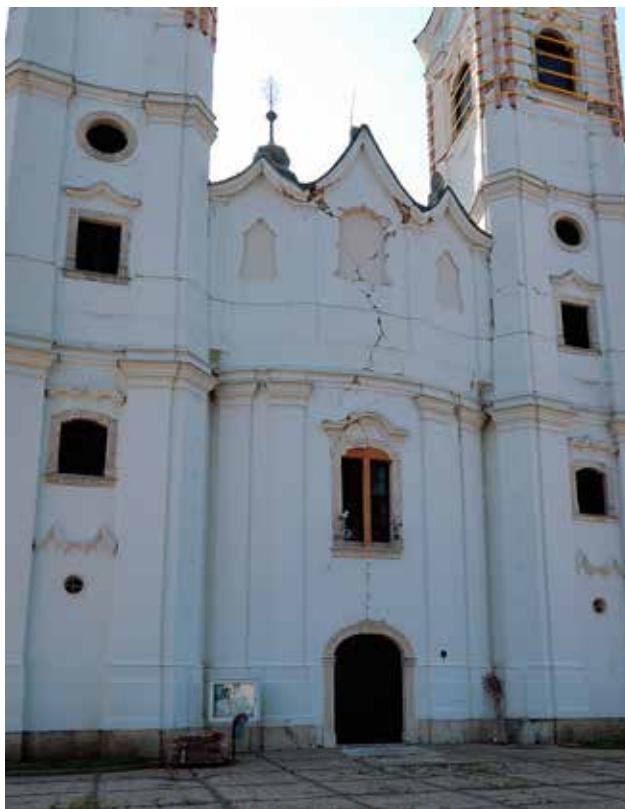
15 Cracking in the main façade (photo: X. Romão, July 2021)
Pukotine na glavnem pročelju (foto: X. Romão, srpanj 2021.)

During the reconnaissance visit, cracking in the façade and lateral walls of the nave was observed, particularly in the zones of openings presently shored internally and externally (Fig. 15-18). Internally, these zones correspond to the lateral chapels topped by arches that exhibited heavy damage and parts of the mural painting that had fallen (Fig. 19). Although the cracking of the nave vault is not very significant, the structure was shored in the area of the dome, which according to local information, exhibited cracking in the drum zone (Fig. 20).

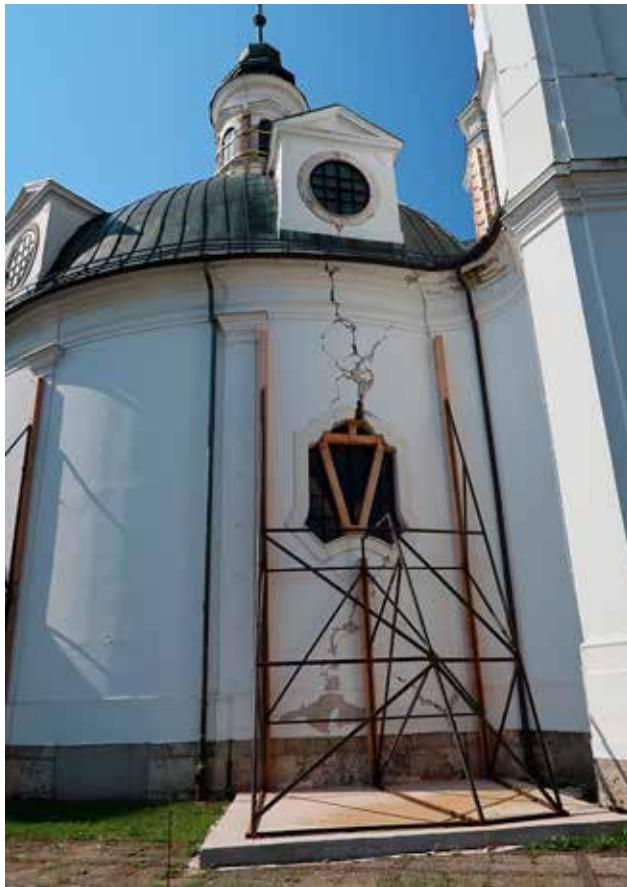
17 External shoring of nave walls in the area of the lateral chapels
(photo: X. Romão, July 2021)

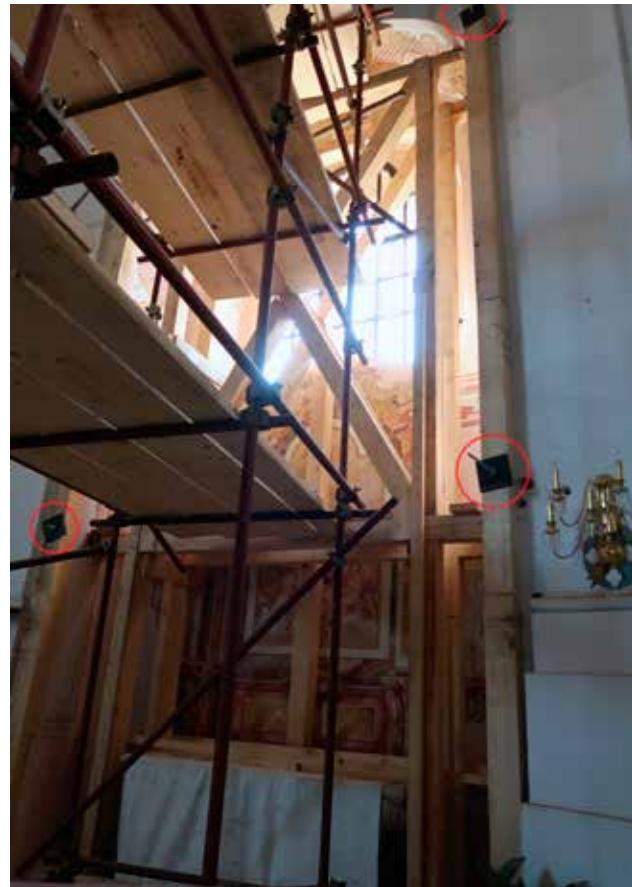
18 Detail of the internal shoring of the lateral chapels and anchorage connections to the exterior (photo: X. Romão, July 2021)

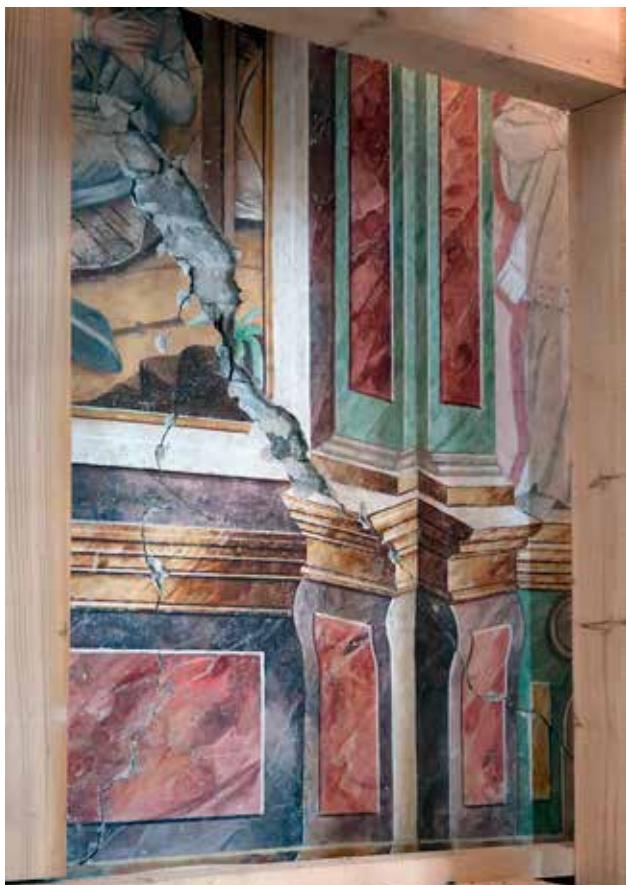
19 Missing parts of a mural painting in the lateral altars (photo: X. Romão, July 2021)

In the rehabilitation of mural paintings, the mortars used in gaps (i.e., in the restoration and completion of lost parts) must be compatible with the existing mortars and the chromatic filling of these gaps must follow the usual conservation and restoration procedures. Mortars that are used in injections for the structural consolidation of cracks in areas with mural paintings must be also compatible with existing mortars.

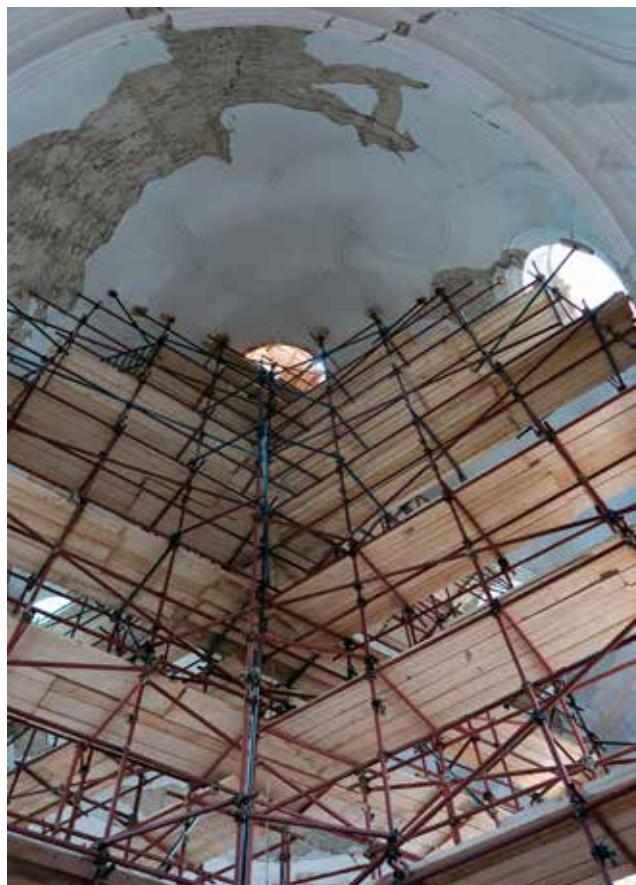
20 Vault shoring in the central zone of the dome showing missing parts of the finishings (photo: X. Romão, July 2021)

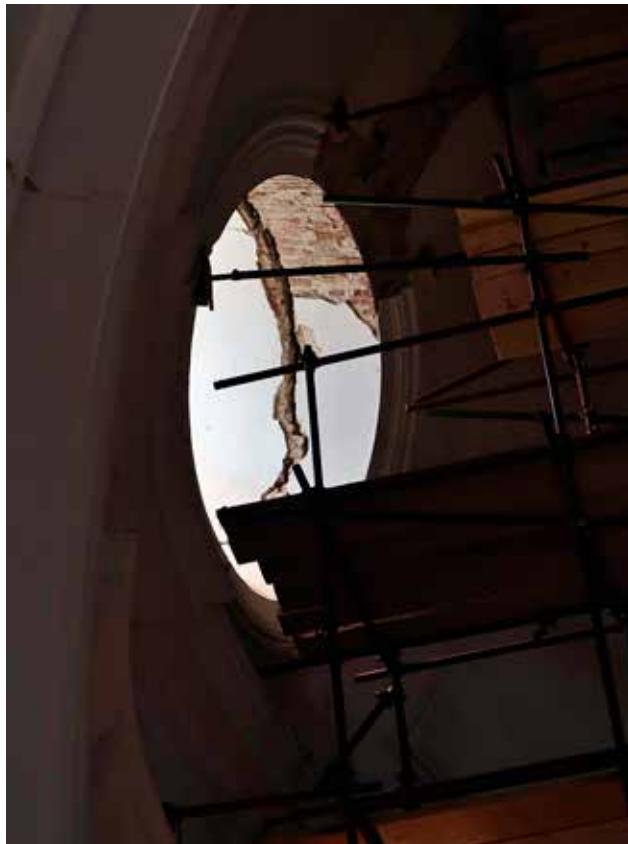
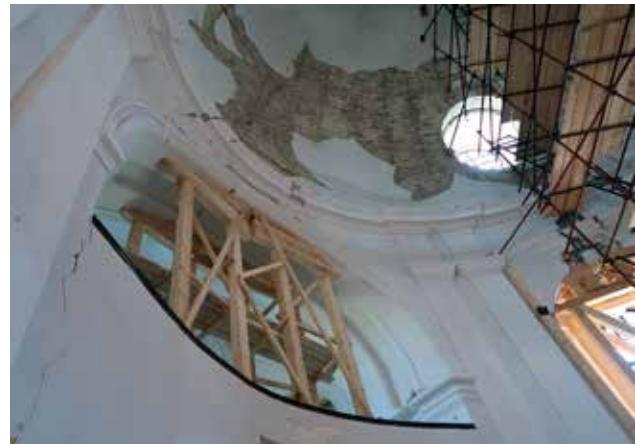
21 a b Opening of joints between the vault and the external walls of the skylight windows (photo: X. Romão, July 2021)

The opening of joints between the insertion zones of the skylight windows of the dome and the walls of the protruding body of those windows towards the exterior was also observed (Fig. 21). In the vault and in the zone of the skylight windows there seemed to be a slight deformation. Additionally, relevant cracking and missing parts of the finishings of the nave walls and vault was also found, as well as in the upper-choir zone located between the two bell-towers and supported by shallow arches (Fig. 22, 23). The towers exhibited cracking and were confined at their upper level (Fig. 24). By precaution, the dome was also externally confined. Although cracking was also observed in the main chapel, it was not significantly damaged (Fig. 25).

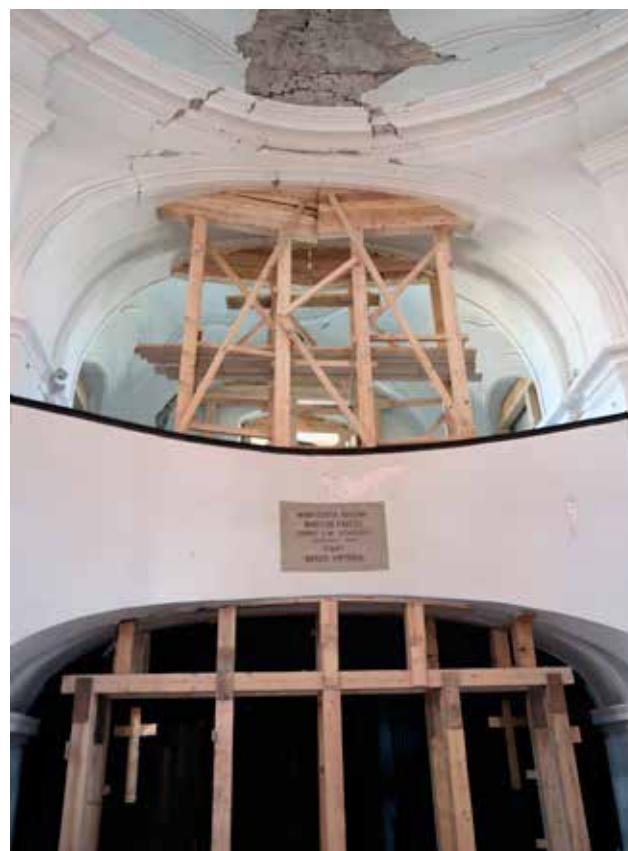
22 Shoring of the arch supporting the upper-choir, (photo: X. Romão, July 2021)

Overall, the damage that was observed suggests a lack of horizontal confinement around the perimeter of the whole structure at the top of the walls, which is consistent with the cracks observed above the openings and the deformation of the shallow arches in the upper-choir zone.

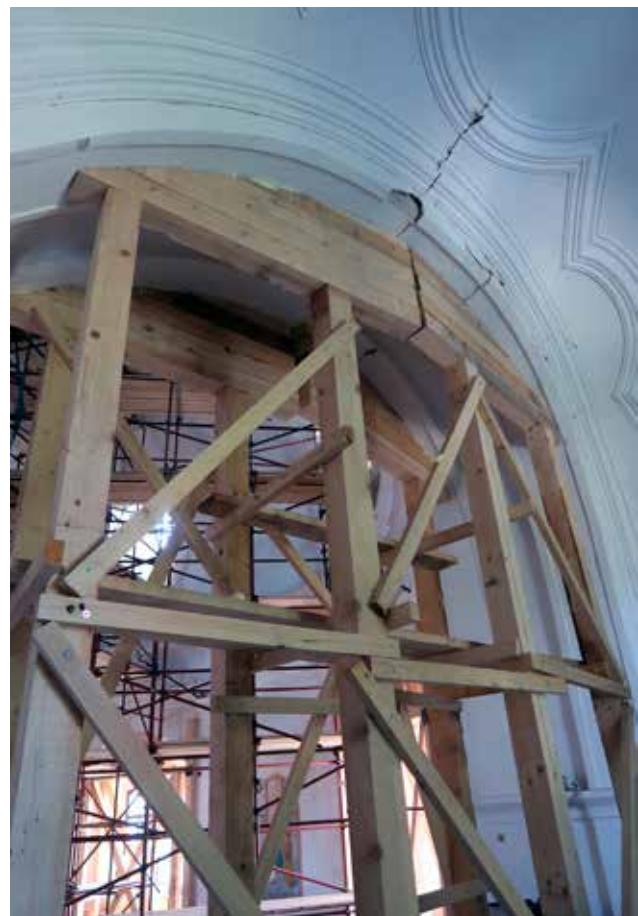
23 Shoring of the arch above the upper-choir which supports the nave vault (photo: X. Romão, July 2021)

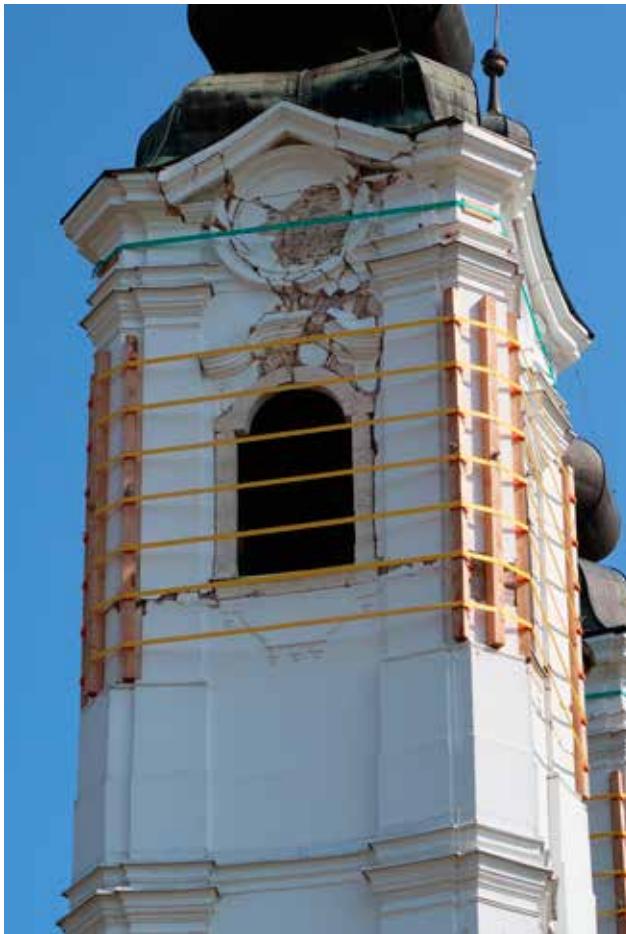
24 Damage in the upper zone of the tower (photo: X. Romão, July 2021)

Strengthening and consolidating the towers (see strategy I2 in Table 3).

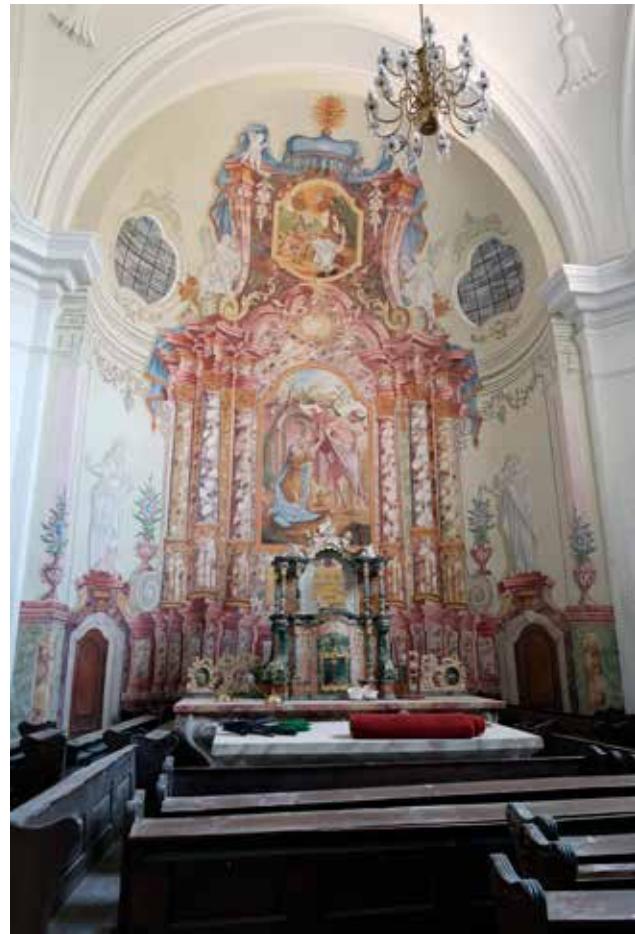
25 General view of the main chapel (photo: X. Romão, July 2021)
