Post-earthquake structural assessment of the Parish house in Sela

The 2020 earthquakes in Croatia highlighted the vulnerability of historical unreinforced masonry buildings. The Parish house next to St. Mary Magdalene church in Sela is one of the cultural heritage buildings that suffered significant damage. As these buildings hold important tangible and intangible values for the local population, their seismic assessment and subsequent retrofitting that respects the value of their historical components is crucial for the recovery of the areas affected by the earthquakes. This paper contributes to this topic by performing structural assessment both for in-plane and out-of-plane mechanisms. Analyses comprise both state-of-art numerical simulations for the in-plane behaviour and hand calculations used for both the verification of in-plane behaviour and the assessment of the out-of-plane behaviour. The paper concludes by proposing retrofitting ideas on a conceptual level.

Keywords: unreinforced masonry, post-earthquake assessment, pushover analysis, equivalent frame models, retrofitting

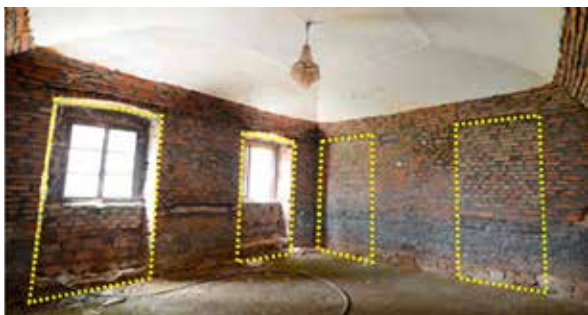
8 Examples of infilled masonry portions considered as openings in the EFM (photo and drawing: Thibaud Maillard, 2023)

A particularity of the parish house is that many walls' portions are filled up with masonry such as old windows, or the spandrels below the windows that are always thinner than the surrounding walls or badly filled up with masonry (Fig. 8). Those infilled masonry portions were considered openings as discussed within the team of authors and suggested by relevant literature.¹²

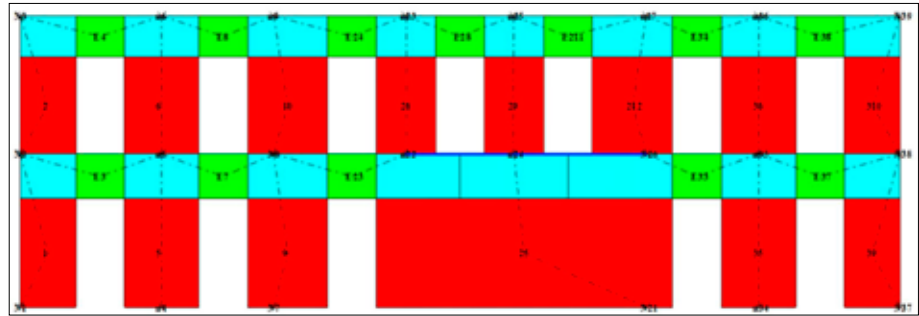
10 South façade wall with its large pier number 25 influencing the failure mode in the x-direction (drawing: Thibaud Maillard, 2023)

Regarding the displacement capacity, because of the very large pier 25 (Fig. 10), the longitudinal direction is controlled by the shear failure of this element, which has a lower drift limit than in the case of flexural failure. The drift limits applied were 0.4 % for shear and 0.8 % for flexural failure.¹⁸ In the y direction, the building fails in flexure, explaining why the displacement capacity is higher than in the x direction.

The difference in the failure mode explains also the stiffness obtained in each direction. Because of the squat pier element 25, stiffness in this direction is higher.

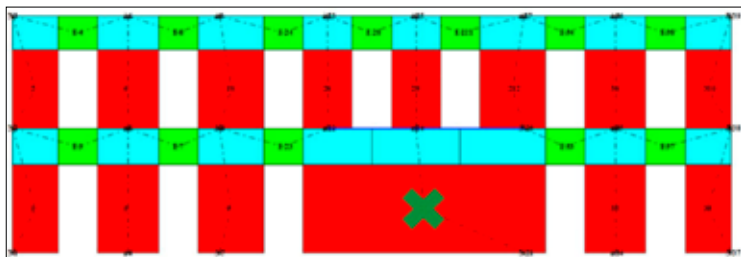
This chapter compares, by a visual inspection, the results predicted by the analysis in Tremuri to the real damage observed directly on the parish house. Regarding the damage predicted by Tremuri in the x direction, it seems that in the simulations the model experienced less damage than in reality. As shown in Figure 12, illustrating the modelled south facade of the parish house with crosses indicating which element has failed in shear (green cross) and flexure (blue cross), only element 25 is failing according to Tremuri. Whereas in reality, almost all the spandrels have failed. All the deformations in the x direction were captured by

12 Prediction given by Tremuri for the south facade. The green cross indicates that element 25 failed in shear (drawing: Thibaud Maillard, 2023)

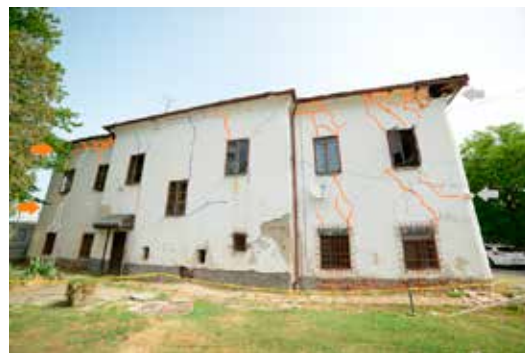
13 Identification of the cracks belonging to in-plane failure modes for the south façade (photo and drawing: Thibaud Maillard, 2023)

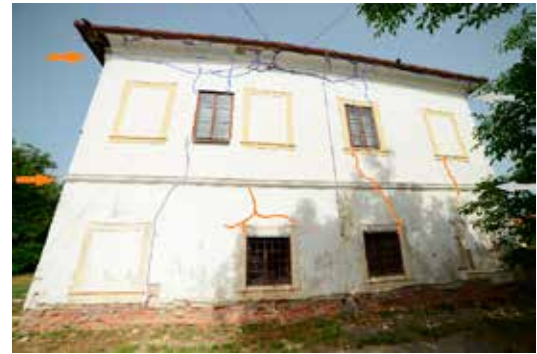
15 Identification of the cracks belonging to in-plane failure modes for the east façade (photo and drawing: Thibaud Maillard, 2023)

When looking at the results obtained for the whole building when solicited in the y direction, the eastern and western facades seem well correlated to what is predicted with Tremuri. The same conclusions can be drawn with regard to the spandrel failure being well estimated by the software.

Figure 15 illustrates the cracks corresponding to in-plane failure modes, whereas Figure 16 shows the model of the eastern facade with, again, green and blue crosses indicating shear or flexural failures of the elements. In this facade also, the cracks not coloured in orange or grey belong to an out-of-plane mechanism.

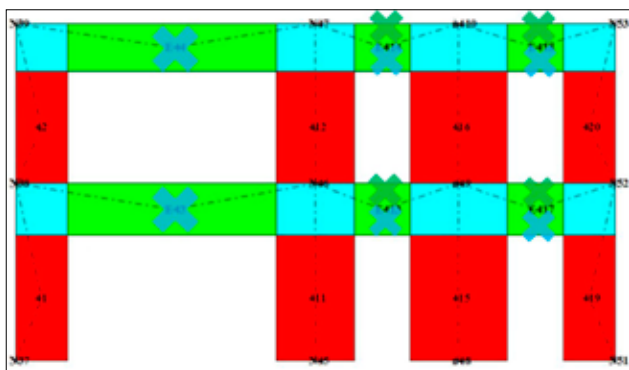
16 Prediction given by Tremuri for the east facade. Crosses indicate elements that have failed (drawing: Thibaud Maillard, 2023)
 Predviđanje iz Tremurija za istočno pročelje. Križići označavaju elemente u kojima je došlo do loma (crtež: Thibaud Maillard, 2023.)

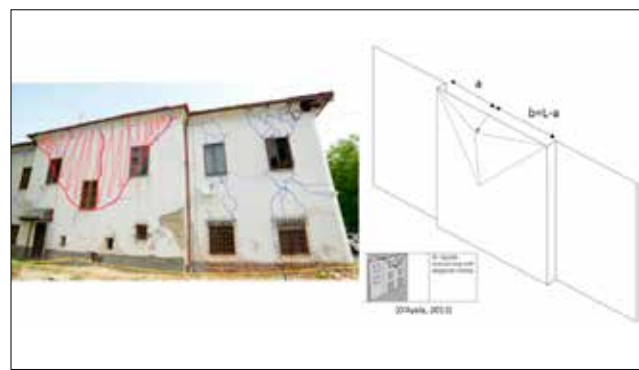
Table 8 Force-based and displacement-based results for the out-of-plane evaluation of the southern facade rotational mechanism. Damage limit state ($q = 1$) and life-safety limit state ($q = 2$) are evaluated.

Table 9 Force-based and displacement-based results for the out-of-plane evaluation of the southern facade overturning mechanism. Damage limit state ($q = 1$) and life-safety limit state ($q = 2$) are evaluated.

17 Out-of-plane mechanism in the south façade (photo and drawing: Thibaud Maillard, 2023)
 Mehanizam izvan ravnine na južnom pročelju (foto i crtež: Thibaud Maillard, 2023.)

The mechanism studied in the south facade is illustrated in Figure 17, and it corresponds to a facade overturning with diagonal cracks.³⁰ Two parameters, a and b , have been set and varied to find the minimum value of the compliance factor. This mechanism is one that can be observed in the real building. The cracks seem indeed to coincide with a facade overturning with diagonal cracks. This kind of mechanism can be approached by two different ways; either assuming that the two macroelements are rotating with respect to one vertical and two diagonal hinges, or that the elements are overturning with respect to the two diagonal hinges with the lowest corner considered as the rotation point. The two configurations are evaluated hereafter.

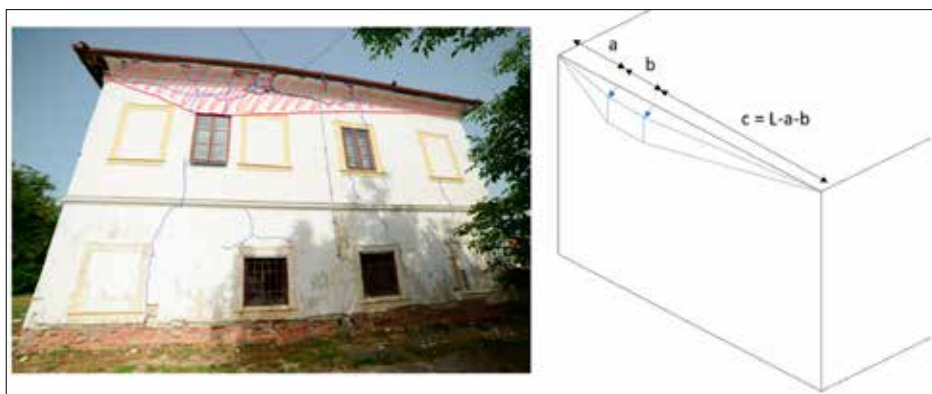
18 Out-of-plane mechanism n°1 in the east façade (photo and drawing: Thibaud Maillard, 2023)

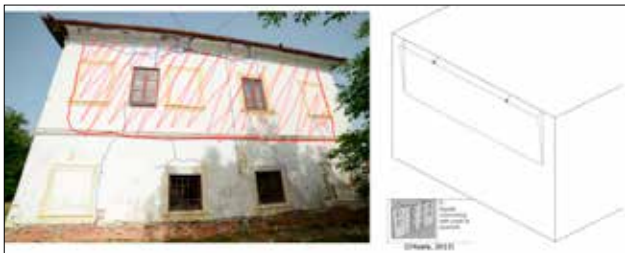
19 Out-of-plane mechanism n°2 in the east façade (photo and drawing: Thibaud Maillard, 2023)

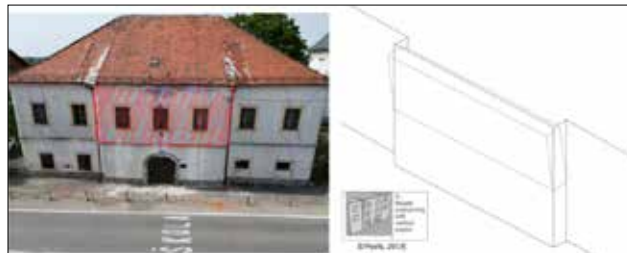
20 Out-of-plane mechanism in the north façade (photo and drawing: Thibaud Maillard, 2023)

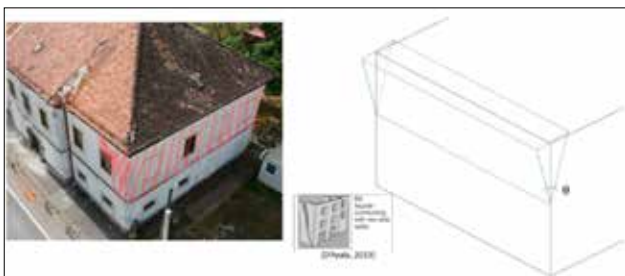
21 Out-of-plane mechanism in the west façade (photo and drawing: Thibaud Maillard, 2023)

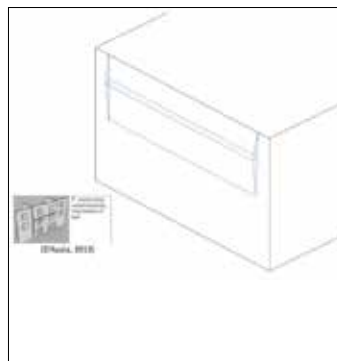
22 Western facade plausible out-of-plane mechanism after the introduction of anchors connecting the top slab's beams to the exterior masonry walls (drawing: Thibaud Maillard, 2023)

The parish house has several out-of-plane mechanisms, as presented in the previous section. The main reason explaining this behaviour were the inappropriate connections between the first-floor level and the exterior walls. The wooden beams are simply lying on the walls, with an embedment length assumed to be half the thickness of the wall, and are resisting out-of-plane solicitations only by friction force. To prevent such mechanisms, the main point is in the improvement of the connections between the walls and the top floor. Therefore, to reduce the likelihood of developing out-of-plane mechanisms, the introduction of anchors fixing the wooden beams to the walls is in a good direction. Such system consists of an L-shaped steel plate connected with screws to the wooden beams and anchors to the masonry walls. By anchoring the beams, sliding and hammering of the beams, would be prevented when out-of-plane solicitations occur and thus limit the probability of the formation of an out-of-plane failure mechanism. The influence on the calculations is found in the fact that the restraining force coming from the friction between the timber beams and masonry walls would change to a stronger restraining force (stabilizing moment). The verification of whether the anchoring of the beams is sufficient needs to be controlled. In the longitudinal direction, only three wooden beams are present, meaning this method might not be sufficient. This is why the verification of the effectiveness of this technique must be evaluated. Despite the positive effects this method might have on stabilizing this mechanism, the anchoring of the beams could create another mechanism over the top storey, as shown in Figure 22. This new mechanism should also be assessed.
