Data dilemma

The transformer under investigation was the Federal Pioneer 230/72kV, 83 MVA autotransformer unit, which was one of two 'merchant' units serving an international tie-line. The SFRA tests were performed, and the results were inconsistent. Careful application of the ABC

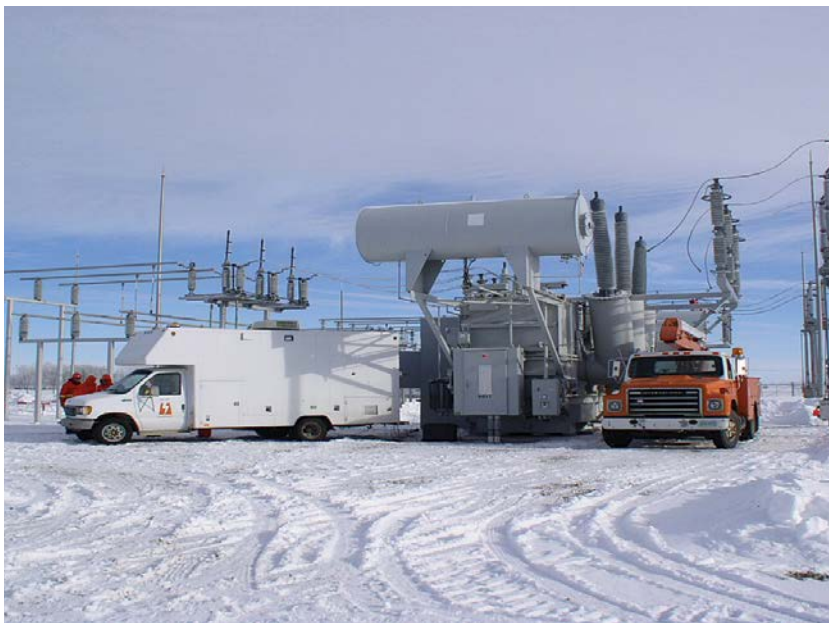
A transmission autotransformer that had previously seen a number of faults and animal intrusions suffered an LV bushing failure, as shown in Figure 1. The Federal Pioneer 230/72kV, 83 MVA autotransformer unit was one of two ‘merchant’ units serving an international tie-line. The

The X1 and X2 bushings were removed, tested and returned to service, and the X3 bushing was replaced. A 3 cm bulge was observed in the main tank, a bulge which had not previously been noted. With concern for the mechanical integrity of the unit, several electrical tests were performed, including:

Figure 1. Transformer during test activities

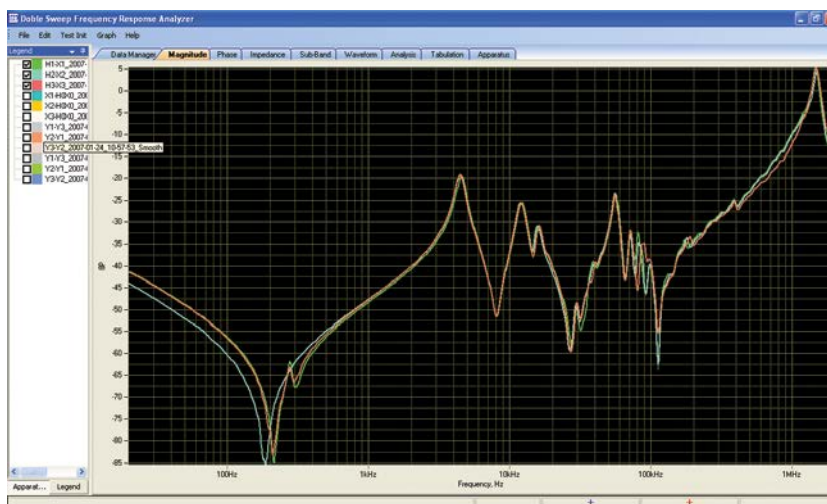
SFRA results for each winding/phase showed no significant variation from expected, with H-X shown in Figure 2; in addition, the short circuit SFRA results were also as expected.

Figure 2. SFRA results for H-X windings

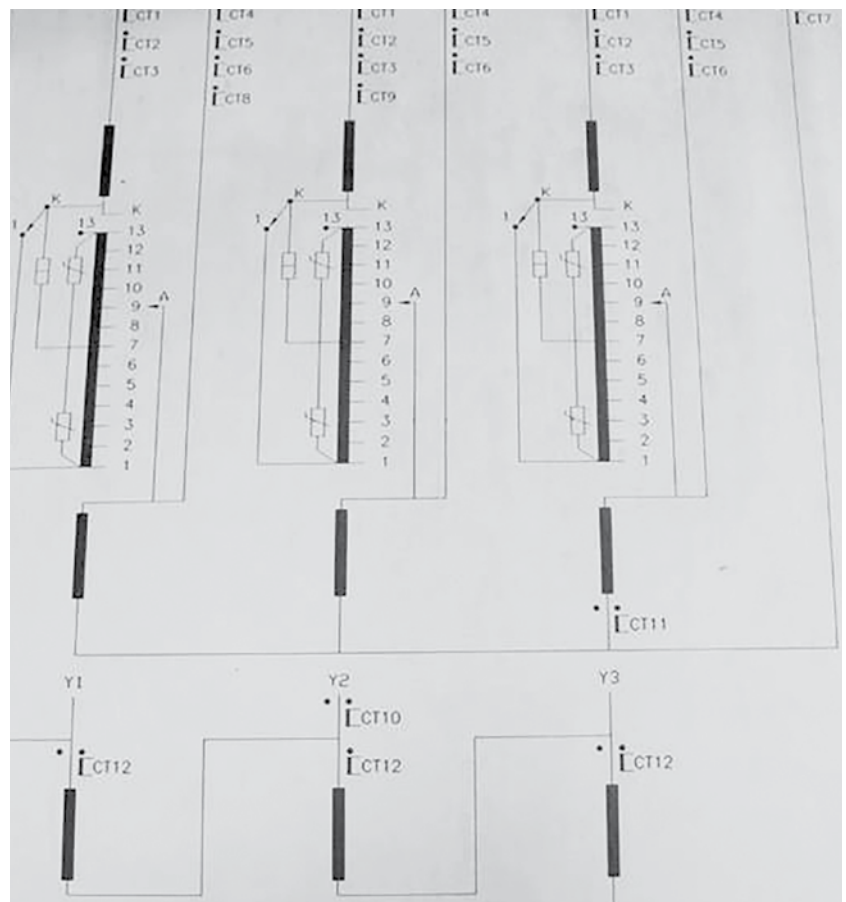
We also started to look more deeply, not just at the results of the tests but also at how those tests were made and what is included in the ‘test object’. What is there about the tertiary which might make it ‘different’? Nothing obvious, we were thinking, as we looked at the nameplate, Figure 3.

Then, either in a moment of clutching at straws or a moment of inspiration, a question came to mind: what if the CTs aren’t shorted? I checked with the site team, and they noted that all were shorted several years ago when the transformer was installed, commissioned and put into operation. And that was when I had an ABC moment... Assume nothing, Believe nobody, Check everything; and I asked for them to be checked. At that time, the site team informed me almost immediately that two of the tertiary CTs had been left unshorted, which placed a differential burden on those phases and different LR results.

Figure 3. Transformer nameplate detail

At this point, the LR kit was, once again, taken out and applied, and all results fell neatly into line! With the dilemma re-
