Zdravko Schauperl, Boris Perić, Gojko Marić

Izlaganje sa skupa/Conference Paper

SOLUTION OF STAINLESS STEEL PIPE CALIBRATION LUBRICATION PROBLEM

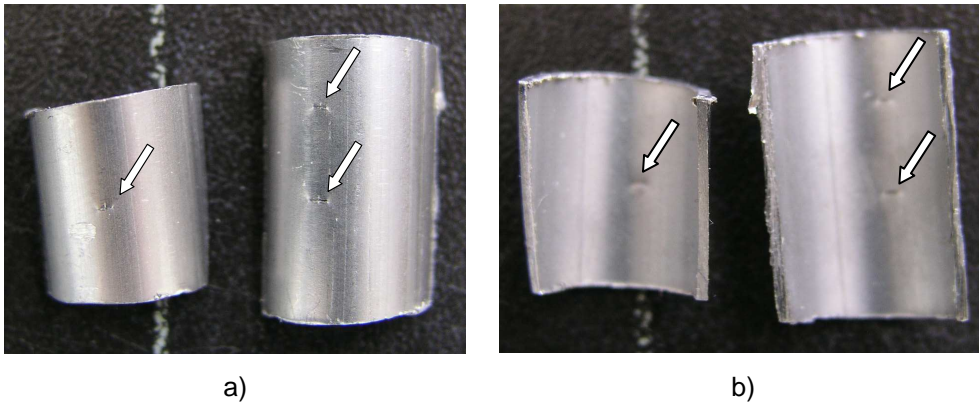
In the process of the production of stainless steel pipes marked 304L we can witness damages in the form of transversal cracks, Figure 1 a and b.

Figure 1: Parts of pipes with cracks: a) outside, b) inside

The cracks emerge in irregular intervals after the calibration procedure and they do not appear by any pattern. The cracks and their detection interrupt the whole production process when these damaged pipes need to be cut and discarded. Apart from this waste of the material and time, there is also a loss of the pipe continuity since they usually need to be produced in one piece of a certain length. Due to the direct and indirect costs caused by these errors and interruptions, a manufacturer is eager to find out what causes them and to prevent them in the future.

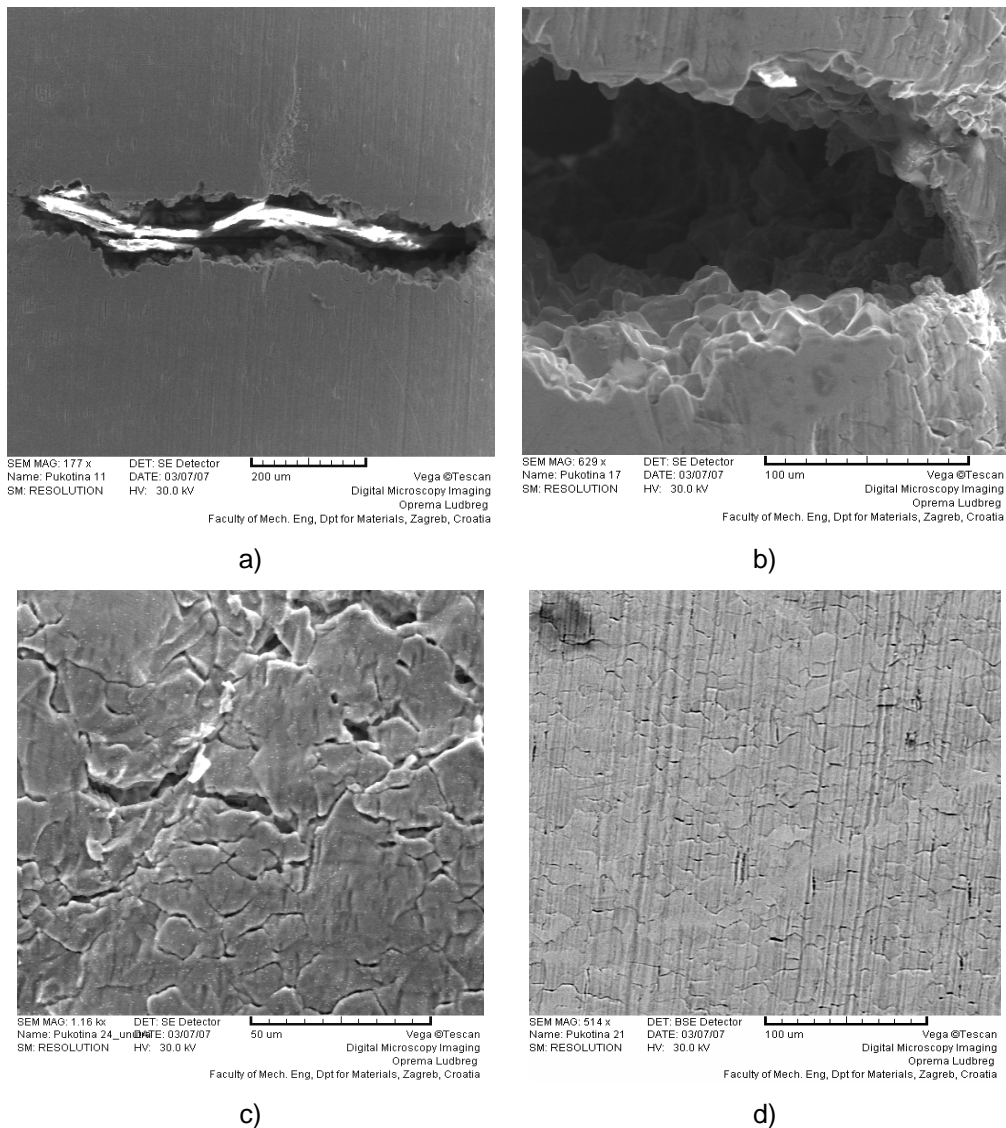
Figure 2: SEM pictures of the crack, SE detector: a) the whole crack, b) a crack edge c) a crack edge, magnified d) the basic material near the crack

The analysis of the damaged pipe surfaces showed the transversal cracks 1, 2 mm long at grain boundaries. At the both ends of all the cracks one can see the material deformation in a recess form. There is a net of cracks spreading in range of few millimeters from the end of a crack towards the basic material and these cracks are

The tests performed on the pipe material showed that there is no irregularity or structural error to cause the cracks. The analysis results with SEM and microhardness values indicate that the cause of it is stress, which means that the cracks emerged due to the outside stress becoming greater than material strength. This means that the cause of this crack is detected within the most critical procedure of pipe production technology, the pipe calibration.

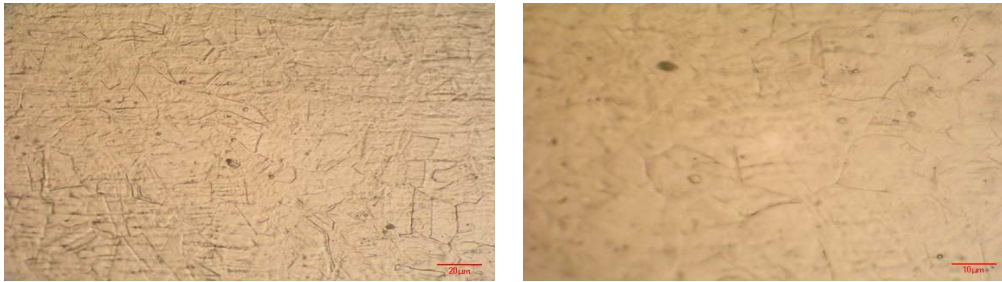
Figure 3: Microstructure of the pipes with cracks in the transversal cut: a) lower magnification, b) higher magnification

The microstructures of pipe materials with cracks in the transversal cut are shown in Pictures 3a and b, and the microstructure pipe materials without cracks in Fig. 4a, b. The analysis of the material microstructure of damaged and undamaged pipes in the transversal cut did not show any significant difference. Both samples have homogeneous austenitic microstructure which is typical for this kind of material.

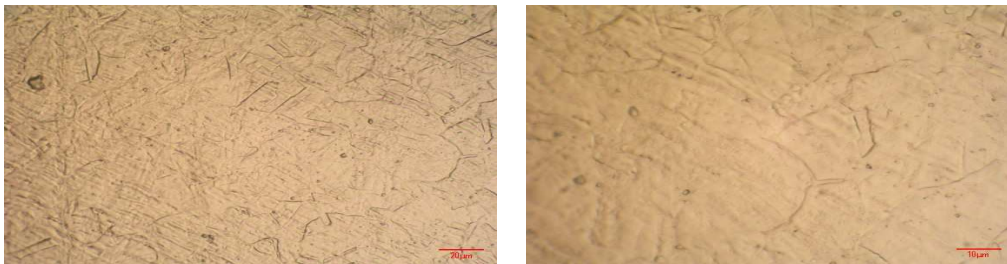
Figure 4: Microstructure of the pipes without cracks in the transversal cut: a) lower magnification, b) higher magnification

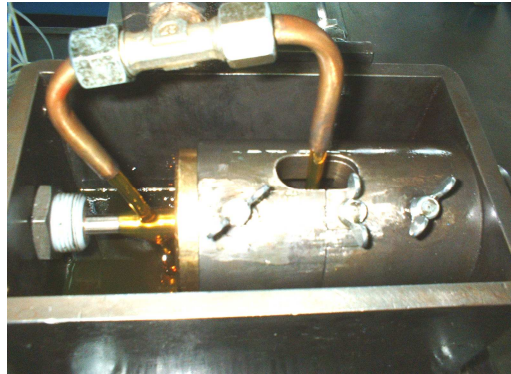
Figure 5: Pipe calibration (a detail)

Out of all these formulations, the one marked as 2 showed the best characteristics. This formulation passed the complete pipe coil production (500 m) without any problems, while there were damages, scores and sticking with all other formulations even after as low as 60 m of produced pipe. The rough surface of the produced pipes were supplementary measured. The results are shown in Table 4.
