FAILURE ANALYSIS OF 48MnV ENGINE CRANKSHAFT

Investigation was conducted on the failure of the crankshaft made from 48MnV alloy steel used in automotive engines. Magnetic flaw defects were detected at the transition fillet between the third main journal and the counterweight of the crankshaft. Macroscopic examination, chemical composition analysis, metallographic analysis, and scanning electron microscopy observation were performed on the crankshaft samples. The testing results were summarized, and the causes of the crankshaft cracking were systematically analyzed. The results indicate that longitudinal cracks occurred on the surface of the crankshaft journal due to the combined effect of thermal stress and normal operating stress, exceeding its load-bearing capacity. These cracks propagated inward, forming magnetic flaw cracks, ultimately leading to crankshaft failure.

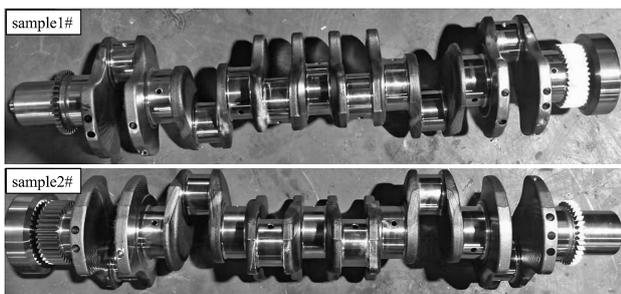
Figure 1 Failed crankshaft samples

Figure 1 shows two failed crankshaft samples. It can be observed from the Figure that both Sample 1 and Sample 2 exhibit wear at the third main journal and bearing. The remaining journals and bearings appear to be relatively intact with no significant signs of wear.

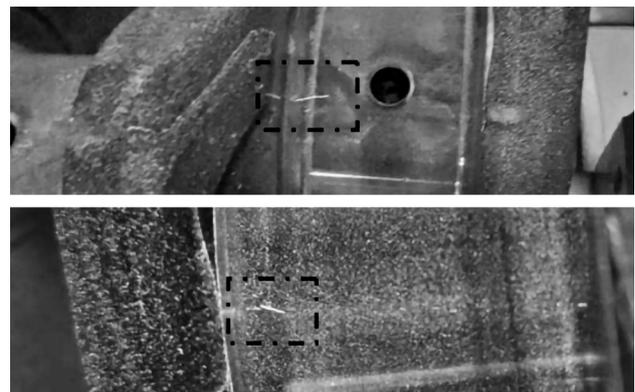
Figure 2 Fluorescent magnetic particle inspection magnetic flaw defect image

To further analyze the defects present in the crankshaft, fluorescent magnetic particle inspection was conducted on the third journal sample of the crankshaft. The resulting image, as shown in Figure 2, depicts magnetic flaw defects at the third main journal of the crankshaft. Irregular serrated magnetic flaw defects are observed at the transition fillet between the crankshaft journal surface and the counterweight, with irregular pointed ends. The defects exhibit a clear outline, with dense and distinct magnetic particle accumulation.

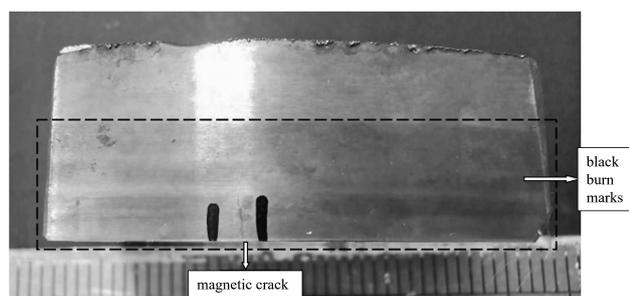
Figure 3 The corroded morphology of the crankshaft specimen

After immersion in a 4 % nitric acid alcohol solution, the defect site of the crankshaft specimen was observed. The corroded morphology is shown in Figure 3. It can be observed from the Figure that there are streaks and circumferential black burn marks on the surface of the crankshaft sample where the magnetic flaw crack defect is located. This is attributed to chemical reactions or physical interactions between the surface of the crankshaft and certain substances under high temperature, pressure, or frictional conditions during operation. Such abrasions may originate from lubricants, coolants, or other media that the crankshaft comes into contact with during operation, or may result from frictional heating of the journal surface leading to surface material oxidation or thermal decomposition.

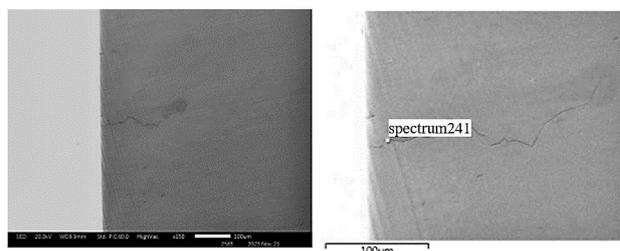
Figure 6 The microstructure of magnetic flaw crack

The sample was observed under a SEM, and the results are shown in Figure 6. It can be observed from the Figure that the magnetic flaw crack extends longitudinally from the surface of the journal, and no metallurgical defects such as inclusions that could have caused the cracking were found inside the crack or in its vicinity. Figure 7 shows the results of energy dispersive X-ray

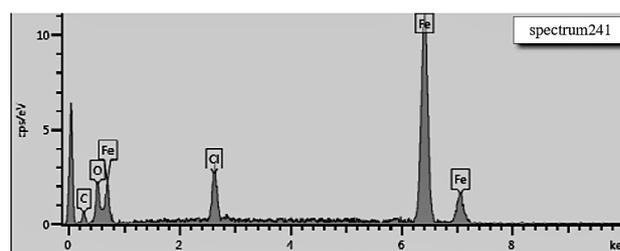
Figure 7 The energy dispersive X-ray spectroscopy (EDS) analysis results at the fracture surface of the magnetic flaw crack

spectroscopy (EDS) analysis at the fracture surface, revealing trace amounts of oxygen. This is attributed to the generation of a large amount of heat when the crankshaft grips the bearing, resulting in charring. Therefore, the high-temperature oxidation of the bearing during crankshaft operation led to the detection of oxygen.
