# Examination of the Causes for Premature Failure of Mating Surfaces in Smart Injector Actuators

Dejan JANKOVIC\*, Mileta RISTIVOJEVIC, Zoran STAMENIC, Zarko MISKOVIC, Aleksandar DIMIC

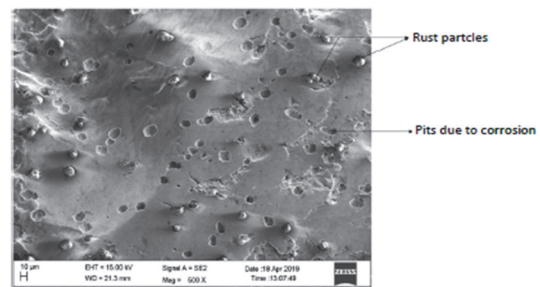
When the maximum tangential stress reaches its critical value, initial crack forms in the subsurface layer. Due to the periodically reverse stress-surface pressure, the initial crack gradually expands and eventually reaches the mating surface. Destruction products, tiny flakes of material, are formed then, and tiny pits form on mating surfaces, Fig. 2. This type of mating surface destruction is called pitting [2].

Figure 2 Rust particles and cam plate pitting caused by surface corrosion [2]

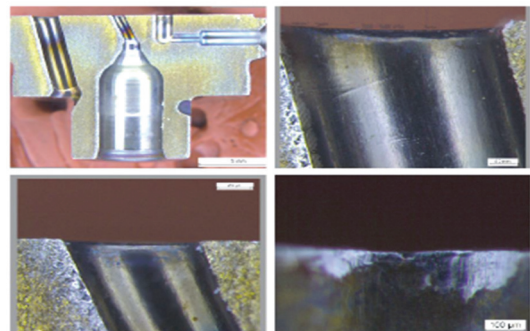
Upon visual inspection, it can be concluded that all actuators are damaged only at the point of contact between the actuator and the intermediate plate, i.e., the central hole and area between flat surface and hole, Fig. 7 and Fig. 8. It was determined that there is a lack of coating on the surface layer between the hole and the flat surface, as shown in Fig. 7.

Figure 7 Macro and microphotographs of injector actuator cross-section

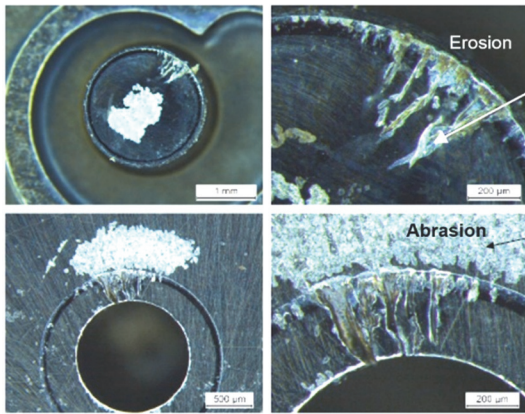
Figure 8 Stereo microscope image of the damage

Stereo microscope image analysis shows abrasive wear as the most common cause of damage to mating surfaces (Fig. 8), assuming that the particle size is smaller in diameter than the gap at the moment fluid is injected. Also, in addition to abrasive wear, the analysis showed erosion that can be caused by the fluid flow, which often occurs on the turbine blades and centrifugal pumps. Additionally, the resulting damage can be superimposed if the fluid carries abrasive particles.

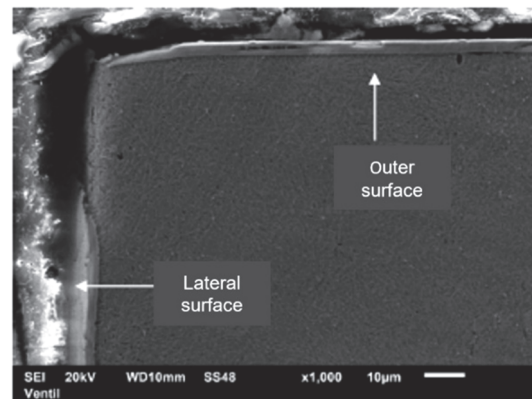
Fig. 10 clearly shows coating on the external flat surface and a 30.5 µm lack of coating on the lateral surface. Low bond strength between the base material and the coating resulted in the coating wear off. The loss of coating is additionally affected by the border surface created at the sample corner, i.e. between the outer and side surfaces, Fig. 11. This border surface may contribute to the formation of cracks on the coating surface [7].

Figure 10 Coating surface

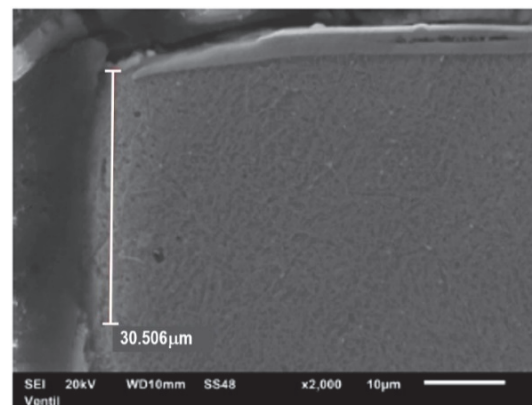
Figure 11 The loss of the coating

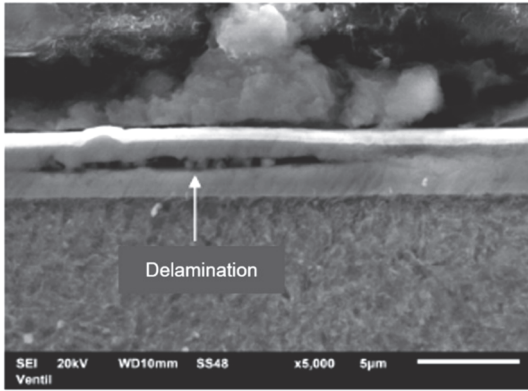
Fig. 12 and Fig. 13 show faults in the coating, and two different layers on the outer side of the sample. Thickness of the coating on the outer sample side is approx. 3.4 µm, whereas it is not uniform on the lateral side and ranges from 7 to 7.5 µm. Delamination between the layers of the coating on the outer surface is observed (Fig. 12 and Fig. 13). Delamination was not observed on the side. Fig. 10 shows a loss in layer 2 at the transition from the outer side to the lateral side of the sample. The cause of the observed faults (poor adhesion, delamination) may be found in an inadequate process of applying the coating,

Figure 12 Delamination in coating

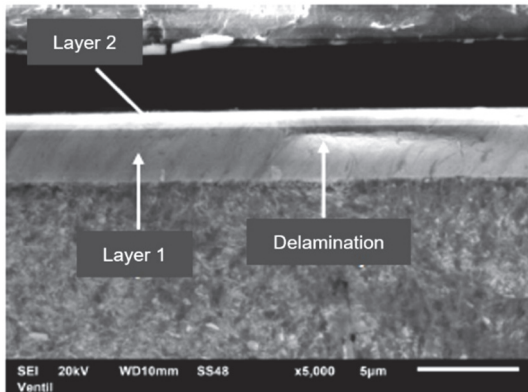
Figure 13 Faults in coating

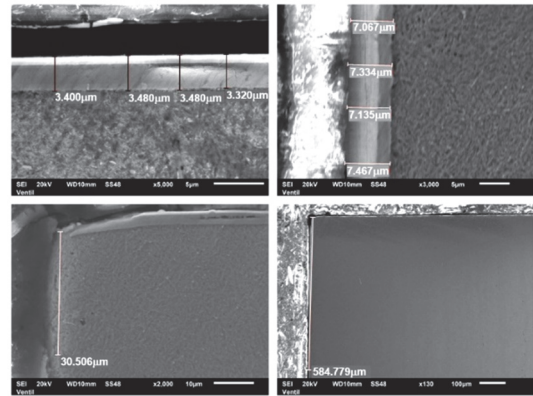
Figure 16 SEM photomicrograph with coating thickness dimensions

DLC coating  $1.8 \div 2.17 \mu\text{m}$  thick with  $22.2 \div 25.7 \text{ GPa}$  surface hardness, evenly applied to the mating surface, did not meet the quality requirements [8, 9].

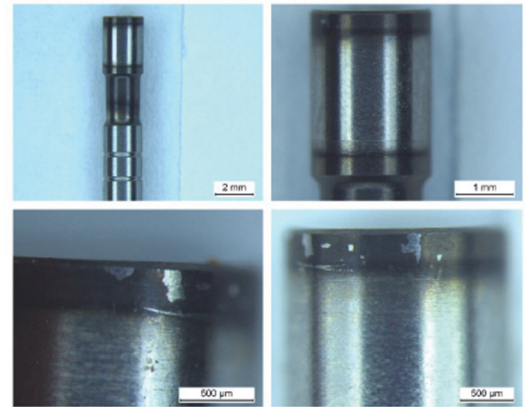
One of the additional factors of the rapid decline in actuator working performance is damage to the coating of actuator pin (the actuator pin and the intermediate plate have a mating surface where the damage was observed). These damages were generated on several new actuators, as shown in Fig. 17.

Damage to the coating indicates inadequately coated pins. Under operating conditions, rapid damage to mating surfaces occurs due to abrasion and erosion caused by

small particles of the detached coating. In further use, this damage causes performance reduction in actuators and smart injectors.

Figure 17 Actuator pin damage

In order to reduce the variation of the life expectancy of actuator mating surfaces, it is necessary to increase control during the formation of the subsurface layer in mating surfaces. In addition to the above, it is necessary to increase control of the operating conditions in terms of the quality of circulating fluid and purifier, as well as the purifier replacement frequency.
