Transformer fleet condition assessment using advanced analytics

practically allocated for repair, refurbishment, or replacement. This article provides a case study for a fleet of eight (8) transformers that were above 50 years of age.

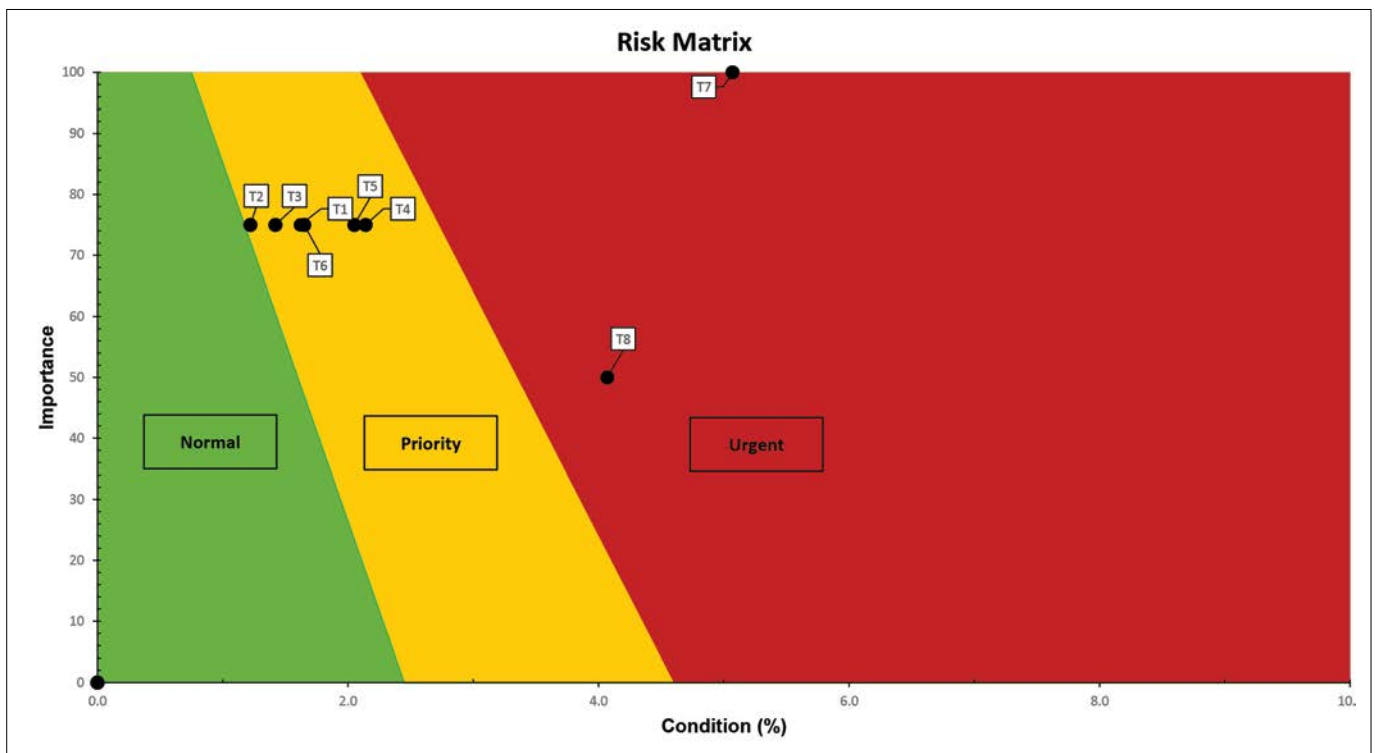
Figure 2. Calculate the risk of failure for transformers under investigation.

The probability of failure for the priority and urgent units is broken down as listed in Table 4 and as shown in the risk matrix in Figure 2.

The number of leaks or rust spots and their severity as well as the presence of PCBs, were used to determine this risk, as shown in Table 4. SS-1 and T2-A showed the highest levels of oil leaks.
