Cracking of HSLA Steel Nioval 47 Caused by Exploitation Condition and Repair Welding

Milan MILADINOV, Branislav ĐORĐEVIĆ*, Simon SEDMAK, Filip VUČETIĆ, Lazar JEREMIĆ, Aleksandar SEDMAK, Olivera POPOVIĆ

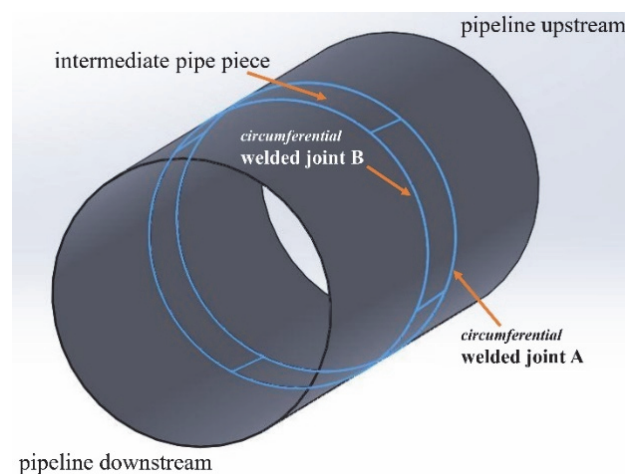
Figure 2 Pipeline number 1

An intermediate pipe piece with length of 100 mm was installed between these two parts during previously carried out reconstruction of pipeline. It was also made of Nioval 47, which was connected to the pipeline with circumferential welded joints A and B. In addition to welds A and B, intermediate pipe piece has 4 longitudinal welds, each with a length of 100 mm. All welded joints were made using electrode similar to E 50 6 1 Ni B 42 by different manufacturer. Part of the pipeline with the intermediate pipe piece and the support rim is covered by a layer of concrete which is connected and is supporter to the rocks (concrete covers approximately one third of the pipeline circumference, while the remaining part is free and accessible). Supporting rim made of basic carbon steel, welded to pipeline, has a predominantly protecting role of the intermediate pipe piece and welded joints (longitudinal and circumferential) from environmental influences. Since no defects were observed (predominantly) on circumferential welded joints between supporting rim and pipeline, no further analysis was taken on this particular pipeline part, which excluded the external (i.e. environmental) effects from further analysis.

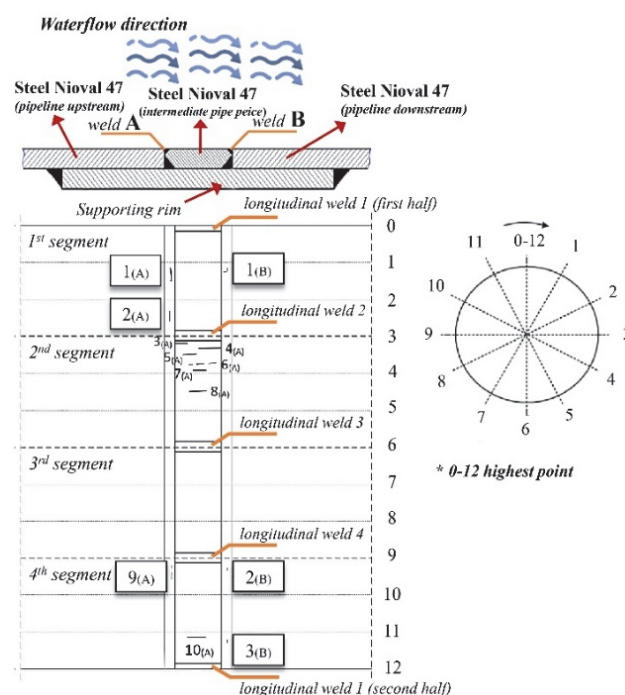
Figure 3 Distribution of cracks in the internal pipeline wall, in the intermediate pipe piece vicinity

Detected cracks/defects in welded joints are mostly oriented along the radial direction, whereas cracks detected in the intermediate pipe piece are longitudinal. It was concluded that the longest cracks were detected in the fusion line between the upstream part of the pipeline and the intermediate piece, i.e., in welded joint A. During the previous reconstruction of the pipeline, welds A and B (as transversal welds used to connect segments) were made using basic electrode similar to E 50 6 1 Ni B 42, manufactured by Železarna Jesenice. This nickel-alloyed electrode is used for welding of non-alloyed and low-alloyed steels, as well as fine-grain steels. According to the available documentation, repair welding technology proposed preheating using a burner with propane-butane-oxygen gas

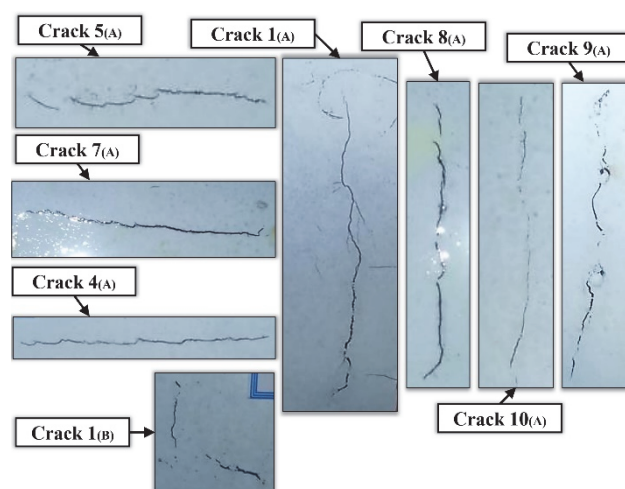
Figure 4 Appearance of some detected cracks/defects on internal pipeline wall

mixture, which could not achieve necessary T_p . The report, among other things, mentions that T_p was lower than required, which lead to the occurrence of local defects (cold cracks, porosity, etc.), along with residual stresses. Considering the damage found in the intermediate pipe piece parent material, it was not possible to ascertain their nature and cause, due to lack of important information. Taking into account the available documentation, installation history and the exploitation conditions of the pipeline, multiple factors could have led to crack occurrence in the parent material of intermediate pipe piece, including: (i) erosion processes; (ii) poor manufacturing technology related to rolling of the repair pieces (considering that the highest concentration of damage is located at segment 2); (iii) corrosive processes (taking into account the damage anti-corrosion later in the internal wall of the pipe at certain locations along with the properties of carbon steel used for the repair, working environment, crack geometry (Fig. 4), etc.

Detected cracks/defects were previously eliminated by grinding with 3-6 mm thick grindstone. Grinding process itself was done in short intervals, without significant increase in material temperature. It was performed up to a point when the crack was no longer visible, which was verified using penetrant testing. Ground locations represent U grooves with slight radial transition, without undercuts, notches or significant changes in geometry/decrease in parent material thickness. After the groove was shaped, its dimensions were measured and it was positioned relative to the adopted reference point.

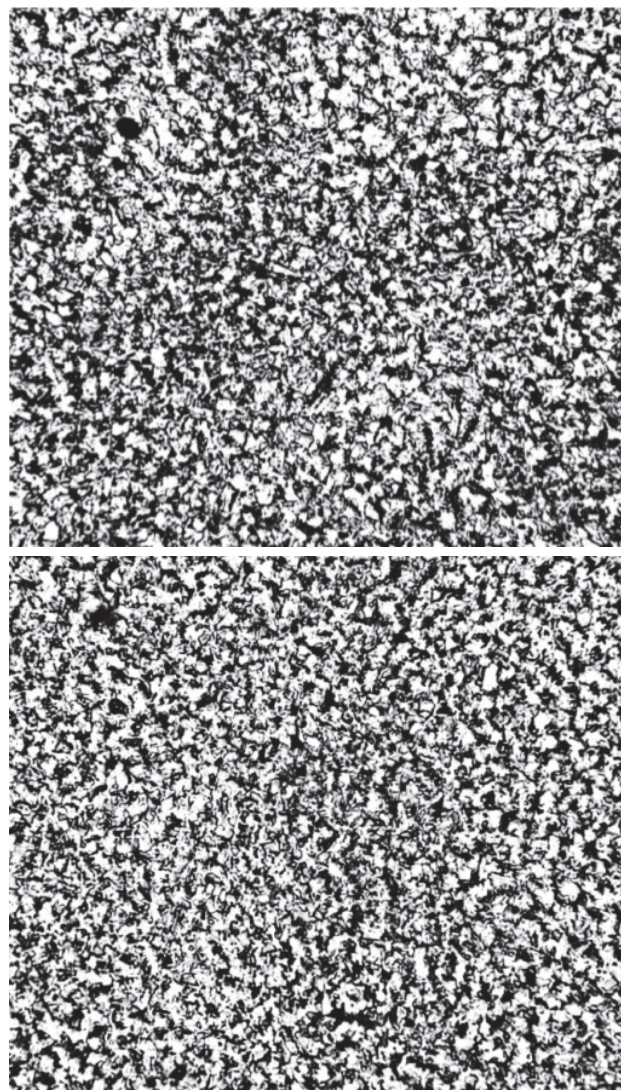
Microstructure of the surface layer of pipeline wall was obtained via replica method, on upstream and downstream parts of the pipeline, and can be seen in Fig. 5. Surface was etched using 8% Nital. Fig. 5 shows the fine-grain ferrite-pearlite microstructure with occasional presence of small non-metallic inclusions of the oxyde and sulfide type.

Figure 5 Microstructure of Nioval 47, sample taken from: up) upstream section of the pipeline; down) downstream section of the pipeline (magnification $\times 100$)

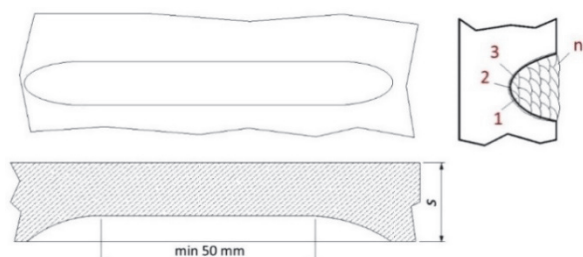
Figure 7 Illustration of U groove after machining and crack(s) elimination with filling plan

Preheating was performed by electric resistance heater, including parts of pipeline and intermediate pipe piece. Temperature was raised to 145 °C using ceramic heaters, with rate 50 °C/h. During the filling of the groove, each weld was started at the groove side, in order to use the heat input of the following pass to temper the HAZ microstructure. Final passes were laid outside of the parent material (1-3 mm for annealing of hardened zones in the parent material). It was ensured that none of the individual weld passes was shorter than 50 mm, Fig. 7. Welding parameters are shown in Tab. 6.

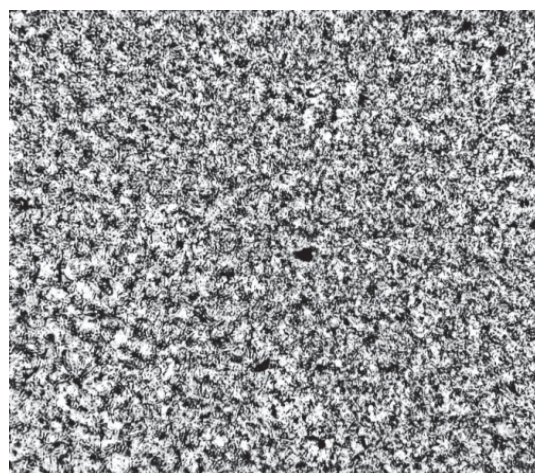
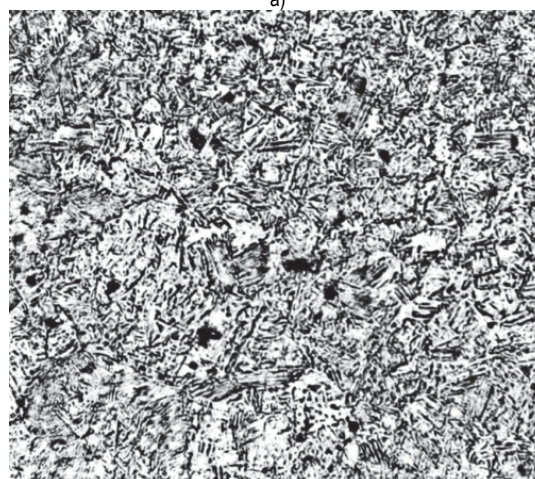
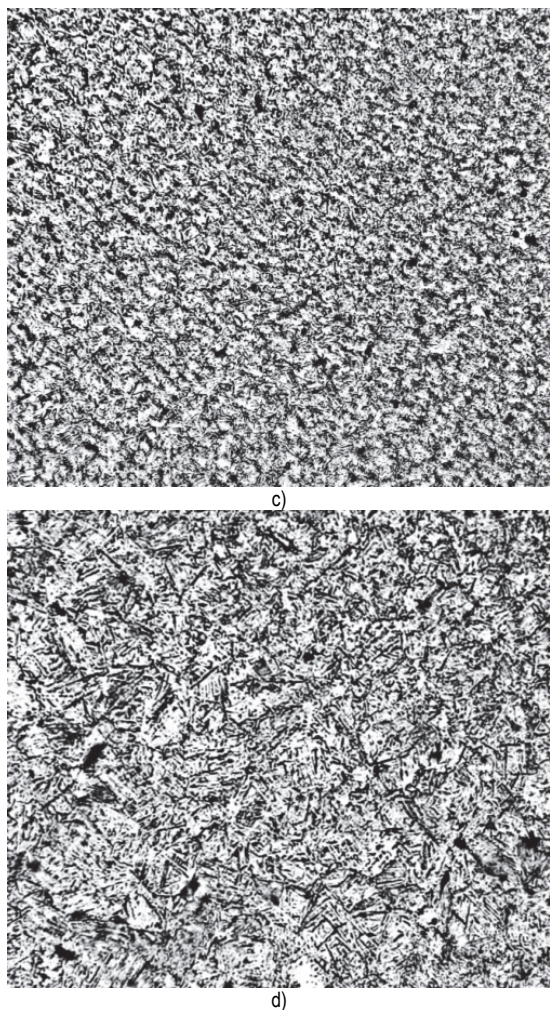
Figure 8 Microstructural analysis: a) weld region A: HAZ/fine-grain structure (repaired crack 1_(A)); b) weld region A: HAZ/coarse-grain structure (the repaired crack 1_(A)); c) weld region B: HAZ/fine-grain structure (repaired crack 1_(B)); d) weld region B: HAZ/coarse-grain structure (the repaired crack 1_(B)) (magnification $\times 100$)

Microstructure analysis of the surface layer was conducted using replica method, in accordance with recommendations of SRPS ISO 3057/2011 standard. This test was performed for the purpose of determining the microstructural state of critical pipeline zones, which included welds A and B, as the most critical welds in the whole pipeline construction. Following the finishing polishing and rinsing, test surfaces were etched using 8% Nital. Analysis of microstructure was performed using the light field technique. Areas with fine-grain and coarse-grain HAZ of repaired crack 1_(A) are shown in Fig. 8a and 8b, whereas these areas in welded joint B at the repaired crack 1_(B) location are shown in Fig. 8c and 8d.

In coarse-grain HAZ region, both welds had shown presence of martensitic structure, along with individual and small and occasionally larger micropores (large black *rounds and stains* look alike marking in the Fig. 8a-d). Microstructures of the WM of both welded joints in repaired zones located in 4th segment are shown in Fig. 9. It can be seen that a bainite-ferritic microstructure is dominant in both welds, along with micropores presence. In WM of the repaired crack 9_(A), a crack with approximate length of 1.8 mm was detected (Fig. 9a-b). This crack initiated in the WM area (Fig. 9a), whereas the crack ended at the fusion line between the WM and the HAZ (Fig. 9b).

Despite thoroughly performed analysis and defining of recommendations for the welding thermal cycle, martensite was detected in the coarse-grain HAZ in both circumferential welds in the repaired zone. Individual small and occasionally larger micropores were also observed. As for the weld metal, bainite-ferritic microstructure was the dominant one, whereas a crack with an approximate length of 1.8 m was detected in welded joint A. This crack initiated in the weld metal and ended at the fusion line. Although criteria defined by standards was fulfilled (in terms of dimensions), this crack needs to be monitored by at least one surface and volumetric NDT method, considering it was detected in a critical location in two welded joint regions (WM and HAZ). In addition, frequent monitoring period is recommended, at intervals of 6 months between two inspections. These intervals can be increased gradually if the results are shown to be satisfactory.

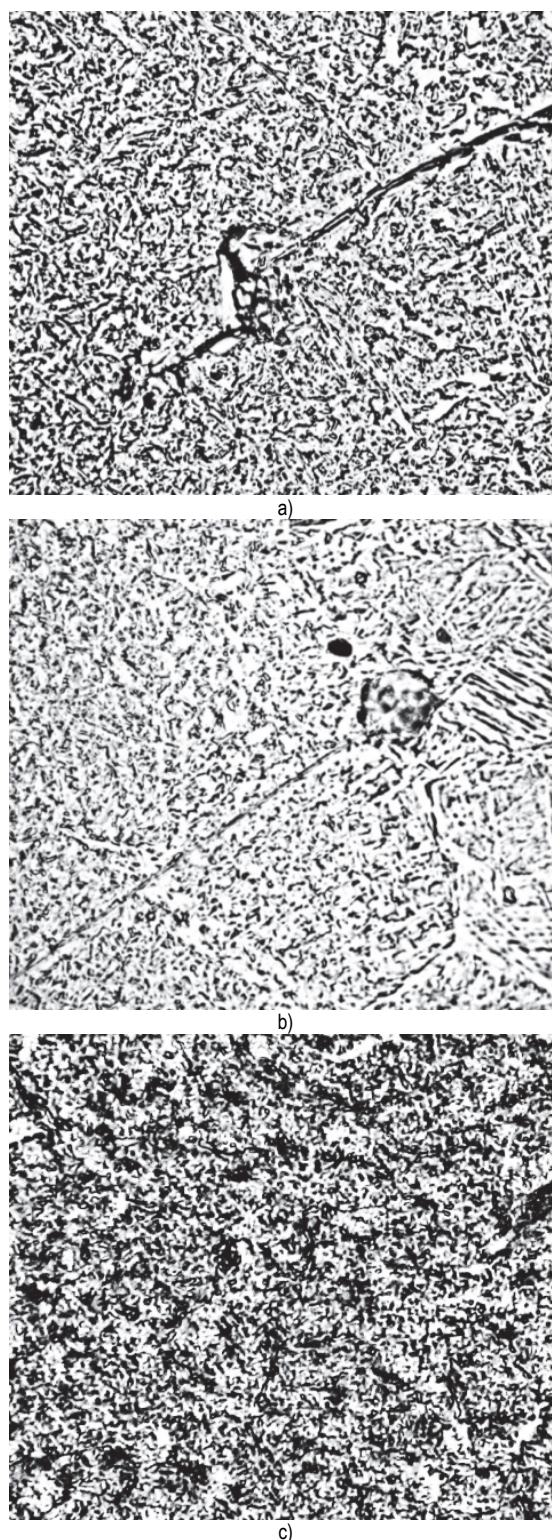
Fig. 9c shows the microstructure of welded joint B of the repaired crack 2_(B).

Figure 9 Microstructure analysis: a) weld region A: weld metal - crack initiation location (the repaired crack 9_(A)); magnification $\times 500$); b) weld region A: crack ending at the fusion line between the WM and the HAZ (the repaired crack 9_(A)); magnification $\times 500$); c) weld region B: weld metal (the repaired crack 2_(B)); magnification $\times 200$)
