# Improving Welding Quality on Zacns 98 m<sup>3</sup> Wagon Underframe

**Abstract:** The Zacns 98 m<sup>3</sup> wagon is a wagon with a tank intended for the transportation of dangerous goods in a liquid state. Accidents caused by faulty production can have serious consequences for material goods and human health. It is therefore necessary to pay particular attention to the quality of the production process. The wagon itself consists of two parts: the tank and the underframe. These and other components are joined together using welding technology. The quality of the weld seams on the underframe, in particular the weld seams that belong to weld seam quality class CP B1 or CP B2 according to the HRN EN ISO 15085-3 standard, is the focus of the quality assurance system. Non-destructive surface and volume tests must be carried out on such weld seams and the results, which indicate problems in the welding process, must be closely monitored. This article presents welding and quality control systems for CP B1 and CP B2 performance class welds. In addition to the technologies of welding and quality control, the authors intend to show the quality level over a longer period and propose meas

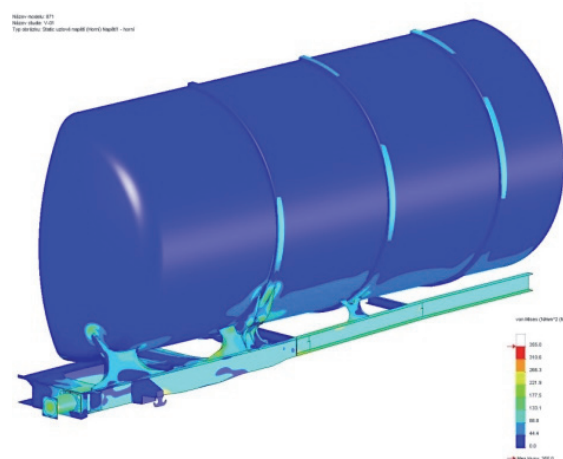
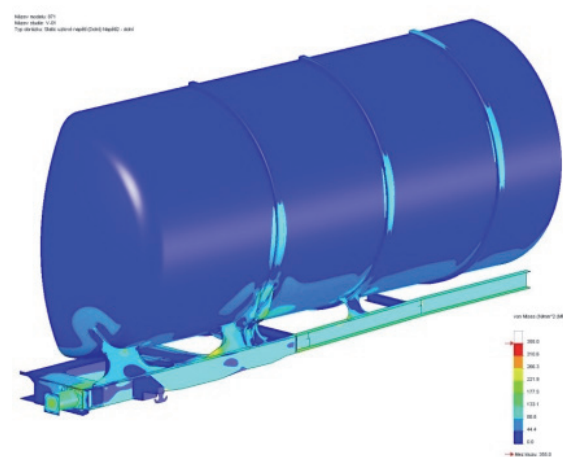
The welding quality of welds which are in the "light blue" and "light green" areas of Figs. 3 and 4, has a decisive influence on the general function and usability of the wagon's underframe. These areas each show calculated stresses between 88 N/mm<sup>2</sup> and 221,9 N/mm<sup>2</sup>. According to Tab. 3 of the HRN EN ISO 15085-3 standard, these welds belong to weld performance class CP B1. The welding quality of CP B1 welds must be confirmed by surface testing (penetrant testing - PT) and volumetric

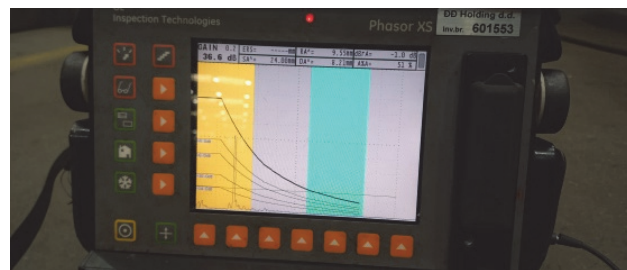
Figure 12 A scan of the defect located in the root of the weld number 1

UT examination of weld number 1 on the upper side of the underframe confirmed the existence of defects in accordance with HRN EN ISO 11666, located in the root and fill area of the weld. Fig. 12 shows a scan of the defect located in a root of the weld.

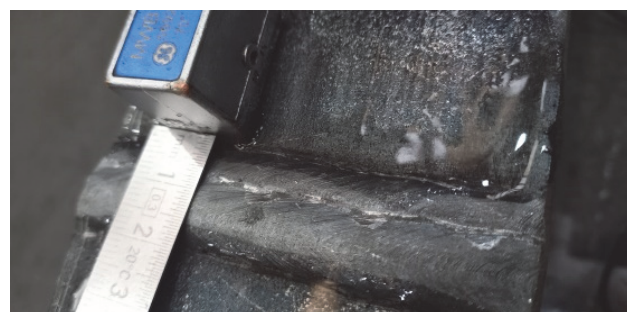
Figure 13 Measuring defect location on the examined weld no. 1

The exact defect location was determined via UT device screen (UT path) and marked on the examined weld measuring from the head of the UT probe shown on Fig. 13.

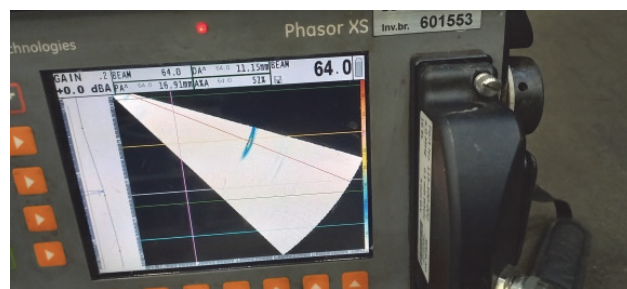
Figure 14 S scan of the defect on the root of weld 1

The presence of the flaw found was confirmed by re-examining the weld using phased array UT technology in accordance with EN ISO 19285. Fig. 14 shows the same defect in the root of weld 1, this time as a sectorial scan (S-scan).

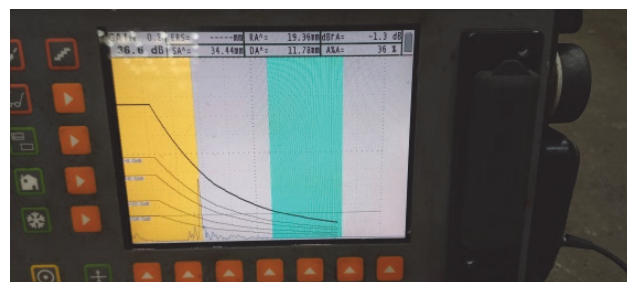
Figure 15 A scan of the defect found in the filled area of the weld

In addition to defects in the root of the weld, in the filled area was also found another defect shown in Fig. 15.

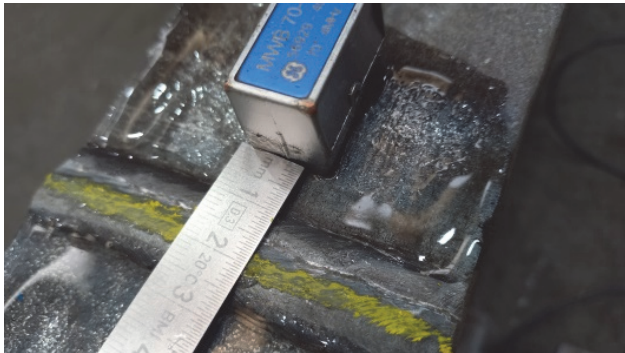
Figure 16 Marking the defect in the filled area of weld no. 1

Defect location was marked on the weld by using a measuring tool from the head of the UT probe, shown in Fig. 16.

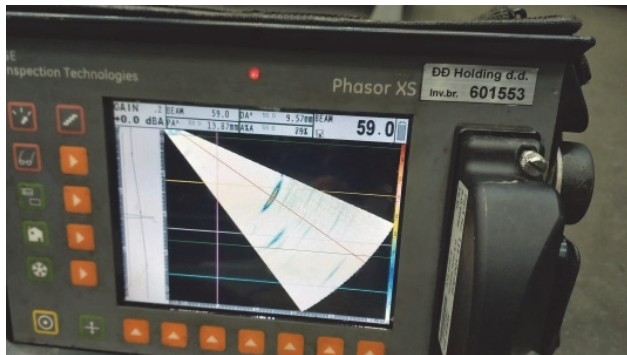
Figure 17 S scan of the defect in the filled area of weld no. 1

Phased array UT technology confirmed the existence of a defect, shown here in Fig. 17 as a sectorial scan.

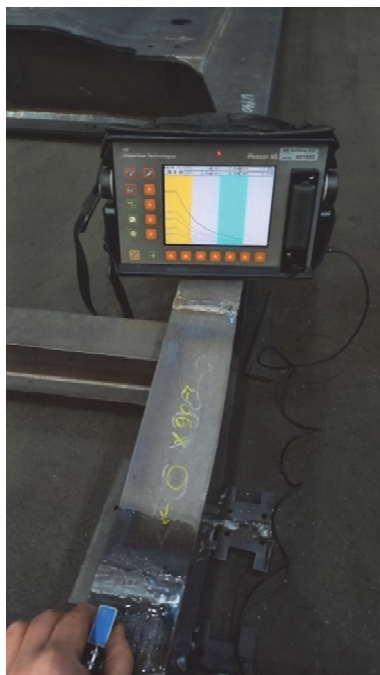
Figure 18 A scan of the defect located in the root of the weld no. 11

Example of the UT examination performed on the lower part of the underframe is presented on weld number 11. Fig. 18 shows the A scan.

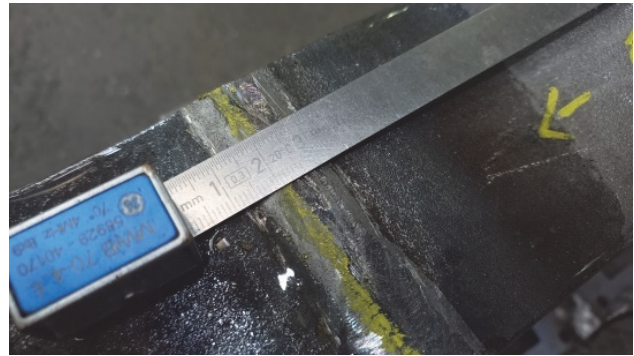
Figure 19 Marking defect location in the root of the weld number 11

Distance of the defect from the head of the UT probe was shown in Fig. 19.

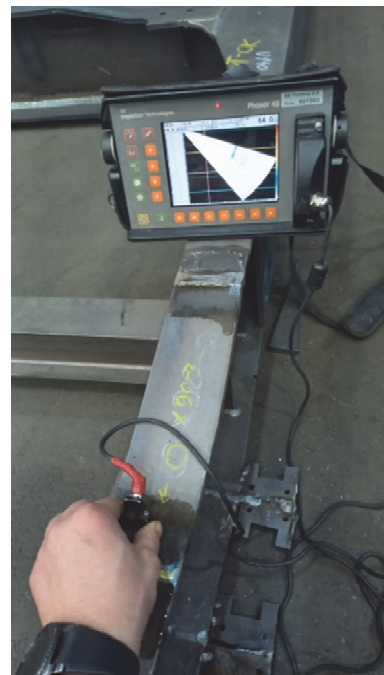
Figure 20 S scan of the defect located in the root of the weld no. 10

Phased array UT technology was used to confirm the existence of the defect, represented here in Fig. 20.

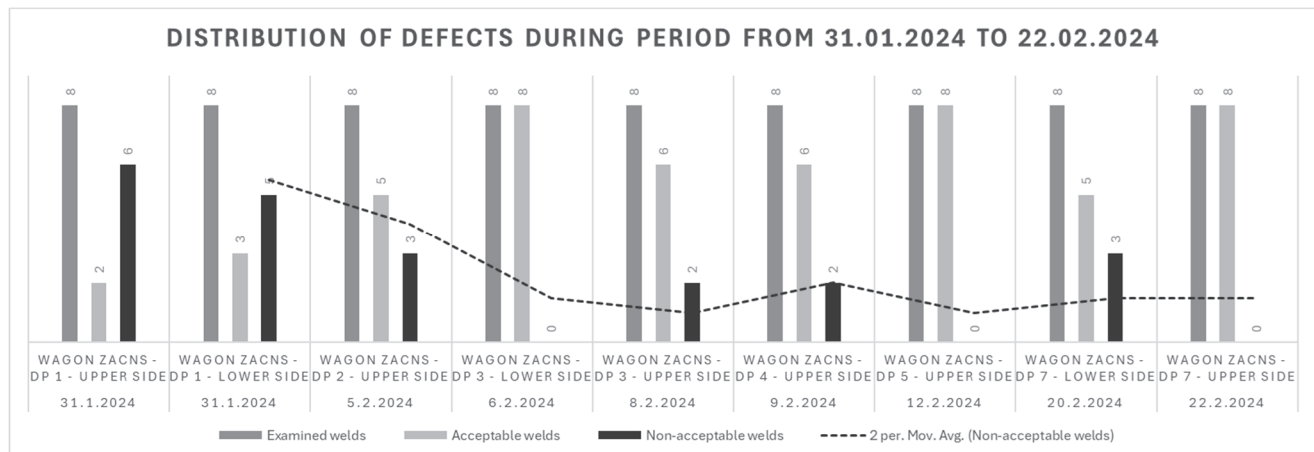
**Figure 23** Distribution of defects after UT examination during period of 31.01.2024 to 22.02.2024

The initial UT inspection defect percentage of 69% was reduced to an average of 9,67% during the testing phase. The results of this work reflect the findings of other authors who have dealt with similar problems [7] and confirm the suitability of the six-sigma method for improving overall weld quality. This method was also used in quality improvement studies by Novaković et al. [8].
