# Fracture Failure Analysis of Rear Axle Suspension Control Arm in Automobile

**Abstract:** Fracture failure occurred in the control arm of the rear axle suspension of a certain vehicle model. To determine the root cause of the failure, comprehensive analyses were conducted, including macroscopic fracture examination, microscopic fracture analysis, microstructural characterization, and hardness testing. The results indicate that the failure was caused by the combined effects of material defects, improper manufacturing processes, and service loading conditions. The fundamental cause of the fracture lies in the initiation of microcracks at the interface between coarse Al-Fe-Si-Mn inclusions and the matrix under cyclic loading. The presence of a strength gradient induced by local segregation of Si further accelerated crack propagation along the inclusion/matrix interface. Under cyclic stress, the cracks propagated progressively through a fatigue striation mechanism and exhibited intergranular fracture in the precipitation-enriched zones along grain boundaries. Ultimately, these factors led to premature fatigue failure of the control arm.

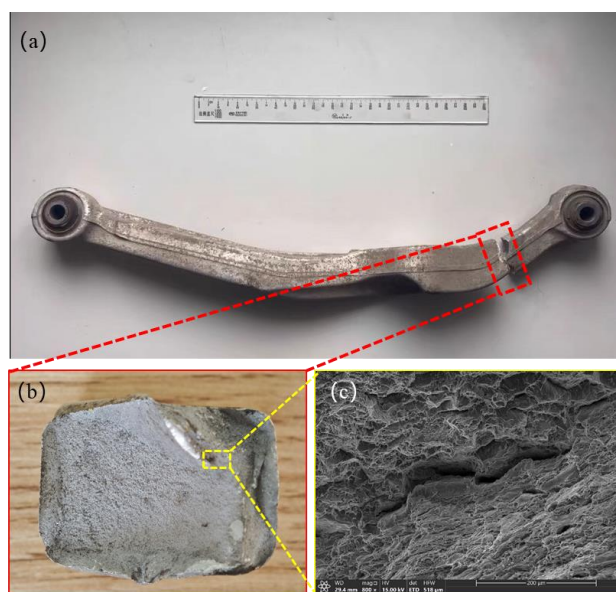
**Figure 1.** Fracture Location of the Elbow and Microstructure of the Fracture Surface

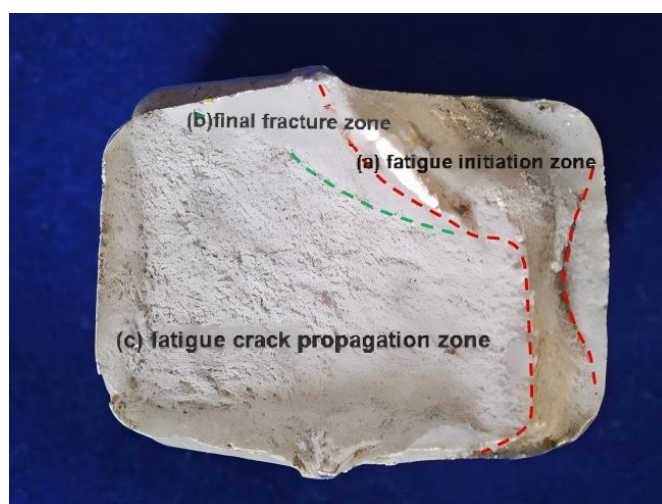
The macroscopic morphology of the fracture surface is shown in Figure 2. The overall appearance is bright and metallic, with no evident signs of plastic deformation. Clear fatigue striations are observed, indicating a typical fatigue fracture. Based on the propagation direction of the fatigue striations, the fracture surface can be divided into three distinct zones: the fatigue initiation zone (a), the final fracture zone (b), and the fatigue crack propagation zone (c).

**Figure 2.** Macroscopic morphology of the fracture surface.

Based on the fracture macroscopic observation, it can be concluded that the control arm fracture originated from the surface, and the crack propagation zone presented a conchoidal arc, that is, fatigue sheen. The ductility of the aluminum alloy led to a relatively shallow sheen. The final fracture zone is rough and uneven, with a large area, indicating significant overload at the final fracture. Further analysis of the Fracture microscopic reveals that, the characteristic of the fatigue arc converging towards the center at the pit defect in the fatigue initiation zone reveals severe stress concentration, making it a preferred crack nucleation point under alternating loads.

Based on the above analysis, several improvement measures are recommended: First, the machining process parameters should be optimized, with strict control over surface quality, especially in critical load-bearing areas, to ensure surface integrity. Second, surface treatment techniques such as shot peening may be considered to improve the residual stress state at the surface. Third, in terms of material selection, it is advisable to use aluminum alloys with higher fracture toughness or to optimize the heat treatment process of the current alloy to enhance ductility. Fourth, the heat treatment protocol should be refined to promote sufficient elemental diffusion and eliminate strength gradients. A well-designed heat treatment schedule can also facilitate the spheroidization of silicide phases and reduce stress concentrations around precipitates. Lastly, from a structural design perspective, increasing the fillet radius in transition regions and optimizing load-bearing geometry can effectively reduce stress concentration. These improvement strategies should be evaluated and selected based on actual service conditions and cost considerations to ensure both performance and manufacturability.

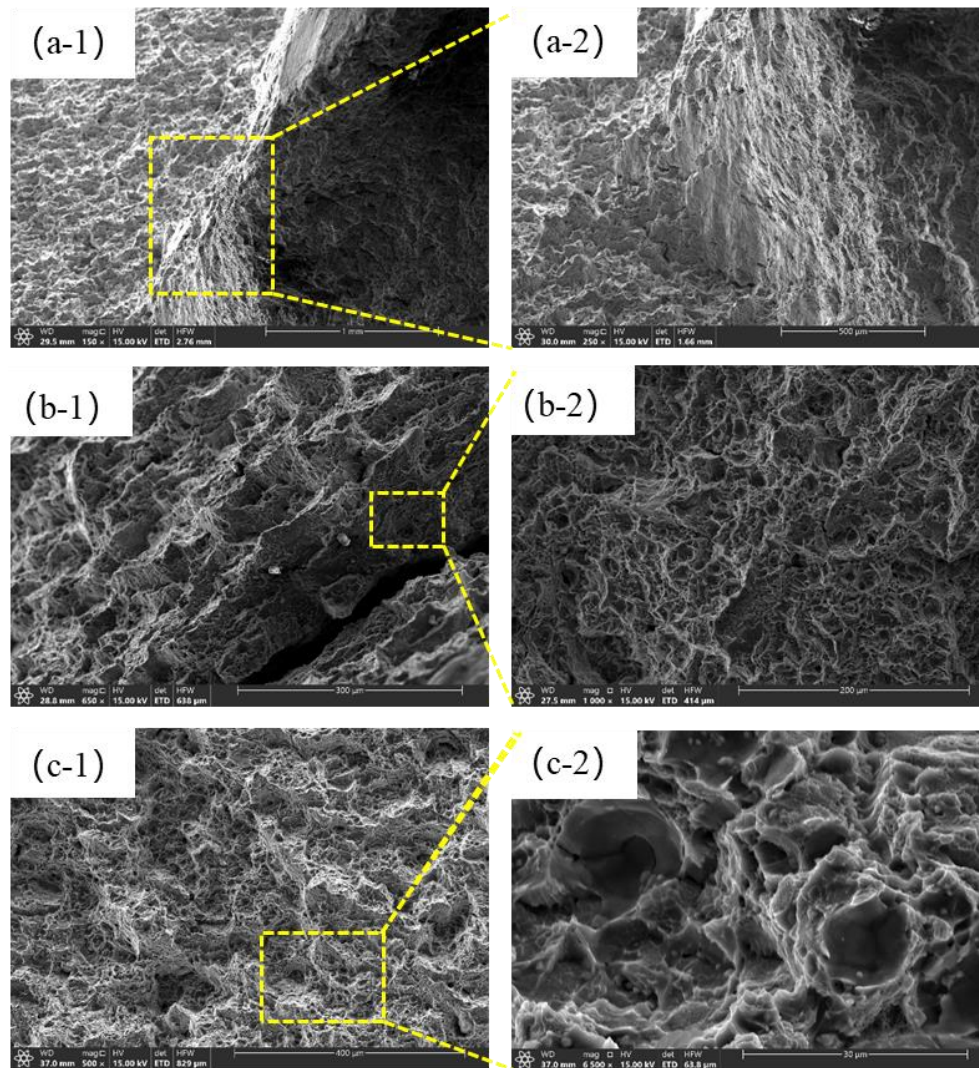
Microscopic examination of the fracture surface was conducted using the Zeiss Gemini 300 field emission scanning electron microscope to reveal the underlying fracture mechanisms and failure processes of the aluminum alloy component. The observations confirmed characteristic features of fatigue fracture, with the fracture surface clearly divided into three distinct regions based on morphological differences: the fatigue initiation zone, the final fracture zone, and the crack propagation zone (Figure 3).

**Figure 3.** Fracture Surface morphology of the fracture surface.

In the fatigue initiation zone (corresponding to Figures a-1 and a-2), two distinct crack initiation sites were identified. The first originated from a relatively large surface pit, approximately 0.5 mm in depth and 0.8 mm in width. SEM images revealed fatigue striations radiating toward the center of this defect. The second crack initiation site was associated with a machining-induced tool mark, approximately 0.4 mm in depth. A clear fatigue edge line can be seen radiating outward from the root of the tool mark, located in the R-angle transition zone of the key force-bearing part of the component.

The microscopic morphology of the final fracture zone (corresponding to Figures b-1 and b-2) is primarily characterized by flat cleavage steps and typical river patterns. In some localized areas, small dimples are also observed. This brittle fracture morphology dominates a large portion of the overall fracture surface.

The crack propagation zone (corresponding Figure c-1 and c-2) shows typical fatigue fracture characteristics, including obvious cleavage patterns, fatigue bands about (2-3)  $\mu\text{m}$  apart, and multiple interleaved secondary cracks.

The cracks derived from the machining tool marks and their radial fatigue edges fully demonstrate the crucial influence of surface machining quality on fatigue performance. Especially the tool marks located in the transition zone of the R-angle, their formation may be related to the "tool shaking" phenomenon, significantly reducing fatigue life. The morphological characteristics of the crack propagation zone reflect that the component has been subjected to high stress amplitude and low-frequency cyclic loads. Multiple secondary cracks further confirm that the material exhibits obvious brittle features during fatigue propagation. The fatigue band spacing can be used to quantitatively evaluate the crack propagation rate and stress level.

The final fracture zone is characterized by the morphology of cleavage steps and river patterns, combined with their relatively large proportion, indicating that rapid brittle fracture occurred when the crack reached the critical size. The river pattern indicates the direction of crack propagation, and the height of the cleavage steps reflects the brittleness degree of the material. Comprehensive analysis indicates that the fracture of this aluminum alloy component is a typical multi-source fatigue fracture and fails in a brittle manner. The main reasons include: Stress concentration caused by surface quality defects (pits and tool marks) (the most critical factor), insufficient toughness of the material itself, and alternating loads with high stress amplitudes.

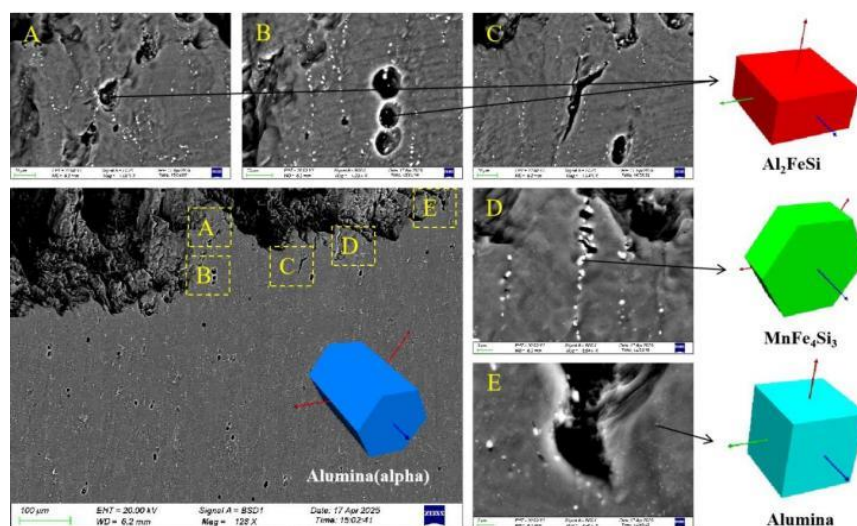
The observations revealed a significant network of secondary cracks in the crack initiation area (Figure 4). As shown in Figure 4-C, representative secondary cracks reach lengths of up to 15  $\mu\text{m}$ . The crack propagation path exhibits a mixed fracture mode, combining intergranular and transgranular features.

More importantly, Figure 4-D reveals white precipitated phases distributed along the crack path. The interfacial energy between these second-phase particles with sizes ranging from 200 nm 500 nm and the matrix is much higher than the grain boundary energy of the Al matrix. These brittle second-phase particles have a weak bonding force with the matrix, intensifying the stress concentration within the grains and at the grain boundaries, providing a source for crack initiation. Microcracks tend to form and propagate around them, causing fracture to occur prematurely. In Figure 4-B, a void triplet is observed with dimensions of 5.8  $\mu\text{m}$ , 7.2  $\mu\text{m}$ , and 6.1  $\mu\text{m}$ .

**Figure 4.** Fracture Longitudinal Section Morphology of the fracture surface.

Microstructural analysis indicates that the fundamental cause of fracture failure in this aluminum alloy lies in an interface-dominated, multi-level damage mechanism induced by coarse silicide phases and elemental segregation. The siliconized phases of  $\alpha\text{-Al}_2(\text{Fe-Si})$  and  $(\text{Fe,Mn})_3\text{Si}_2$  with a size exceeding  $10\text{ }\mu\text{m}$  distributed the crack initiation zone. Due to the performance mismatch such as low interfacial binding energy with the matrix, significant crystal structure differences, and a thermal expansion coefficient difference of approximately

$\Delta\alpha \approx 7 \times 10^{-6}/\text{K}$ , the damage is driven by a dual action under cyclic loading. It not only directly induces the nucleation of microcracks that exceed 90 % of crack sources as brittle particles but also promotes interfacial dissociation to form nano-micropores due to the thermal mismatch stress. These nano-micropores aggregate and grow into triplet voids ranging from 5.8  $\mu\text{m}$  to 7.2  $\mu\text{m}$  through dislocation slip mechanisms, resulting in a loss of 35 % of the effective bearing area of the material.

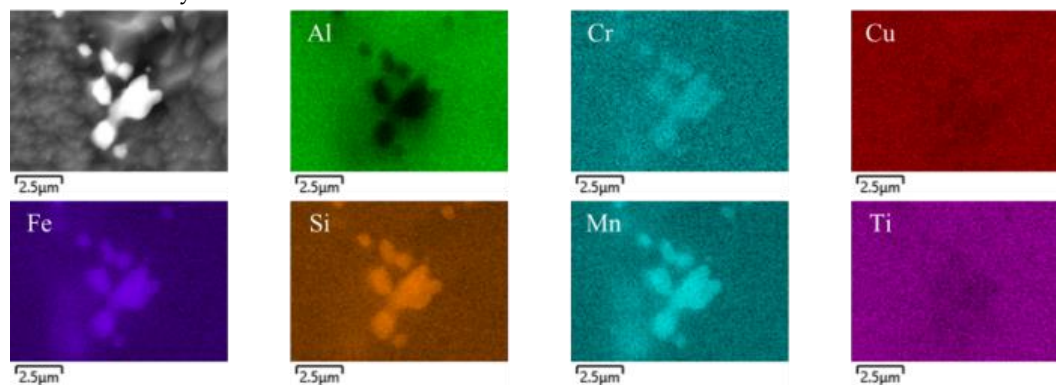
EDS line scan observation (Figure 5) revealed a compositional gradient of Si content extending from the inclusion toward the aluminum matrix. Within a 2  $\mu\text{m}$  distance from the interface, the Si content decreased gradually from 4.2 wt.% to 2.8 wt.%. EDS area scan analysis of the crack initiation zone (Figure 6) revealed significant elemental segregation of Si and Mn. A Si-enriched band approximately 2.5  $\mu\text{m}$  in width was observed along both sides of the crack path, with a local Si concentration reaching up to 5.2 wt.%, compared to an average Si content of only 1.1 wt.%.

**Figure 5.** EDS Maps of Area Scans of Precipitate Phases on the Fracture Longitudinal Section

Additionally, EDS scan analysis confirmed that elemental segregation significantly weakens the material: silicon concentration decreases from 4.2 wt.% at the inclusion–matrix interface to 2.8 wt.% beyond 2  $\mu\text{m}$  into the matrix, forming a localized under-aged zone. Silicon-rich bands approximately 2.5  $\mu\text{m}$  wide were observed along both sides of the crack path, with local silicon concentrations reaching up to 5.2 wt.%, compared to an average matrix value of only 1.1 wt.%. These zones, in conjunction with manganese enrichment, form a low-strength path that facilitates crack propagation. EBSD analysis further revealed interfacial strain concentration effects. Based on IPF and KAM plots, the dislocation density at the silicide/matrix interface was found to be 3 to 8 times higher than that of the surrounding matrix. This local lattice rotation and dislocation proliferation, induced by the compositional gradient, may reinforce the interface structurally, but ultimately lead to a significant reduction in fracture toughness.

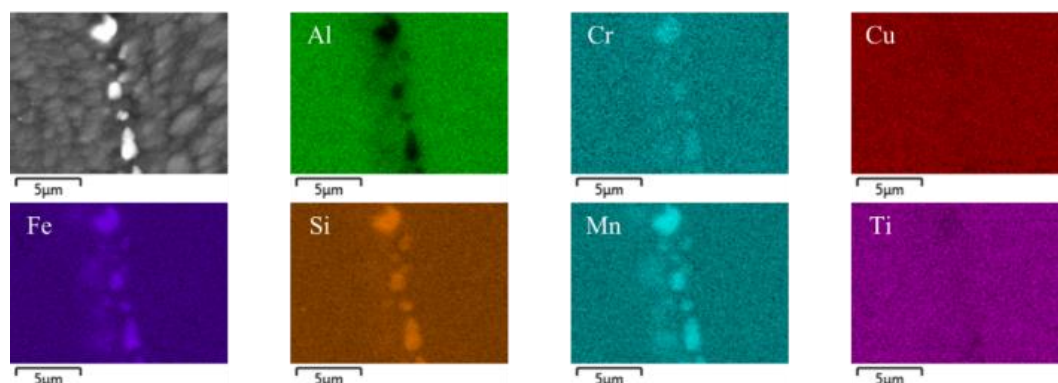
**Figure 6.** EDS Maps of Precipitate Phases at the Crack on the Fracture Longitudinal Section

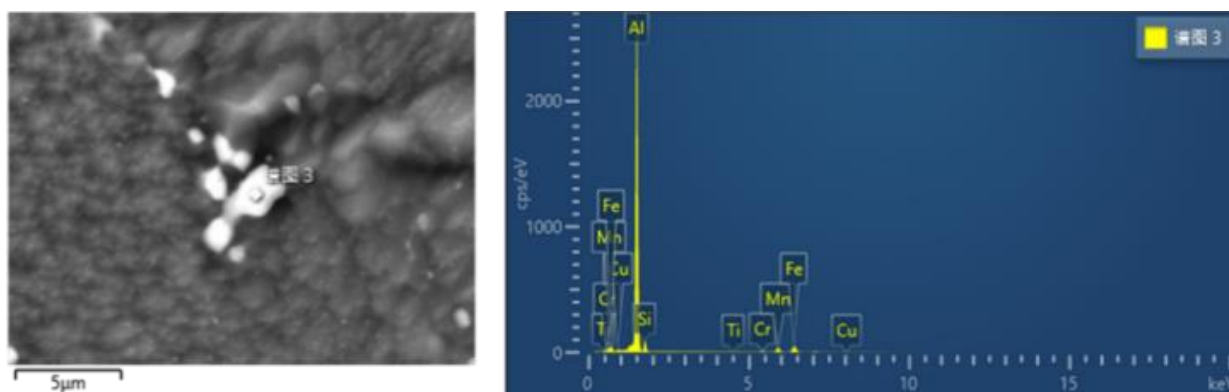
Point EDS analysis was performed on precipitates located near the crack path, and the compositional results indicate that these precipitates are primarily silicide phases. According to the elemental quantification from point scan EDS analysis (Figure 7, Table 3), these silicide particles are predominantly identified as  $\alpha$ - $\text{Al}_2(\text{Fe-Si})$  phases, containing alloying elements such as Fe and Si.

**Figure 7.** EDS Maps of Precipitate Phase Point Scans on Fracture Longitudinal Section

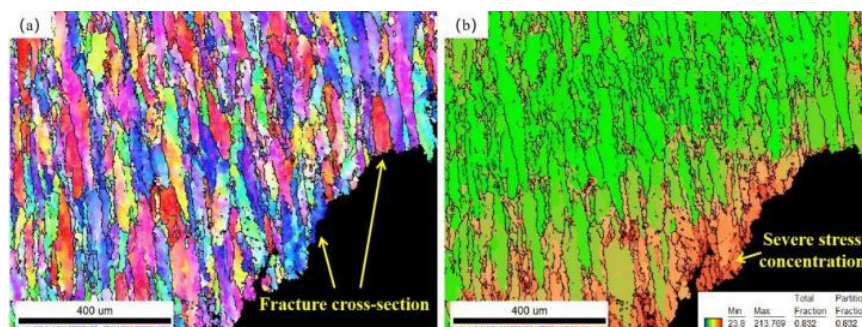
Figure 8. Fracture Longitudinal Section IPF and KAM Maps
