Core and frame insulation of power transformers

Part I: History, past and present issues

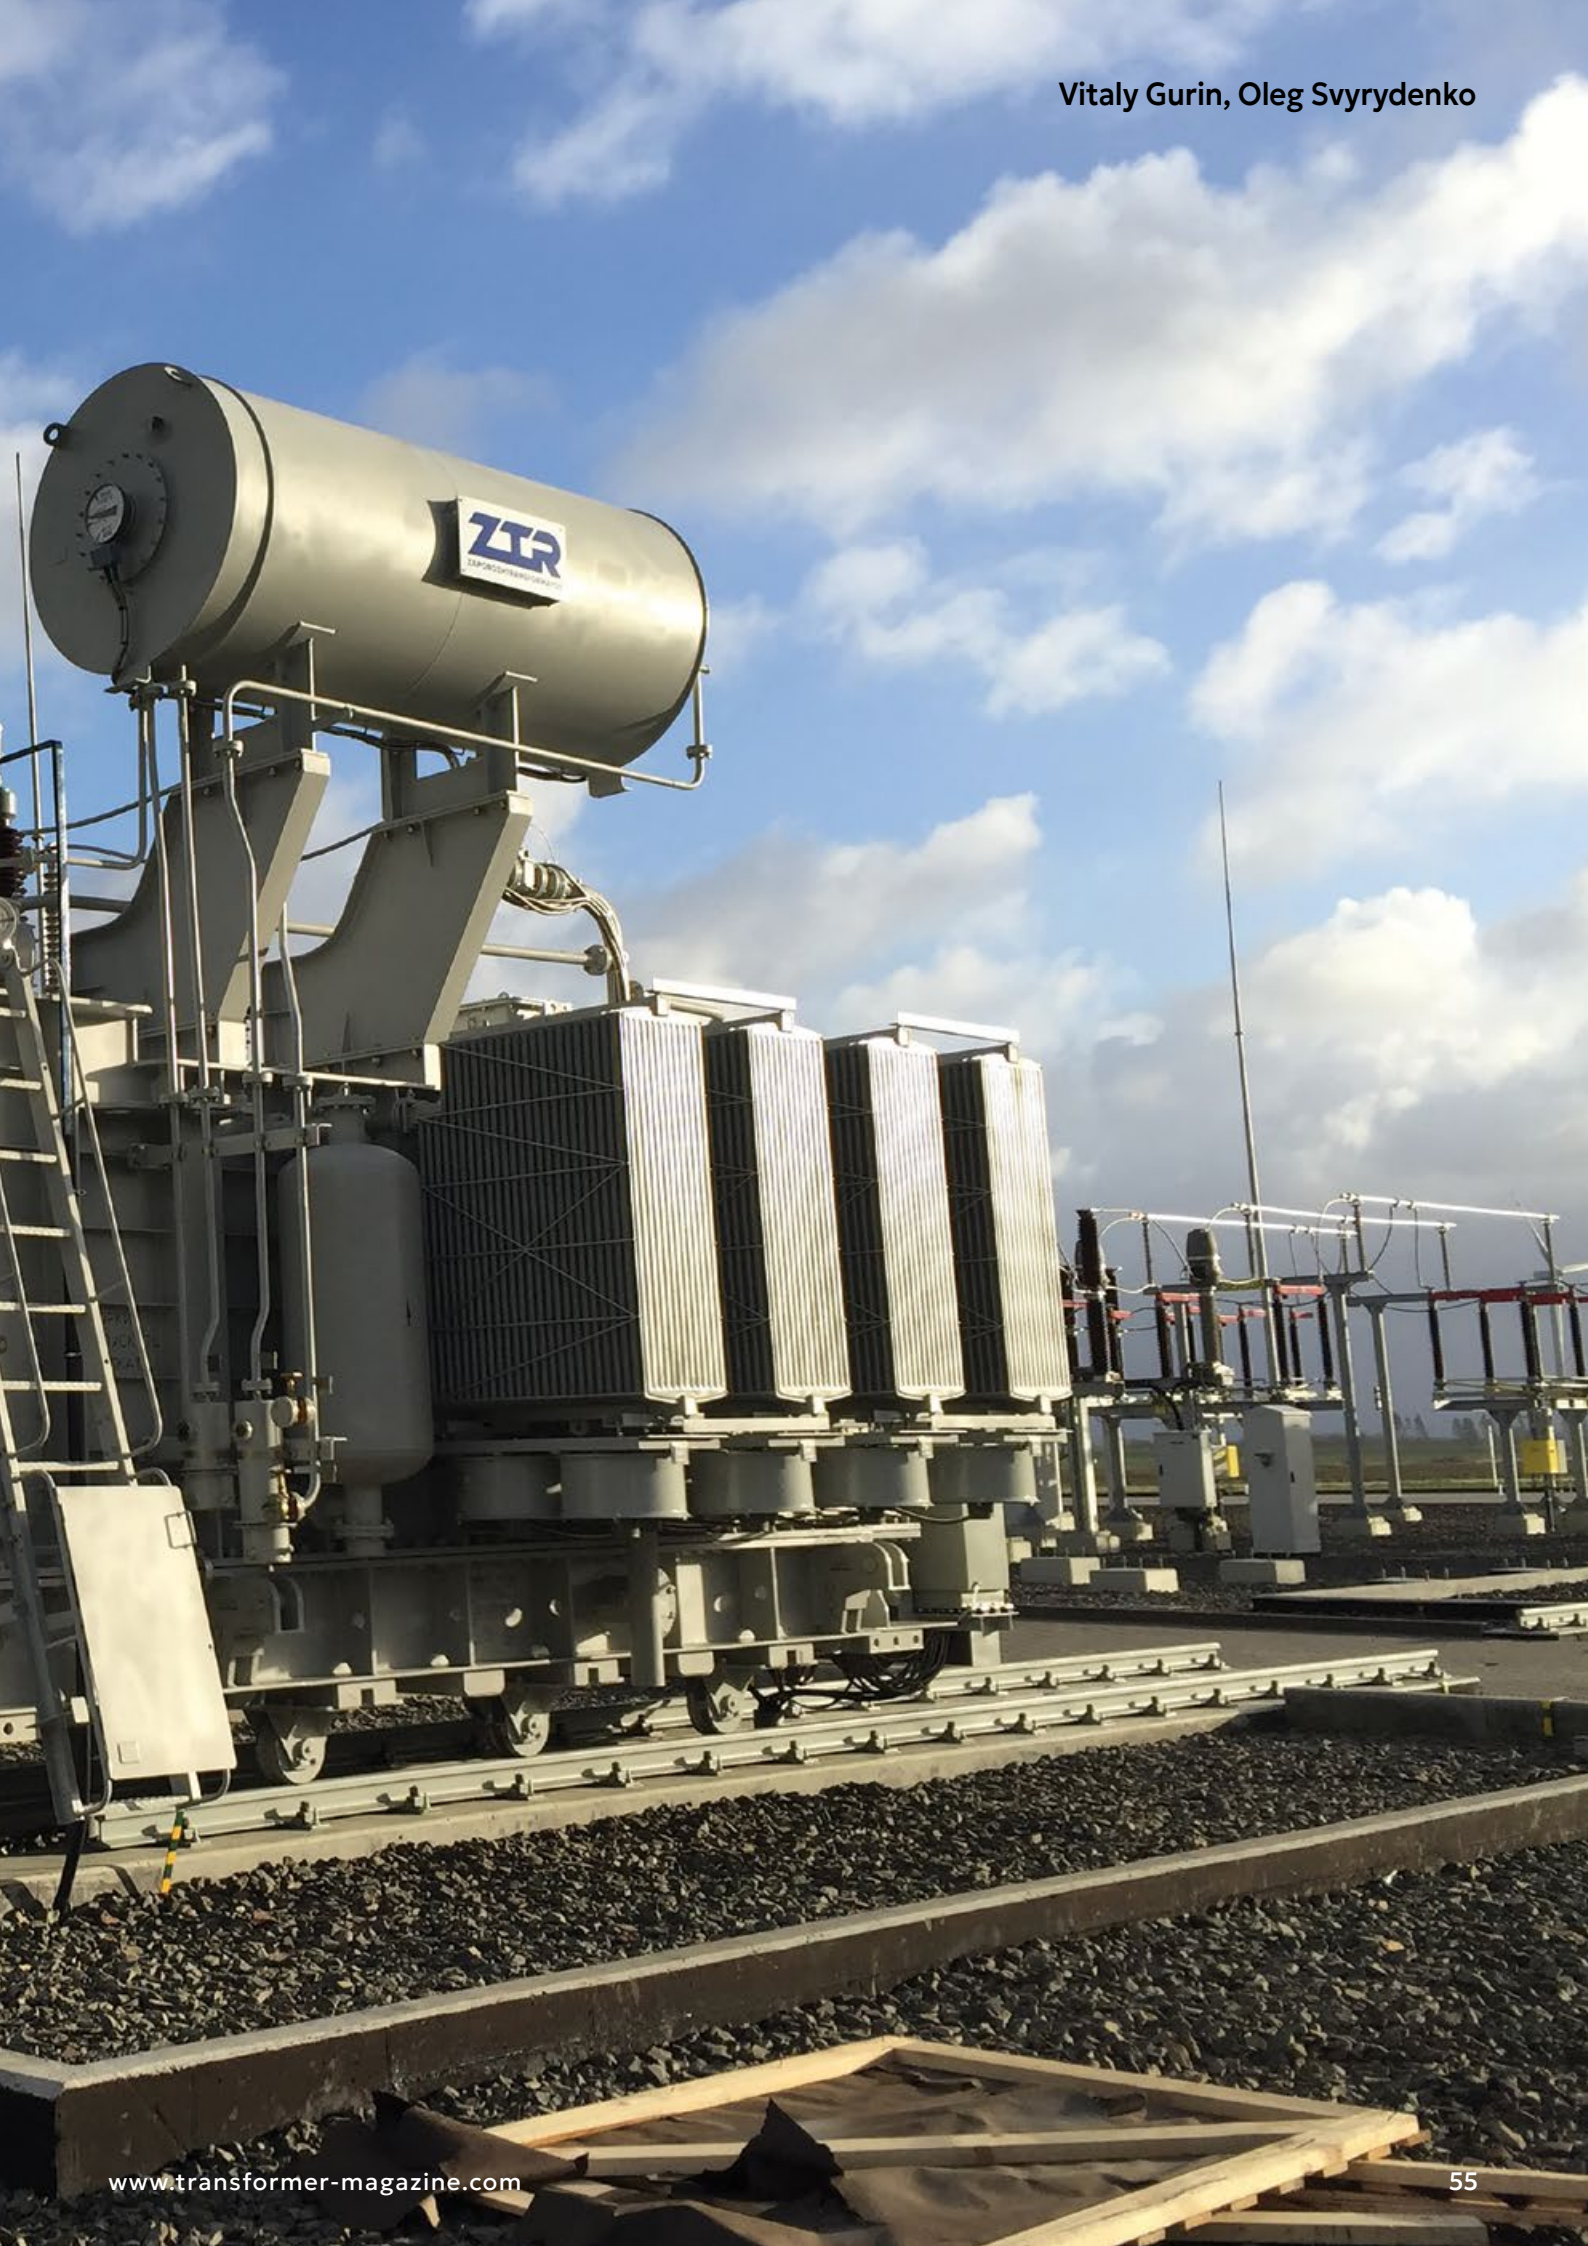
The core and frame (or clamp) insulation are an integral component of the active part (AP) of a power transformer

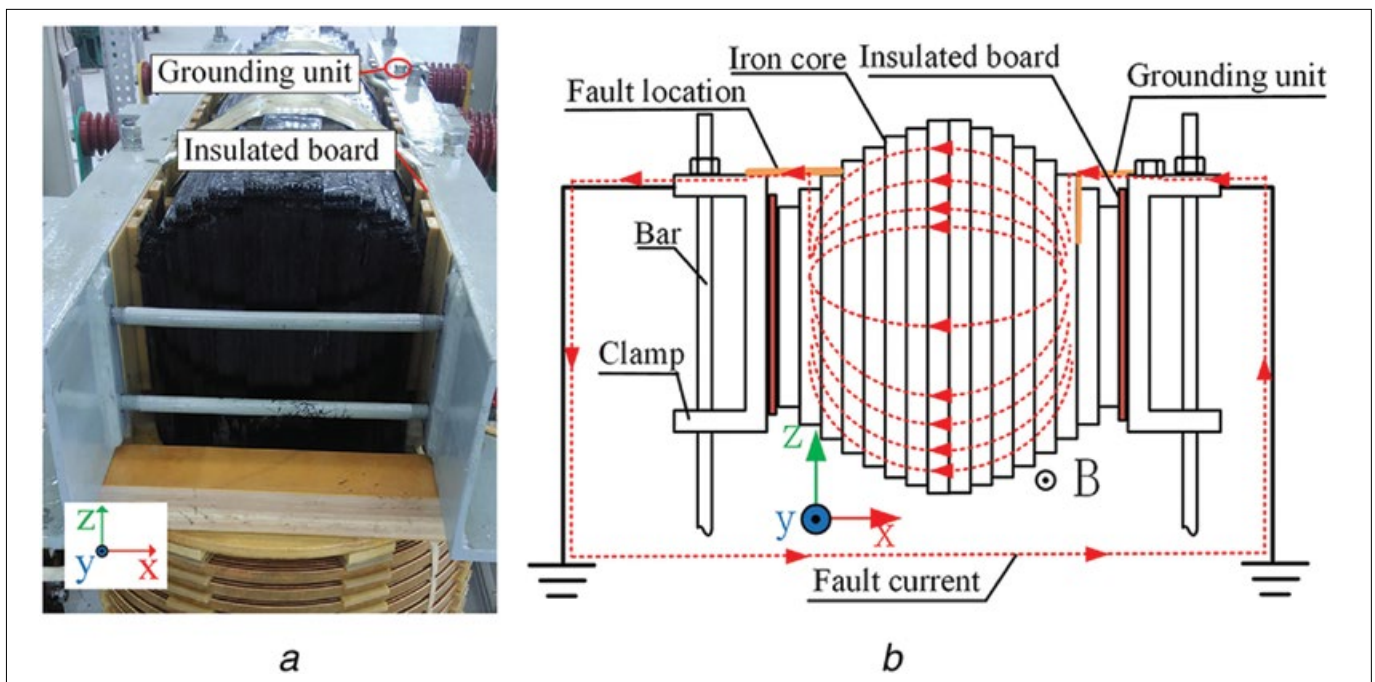
Figure 1. Side view of core grounding (a) and multipoint grounding diagram (b) [2]

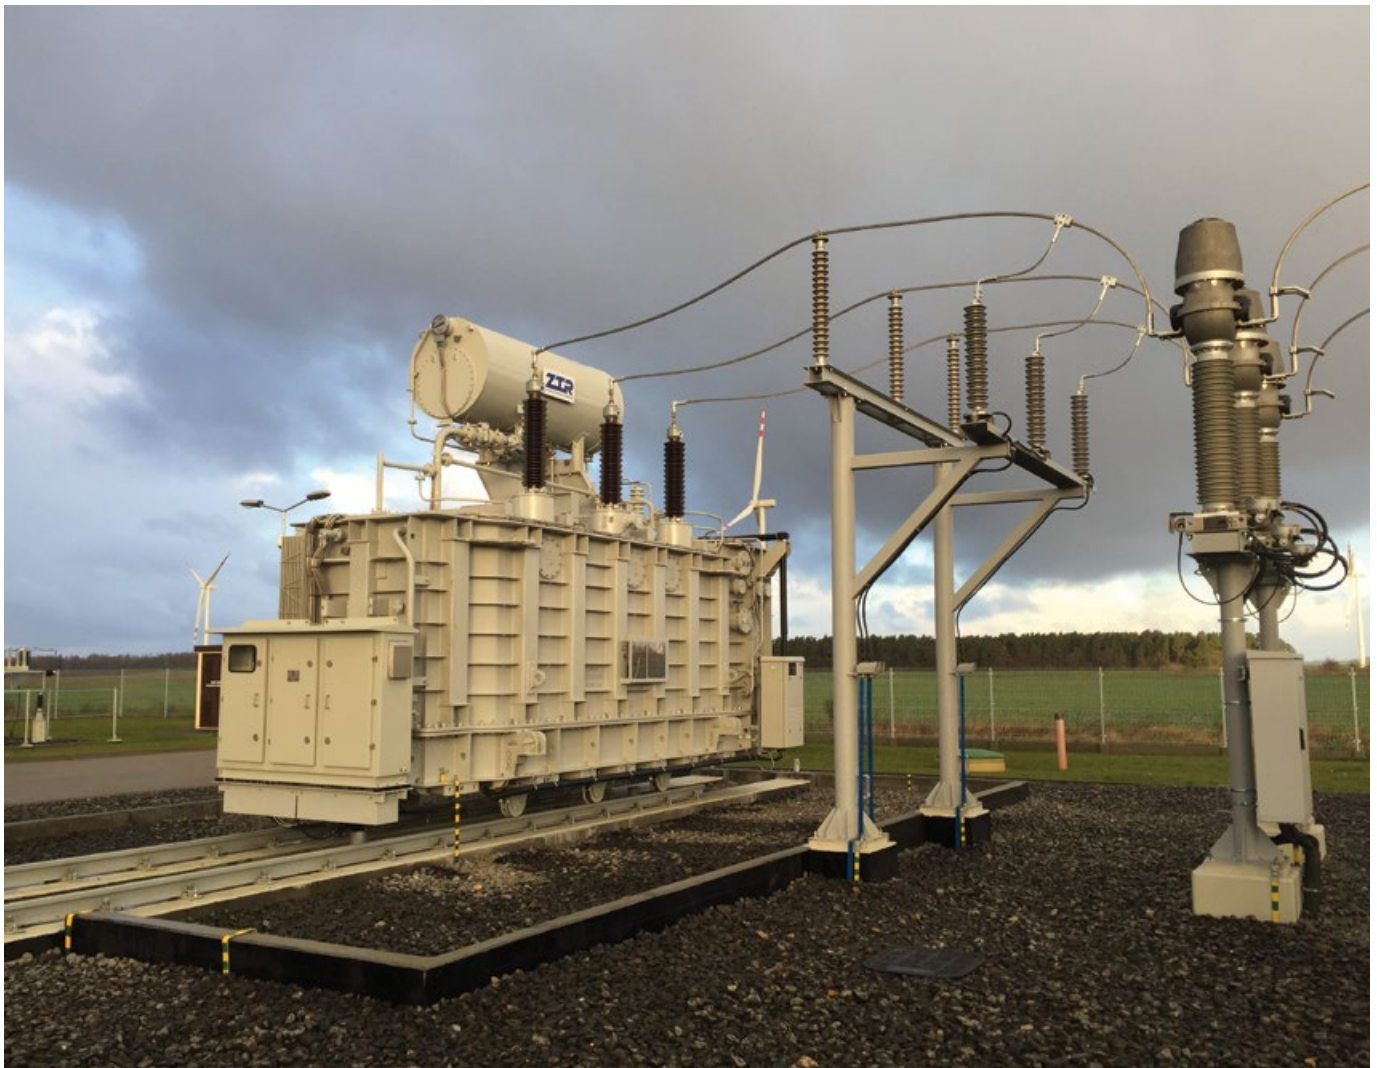
One of the bolts was installed on a beam surface that was not cleaned of paint, leading to micro discharges occurring at this location, causing paint and oil to burn

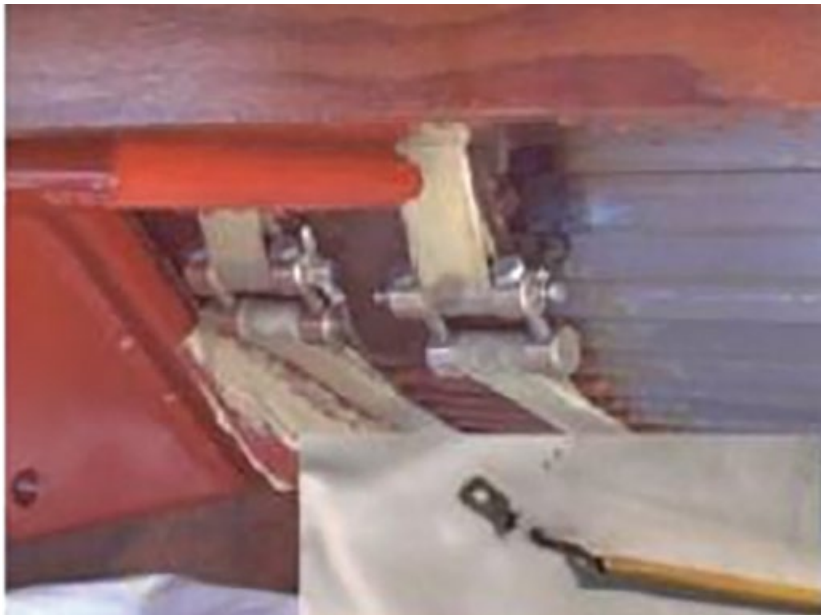
Figure 4. The breakage of the grounding wire from the tip attached to the frame of the core [5]

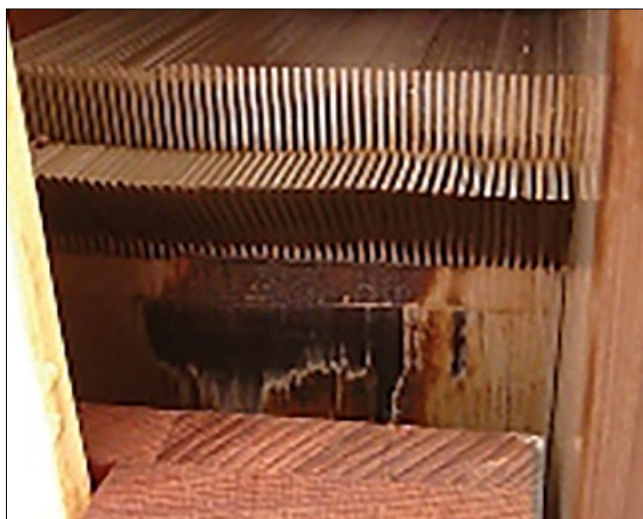
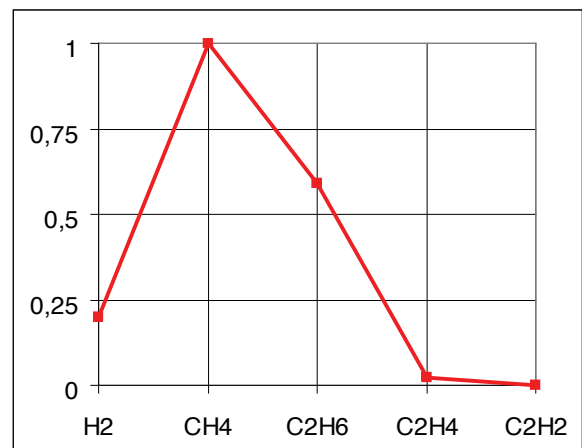
Figure 6. Hot spots in the core and relative dissolved gas levels in reactor 26.67 MVA

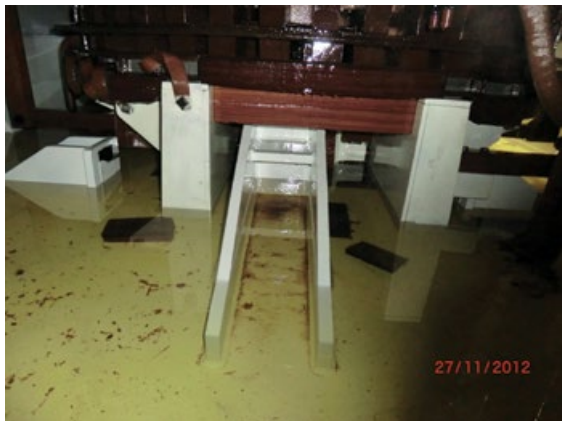
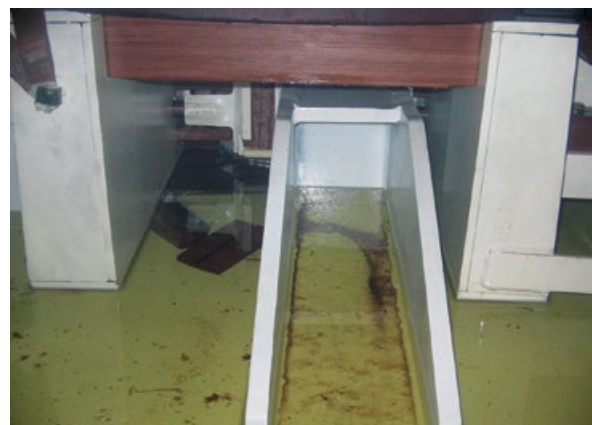
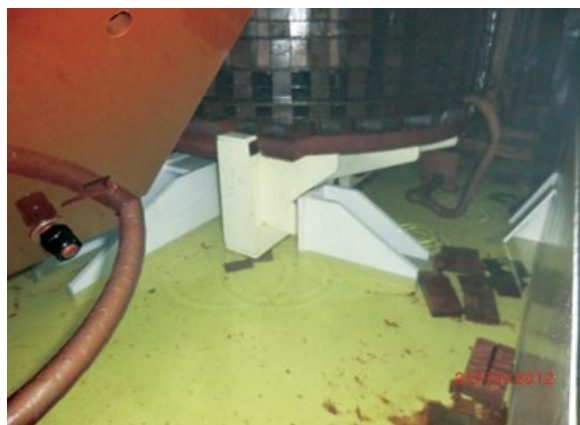
Figure 7. Active part displacement of 63 MVA, 220/110 kV autotransformers cover

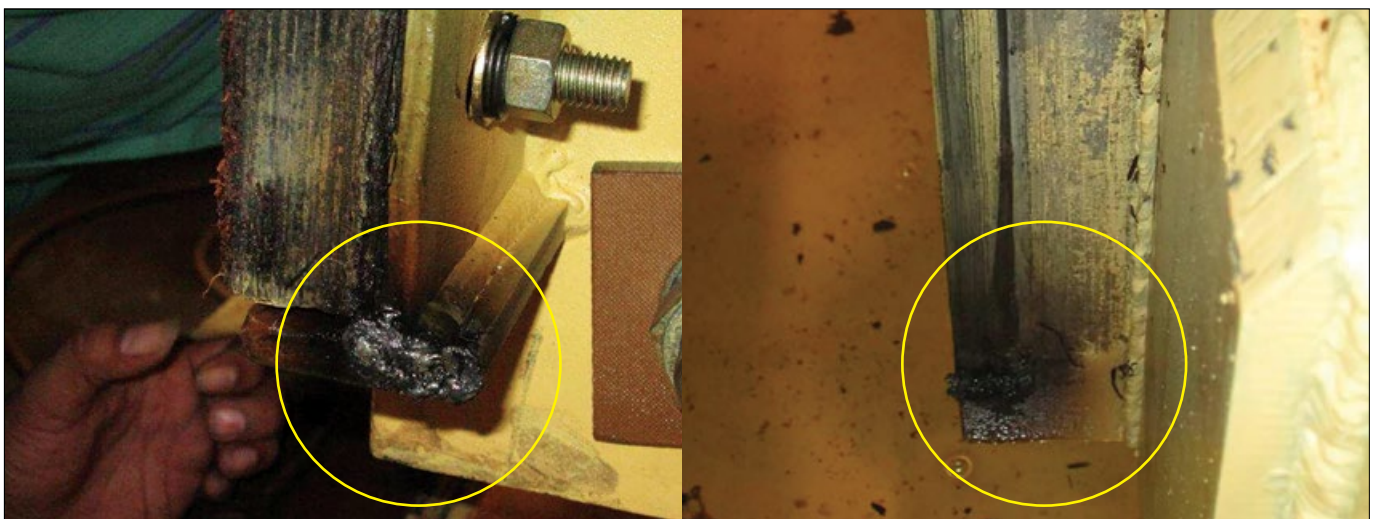
Figure 8. Overheating was observed in the core frame and locking plate of the 167 MVA autotransformer [3].

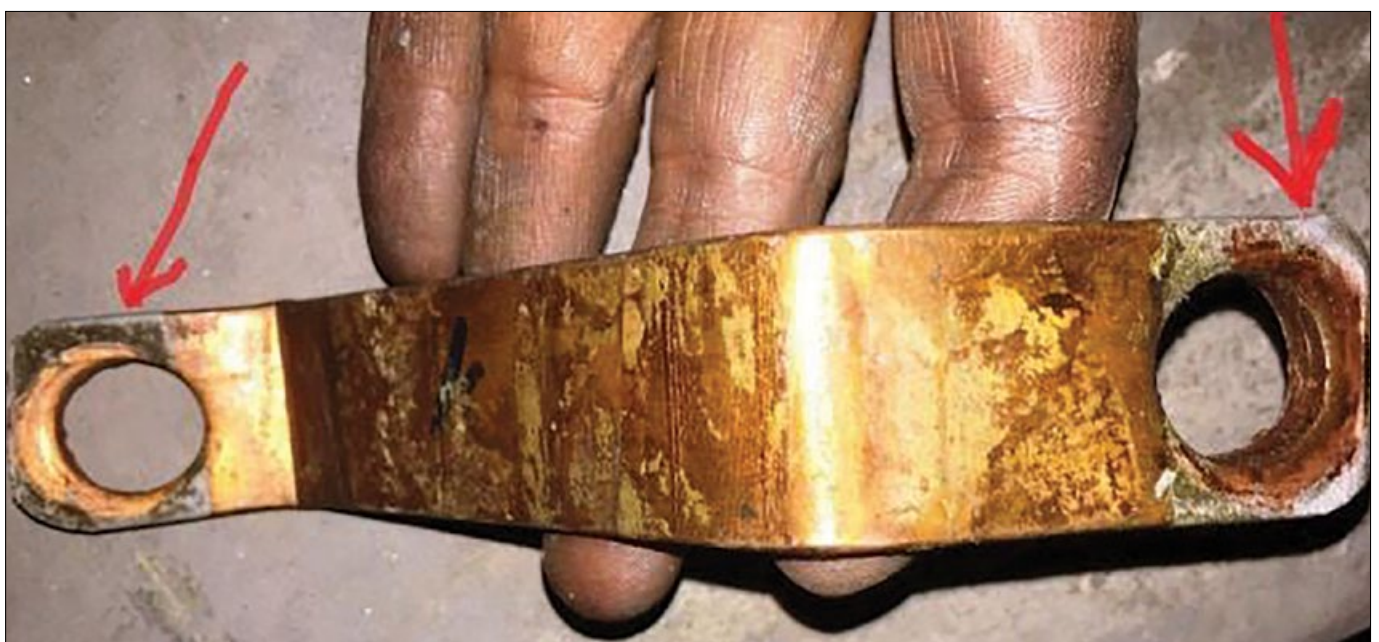
Figure 9. Severe oxidation on the core-ground connection, resulting in poor contact by [7].

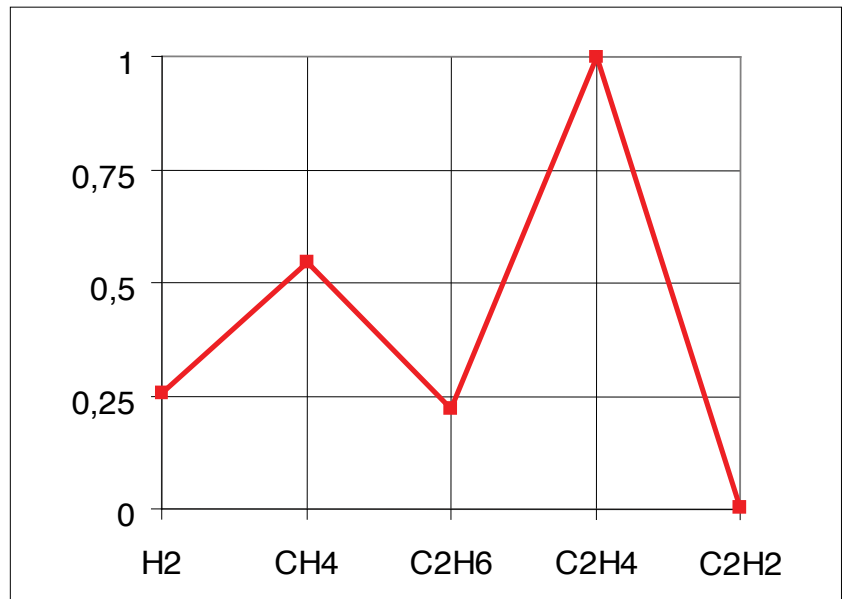
Figure 10. Relative level of dissolved gases in AT 120 MVA
