## **Preparing the Ship and Slipway for Launching After a Long Period of Construction Downtime**

This paper presents the preparation of a ship and slipway for launching after a long period of construction downtime in the shipbuilding process. The research is based on the specific case of the vessel “Novogradnja 526” at the Uljanik shipyard, where construction was suspended for a prolonged period. This suspension required a detailed assessment of the ship’s condition and its surrounding environment. Special attention was given to determining the ship settlement on slipway during the period of inactivity, positioning of the vessel on bilge blocks, launch calculations, and a technical overview of each phase of the process. Furthermore, the factors influencing the height of the ship’s keel relative to the slipway line, i.e., the definition of the settling curve, have been analyzed. The need for additional ballasting and work on the bilge blocks system has been presented in order to enable launching operation that will prevent phenomena such as bow dipping or impact with the slipway. Based on the results, it was concluded that launching process can be successfully executed if newly def

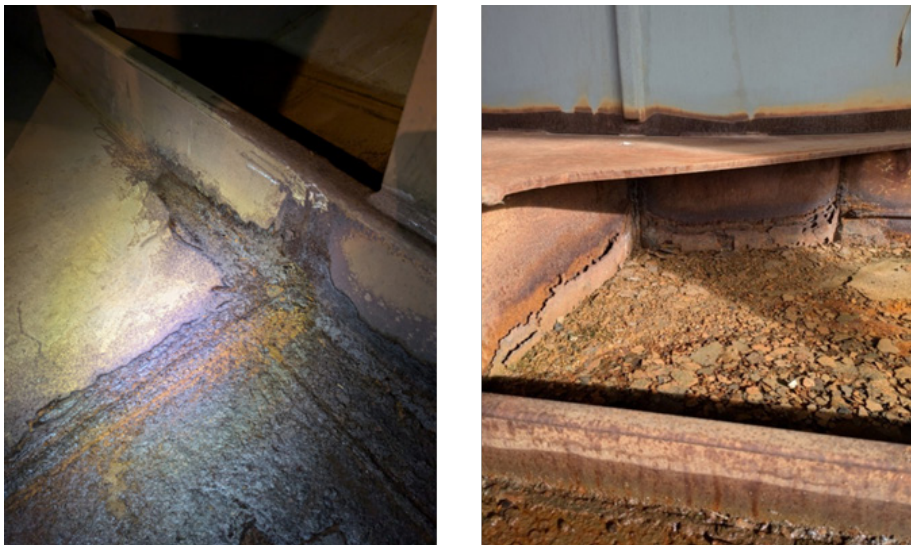
Figure 1. Condition of the hull [1]

Visual inspection of the structural elements revealed significant corrosion activity affecting both primary and secondary members. The most severe damage was observed in the aft section and machinery spaces, where rainwater had accumulated for extended periods. The consequences of such conditions are evident in pronounced manifestations of both general and localized corrosion. A particular concern is related to welded joints. Although no visible cracks were initially detected, closer examination revealed rust formation and pitting marks, indicating the onset of pitting corrosion in these critical areas [2]. In addition to conventional corrosion, the inspection identified the influence of biological factors such as moss, fungi, and lichens. By retaining moisture and creating micro-environments, these organisms further accelerate metal degradation and

promote microbiologically influenced corrosion. As a result, the condition of plating and joints has further deteriorated, although it should be emphasized that despite extensive surface degradation, no deformations of the shell plating were detected, meaning that the vessel's basic form and the arrangement of primary structural elements remain intact. The inspection was not limited to visual observation, ultrasonic testing was also employed for precise thickness measurements of plates at critical locations. This enabled comparison with IACS and AMSA requirements, which clearly define the limits of acceptable imperfections and deficiencies [3]. In cases of material delamination, the installation of insert plates is foreseen. Weld defects and their susceptibility to corrosion are of particular concern, as they directly affect load transfer capacity. In addition to structural elements, the installed equipment was also inspected. It was established that nearly all pipelines located within 500 mm above the tank top had suffered such extensive corrosion that their replacement is mandatory. Corrosion had also severely damaged pipe flanges, valves, and pressure gauges, necessitating complete dismantling and installation of new connections.

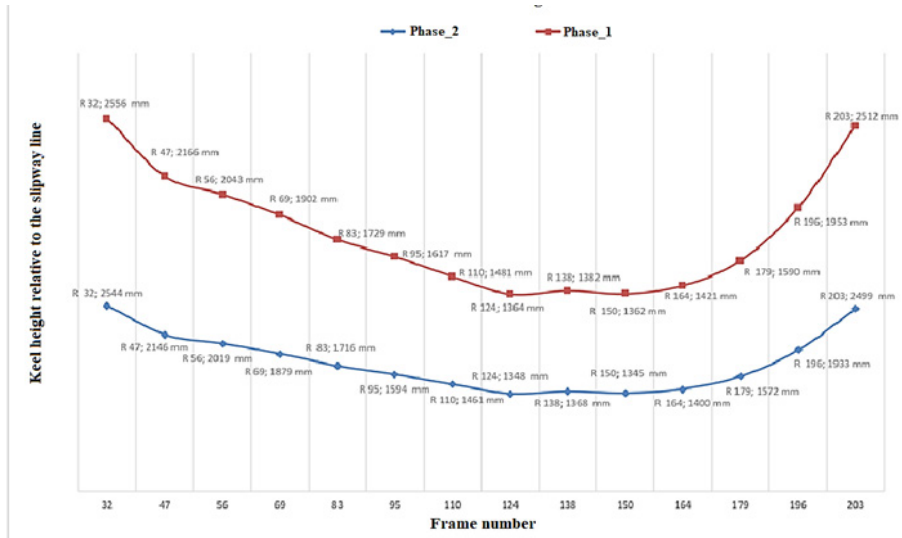
Figure 3. Detected settlement of the ship [1]

The measurement results are presented graphically. The diagram “*Initial Reading and Actual Condition*” compares *Phase\_1* and *Phase\_2*, highlighting the changes caused by the construction halt. The diagram “*Keel Position Curve*” shows keel height by frames in all phases, clearly indicating risk areas where height drops below 1,300 mm, with a critical limit at 1,200 mm. The largest differences occur in the midship region, between frames 120 and 170, while the end frames show elevated values due to hull form and slipway curvature. Further diagrams illustrate in more detail the relationship between mass and settlement. It is demonstrated that with increasing mass, settlement progresses linearly, with frames outside the stopper area being the most sensitive. Special emphasis is placed on the installation of the main engine and machinery in the engine room, which will cause additional settlement. The largest deviations are observed at frames 150 and 203, while the stern shows minimal differences. Frame-by-frame settlement analysis shows that the greatest deformations occur at frames 56, 150, 164, and 179, with values ranging from –55 to –65 mm. The end frames exhibit smaller but still notable settlements, confirming that the midship region is the most heavily loaded. A reduction in stopper height of 42 mm was also observed, which remains within safe limits but requires continuous monitoring.

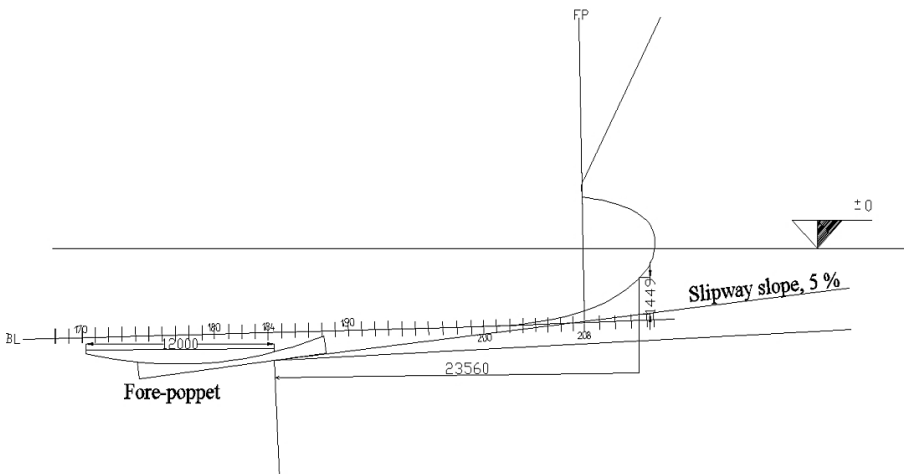
Figure 5. Ship departure from the slipway [2]

The most critical consequence, creating the greatest uncertainty, is the insufficient keel height of the vessel relative to the slipway line. This may result in a situation where the ship does not meet the required launching conditions and cannot be launched without hull damage [5]. During the placement of the vessel on sledges and grease, problems of improper longitudinal and transverse bearing occur. This refers to the situation in which the hull is not evenly supported on the blocks and therefore cannot rest uniformly on the sliding ways. Such uneven bearing may cause localized stresses and increase the risk of damage during launching, particularly in the double bottom structure. Since the launching process itself represents the phase in which the vessel is exposed to the highest stresses, it is necessary to install structural reinforcements at critical locations. In this case, reinforcements are arranged as brackets on longitudinals in the stern and in the bottom of the cargo hold, and as transverse brackets on frames in the bow area. The most hazardous consequence is the phenomenon of so-called *bow slamming*, which arises from a combination of the unfavorable position of the pivoting sledge, the amount of ballast required, and the lower initial bow height on the slipway [7]. In order to prevent bow slamming, 250 tons of ballast are applied to the aft section tanks. A very important parameter in launching calculations is the height of the sledges with their complete packing and preparation. The settlement of the vessel i.e., the final hull height before placement on sledges, must be greater than the calculated sledge height in order to ensure a safe launch. If the calculated sledge height exceeds the final vessel height on the blocks, bow slamming against the slipway end and subsequent structural damage is likely.

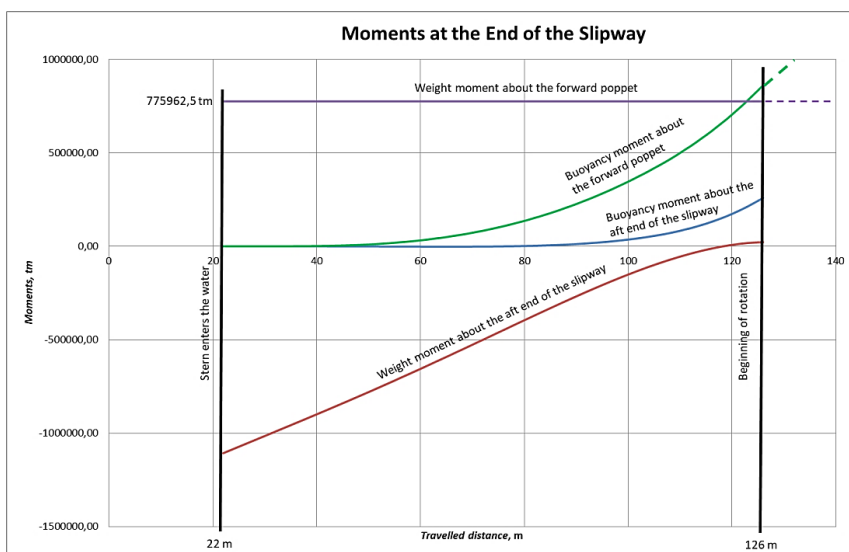
Figure 6. Moments at the end of the slipway [1]

Technological, bilge blocks on quartz sand, which are not functional, present the greatest difficulty, their removal must be adapted to the new conditions. Improper removal increases stress on the structure and may lead to extrusion of the grease from the sliding ways. Furthermore, the 48 hour time limit applies, ensuring that the grease retains its primary characteristics. Another potential issue is *tripping* during launching. This is verified by checking whether the buoyancy moment curve at the end of the slipway lies above the mass moment curve at the same position. The risk can be mitigated by loading ballast in the forward part of the vessel to shift the center of gravity forward. However, in this particular case, due to pronounced bow slamming, ballast is placed exclusively in the stern.

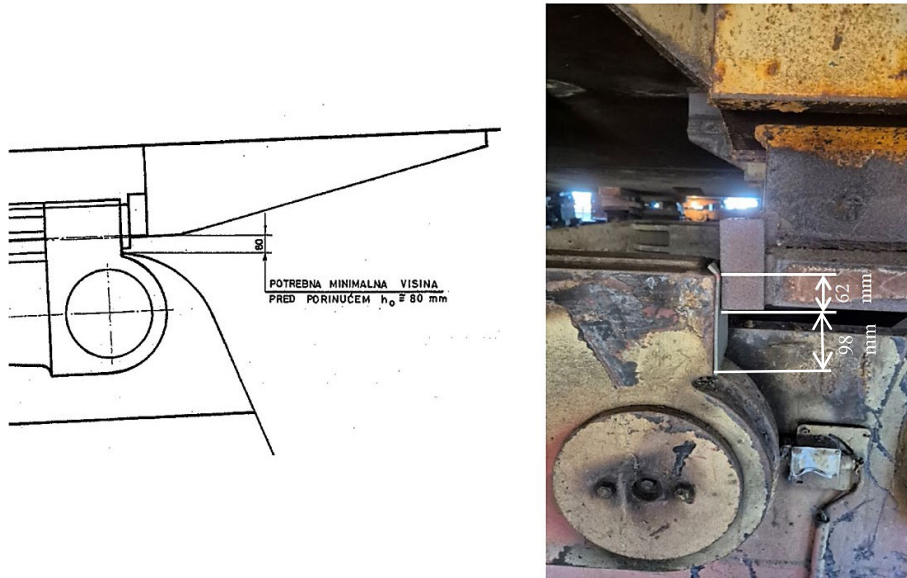
Figure 7. Allowed and current overlapping on hydraulic stopper [1]

A significant issue is also the overlapping of stopper teeth, specifically the reduction in stopper height by 42 mm compared to the design value. The target installation height was 1390 mm, however, due to construction delays and the added mass on the slipway, the height decreased to 1348 mm [2]. Although this value is still within the safe range for launch execution, it must be carefully monitored until completion of vessel construction. The minimum clearance at the beginning of ship construction between the ship's keel and the upper edge of the slipway stopper mechanism shall be 300 mm. The clearance between the lower edge of the pawl tooth and the housing line of the stopper mechanism at the beginning of construction is 120 mm. The engagement height of the pawl tooth prior to launching is approximately 110 mm, while the theoretical clearance between the lower edge of the pawl tooth and the stopper housing immediately before

launching should be 40 mm [8]. This provides an additional safety margin in case of fabrication deviations. The current overlapping value is 62 mm.
