**ASSESSMENT OF A HISTORIC MASONRY BUILDING:
A CASE STUDY OF THE 1ST GYMNASIUM**

ORIGINAL SCIENTIFIC PAPER
[https://doi.org/10.31522/p.34-1\(71\).1](https://doi.org/10.31522/p.34-1(71).1)
UDC 727:699.841 (439.55 Sarajevo)

ASSESSMENT OF A HISTORIC MASONRY BUILDING: A CASE STUDY OF THE 1ST GYMNASIUM

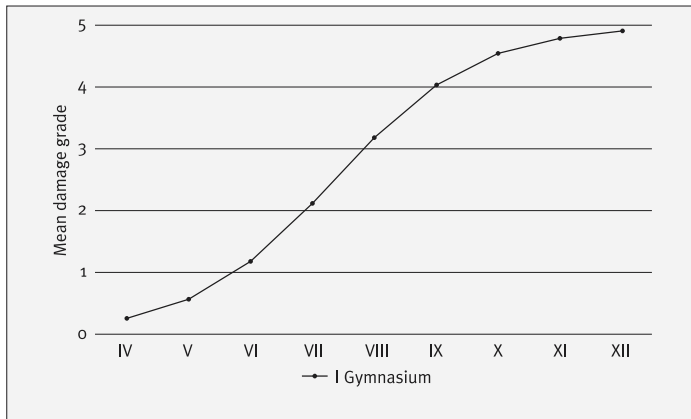
FIG. 4 VULNERABILITY CURVE FOR THE BUILDING OF THE I GYMNASIUM

The vulnerability curve illustrates the relationship between the expected mean damage grade of the building and the earthquake's intensity as per the EMS 98 scale. Structure action is assessed for different earthquake intensities, from the weakest (IV) to the most catastrophic earthquake (XII). According to the assessment, the building where the I Gymnasium is located would experience small damage if exposed only to earthquakes of lower intensity (IV), keeping the mean damage grade lower than 0.5, indicating superficial or negligible damage to the structure and facades. The slope of the vulnerability curve gradually increases as the earthquake intensity rises. The most interesting intensities for Sarajevo are VII and VIII, whereby the mean damage grade reaches values of 2.12 and 3.19, indicating moderate damage, which would be manifested with cracks in the non-load-bearing walls and potential damage to load-bearing elements. At intensity VII, the building shows moderate resilience, with the highest probabilities in moderate damage ($\approx 34.3\%$) and substantial to heavy damage ($\approx 25.3\%$). As the intensity rises to VIII, the probability of substantial to heavy damage increases sharply to $\approx 34\%$,

and very serious damage would be experienced by 30% of all structures, reflecting a significant escalation of vulnerability with stronger ground shaking. This is following the observed damages in the Croatian schools of this typology (Salaman et al., 2023: 10, 15; Lulić et al. 2021: 2; Atalić et al. 2023). These results highlight the building's sensitivity to higher-intensity earthquakes and emphasize the importance of targeted risk reduction measures, structural strengthening, and informed seismic risk management strategies (Fig. 5). The quantified probabilities provide a reliable basis for planning targeted risk reduction measures, structural strengthening, and informed seismic risk management. The main limitation of this analysis is that it does not account for the strengthened floor; a more detailed assessment incorporating this element will be conducted in subsequent analyses.

For earthquakes of higher intensities (X–XII), the curve shows a rapid, sharp increase, indicating a significant increase in heavy and severe damage, leading to the complete collapse in the case of XII intensity level, where the mean damage grade reaches the value of 4.91. This kind of information is very valuable as it identifies earthquake intensities when the building becomes particularly vulnerable. Useful information for engineers and planners when in the processes of decision-making with respect to strengthening, rehabilitation, and seismic safety of educational facilities.

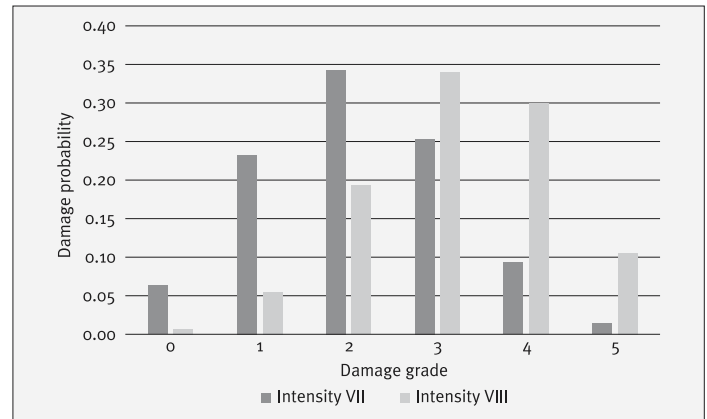
FIG. 5 DAMAGE PROBABILITY MATRIX

At intensity VII, the structure is most likely to experience moderate ($\approx 34.3\%$) and substantial damage ($\approx 25.3\%$), while at intensity VIII, the probability of substantial damage increases to $\approx 34\%$, and very serious damage affects approximately 30% of cases, confirming a non-linear escalation of vulnerability. These results are consistent with observed damage patterns in comparable school buildings of similar typology in Croatia, providing validation of the applied methodology. The analysis's primary drawback is that it ignores the stronger floor; a more thorough evaluation that takes this factor into consideration will be carried out in later assessments.

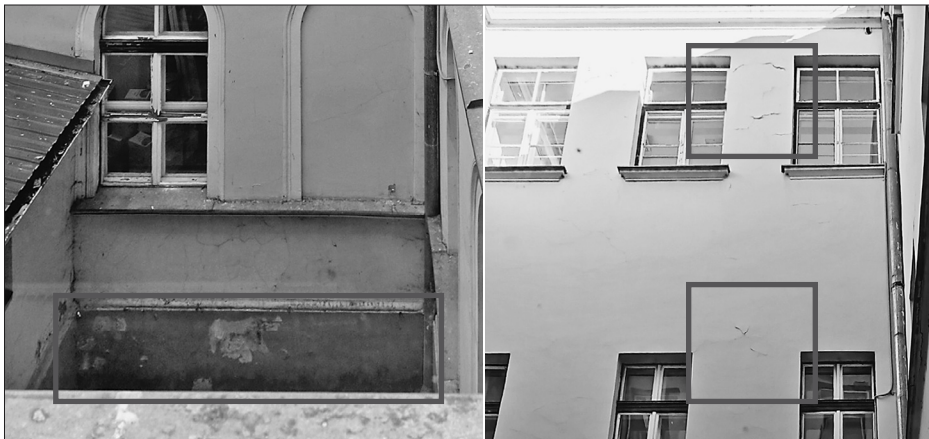
FIG. 6 MOISTURE PENETRATION, CRACKING, AND PEELING OF THE MATERIAL (AUTHOR'S PHOTOS)

One of the most common causes of masonry deterioration is the penetration of moisture into walls (see Fig. 6), which can have various negative consequences. Water penetrating the walls carries soluble salts that crystallize on the surface, weakening the mortar and reducing the building’s aesthetic value.

In colder areas, freeze-thaw cycles of water absorbed into the walls can cause cracking and peeling of the material (see Fig. 6), especially in porous walls such as limestone or sandstone. Incomplete or inadequate drainage can lead to moisture rising through the walls due to capillary action, causing the rotting of wooden structural members, mold growth, and deterioration of stone or brick walls, reducing the durability and safety of the building.

Therefore, regular maintenance is seen as the first step for preventing the various effects that can have a direct impact on the deterioration and degradation of the material, which would lead to the reduction of the structural resistance. Key measures include proper drainage and waterproofing, removal of surface salts, timely repair of cracks, and the use of aggregates, mortars, and protective coatings that limit moisture and pollutant penetration.

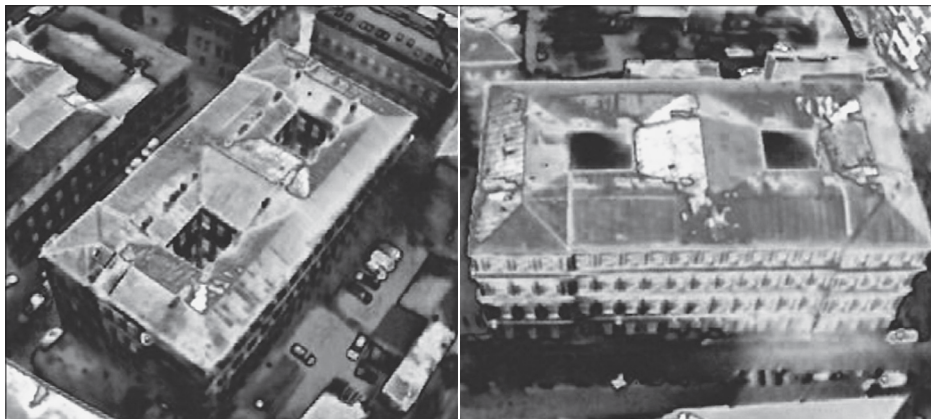
FIG. 7 INFRARED THERMOGRAPHY METHOD OF THE I GYMNASIUM (AUTHOR’S PHOTOS)

The magenta colour is seen on the ground surface next to the school (see Fig. 7). This phenomenon directly indicates the capillary rise of moisture from the foundation soil towards the walls. Such moisture distribution is characteristic of masonry buildings without adequate horizontal waterproofing, where porous materials enable capillary transport of water to higher zones of the structure. Identification of these cold and damp areas utilizing the infrared thermography method is an important step in diagnosing the condition of the building, as it allows the identification of locations with an increased risk of material degradation, reduced thermal efficiency, and the development of biological damage.

cern that may require targeted monitoring, further material testing, or preventive intervention to ensure the building's structural and architectural integrity.

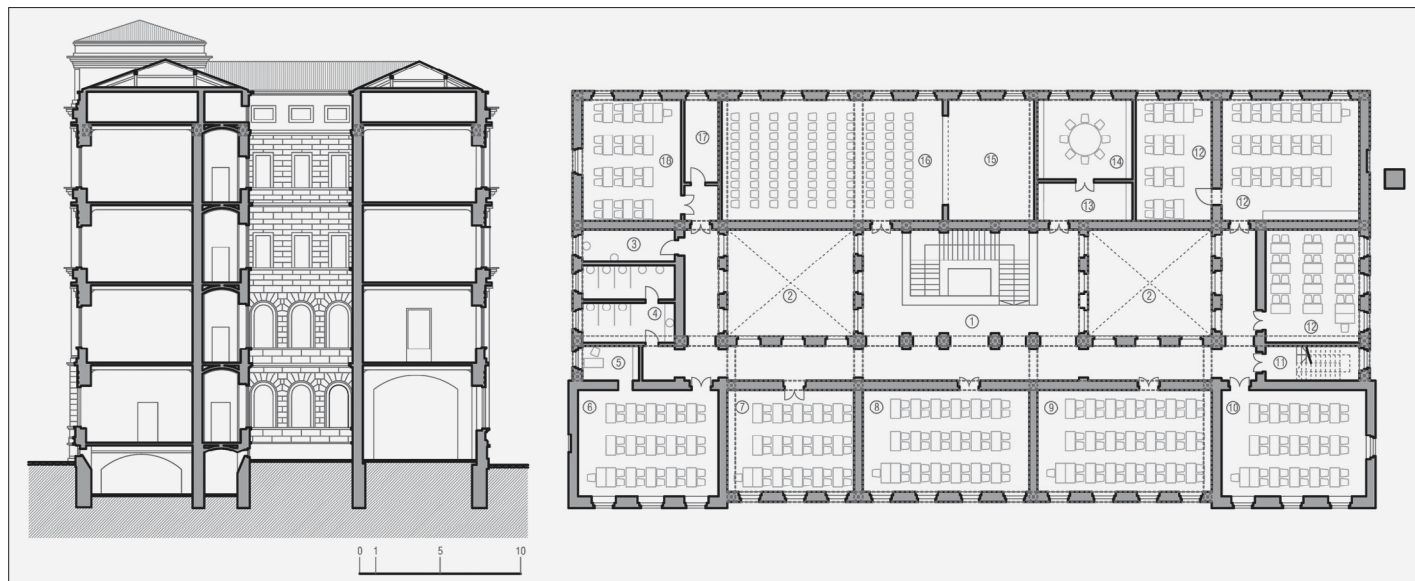
FIG. 8 STRENGTHENING OF THE THIRD FLOOR OF THE I GYMNASIUM WITH HORIZONTAL BOND BEAMS (AUTHOR’S CONTRIBUTION)

The construction of additional storeys of existing structures, made as unreinforced masonry structures (URM) without vertical and horizontal tie-beams, represents a significant challenge from the aspect of statics and conservation requirements, illustrated by the example of the I Gymnasium. From the perspective of seismic safety, partial and localized strengthening can cause non-uniformity in stiffness and strength distributions between the strengthened and original floors. Such discontinuities in the structural system can lead to stress concentration at transitions, which increases the building's susceptibility to seismic damage. For the strengthening measure to be effective, it is of the utmost importance to apply consistent measures to the entire height of the structure, and not just localized as is done in this structure. In this case, the original load paths were not respected, which, as a result, has an impact on the overall action of the structure once exposed to ground shaking. The construction of the third floor included the introduction of the horizontal bond beams and tie columns (marked in red), as illustrated in Fig. 8 and Fig. 10 by red colour.

Cement mortar was most probably used in the construction of the new additional floor.

As the rest of the structure is made of lime mortar, this is completely inconsistent with international guidelines for historic structures, (ICOMOS, 2003: 5), where the importance of material compatibility is emphasized. Cement mortars are significantly stiffer and less vapor permeable than traditional lime mortars, which leads to mechanical and chemical incompatibility with original materials. This kind of incompatibility can have negative impacts on the structure, which can be seen in the accumulation of stress, possible crack formations, and salt accumulation. This all could and most probably would accelerate the deterioration of the structure.

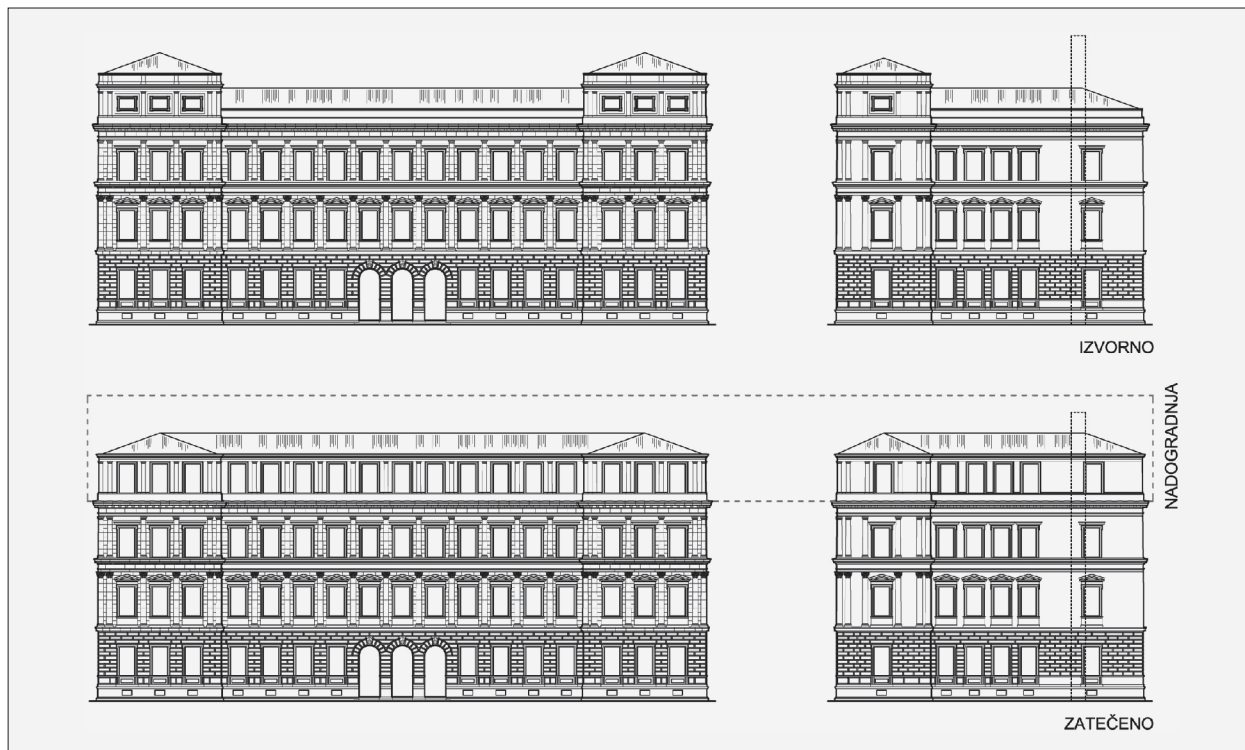
FIG. 9 | GYMNASIUM,
CONSTRUCTION
OF THE THIRD FLOOR
(AUTHOR'S CONTRIBUTION)

Fig. 9 illustrates the current state of the structure, indicating the creation of the additional third floor. This addition has increased the mass of the structure, and with the usage of the reinforced concrete bond beams and tie columns, this has significantly altered the dynamic action of the original URM structure. The addition of the mass and the change in the stiffness of the upper floor have had an impact on the natural frequency. If the connection of the old part of the structure and the new part is not conducted in a proper way, this could have an impact on the structure's seismic response. At the location of intervention, there is an obvious stiffness and mass discontinuity, which may lead to differential movements, cracks, and stress concentrations, as seen in similar cases in Italy (Fig. 2). The dynamic

properties of reinforced concrete elements (bond beams and tie columns) are not fully compatible with URM walls, together with uneven stiffness distribution, may cause the amplification of the vibration effects, especially in the transition zones, reducing overall seismic resistance.

In conclusion, the construction of the new floor added new mass to the structure, and localized reinforced concrete elements changed the localized stiffness of the structure, which altered the original dynamic action of the URM structure, increasing its vulnerability. One of the most important elements in the process of strengthening existing structures is to maintain and ensure uniform mass and stiffness distribution along the building height. This is crucial as, in this way, the dynamic behavior of the structure will not be changed, or this change will be kept to a minimum, leading to higher structural resistance.

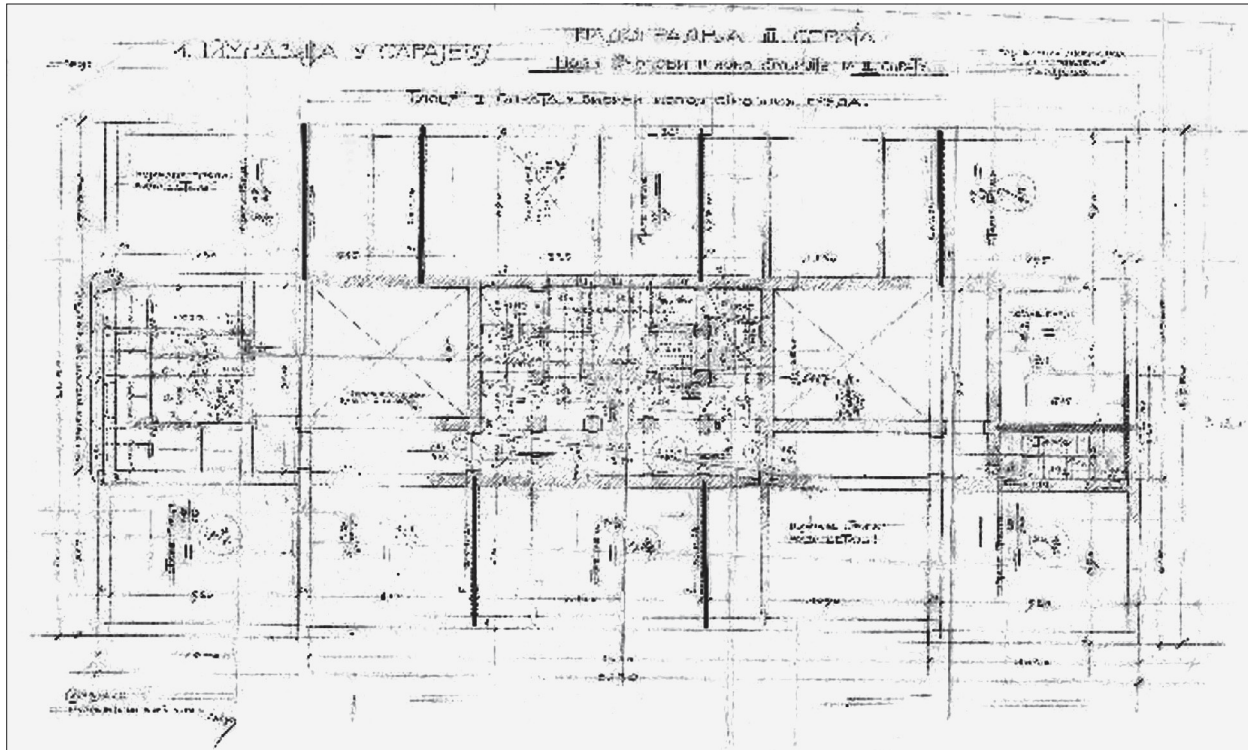
FIG. 10 | GYMNASIUM, STRUCTURAL REINFORCEMENT OF THE SECOND-FLOOR CEILING (SOURCE: ARCHIVAL MATERIALS OF THE FIRST GYMNASIUM)

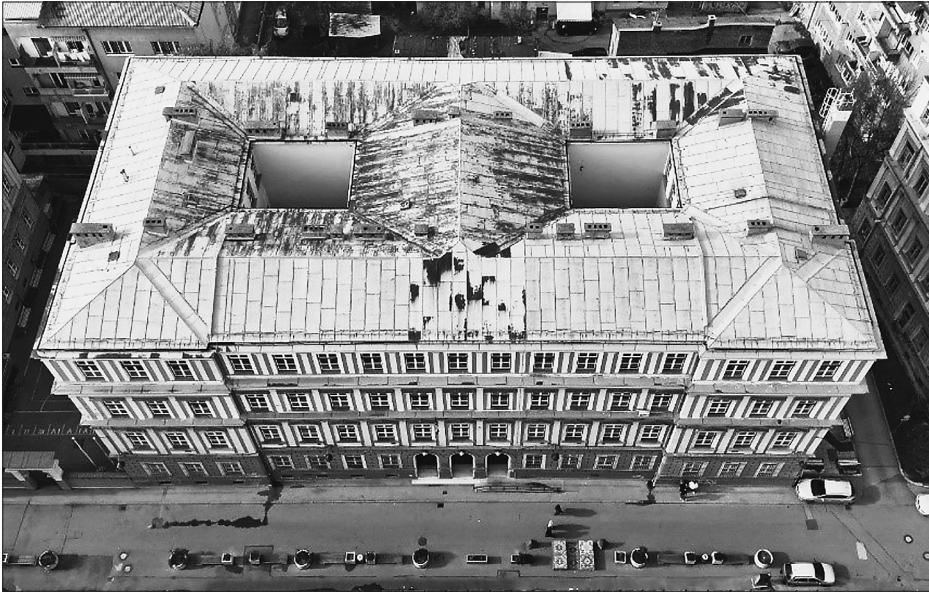
Poor maintenance can be identified as one of the crucial causes of masonry structures' degradation (Fig. 11). If regular inspections and timely repairs are conducted, many of the causes (water infiltration, crack formation, and biological influences) can be significantly mitigated. Progressive deterioration is

FIG. 11 | GYMNASIUM, INADEQUATE MAINTENANCE (AUTHOR'S CONTRIBUTION)

usually seen on masonry structures that are not timely and well-maintained, which may lead to severe damage that requires expensive and extensive interventions.
