Materials Analysis of Parts of a Subsystem for the Tailings' Spreader Movement

Dušan ARSIĆ*, Ružica NIKOLIĆ, Aleksandra ARSIĆ, Malgorzata ULEWICZ, Nenad GUBELJAK, Dragan CVETKOVIĆ

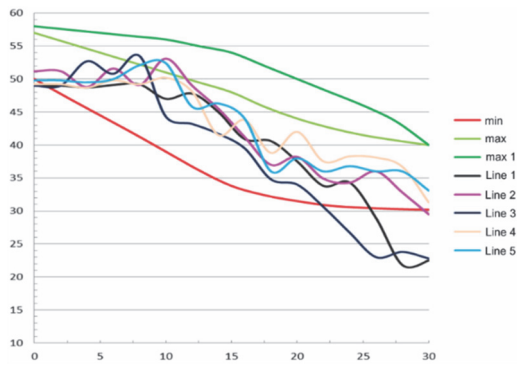
Figure 8 Hardness variation along the material's depth with minimum and maximum values

By analyzing the results, it can be concluded that the wheel material is homogeneous since there are no major deviations in the results in different measurement zones.

By calculating the strength according to the mentioned formulas, a slightly higher strength is obtained than that prescribed for the tested steel. High strength in the surface zones of the track material (acted by the wheel) can lead to peeling of the material and significant damage to the track [9].

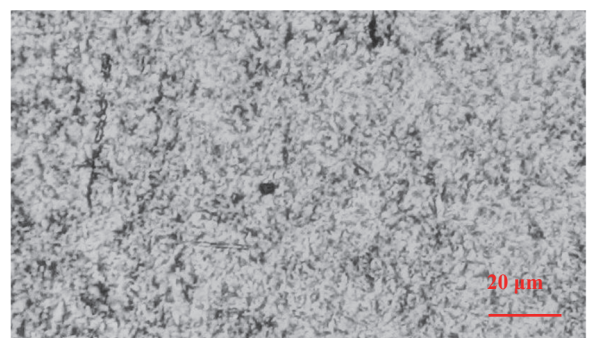
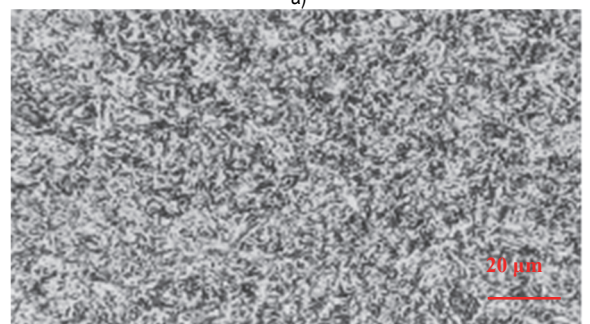
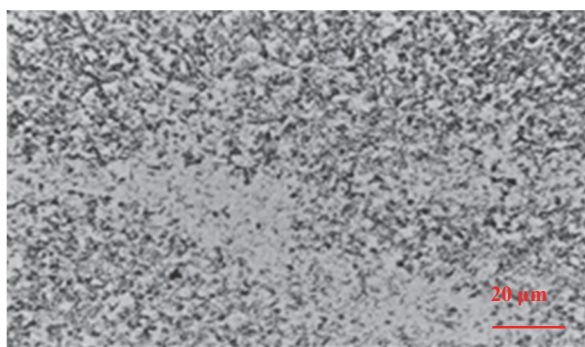
Figure 10 Results of microstructure investigations: a) Surface zone; b) Subsurface zone; c) Specimen bulk

The microstructure in the surface and subsurface zone of the examined piece (at depth of 3 mm from the sample surface) consists of martensite (Fig. 10a and 10b), and the microstructure in the bulk (at depth of 10 mm from the sample surface) of martensite and bainite, Fig. 10c, which corresponds to the material class of steel forging 42CrMo4 +QT.

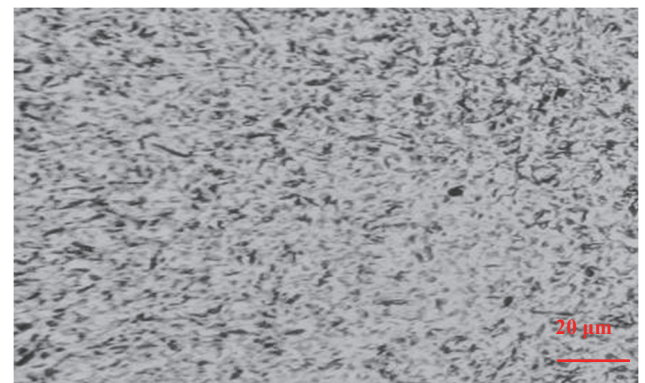
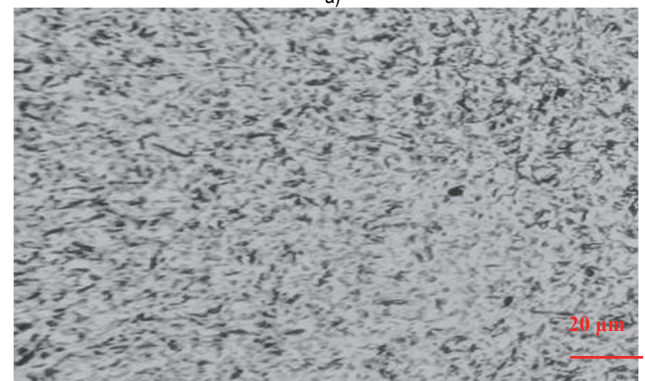
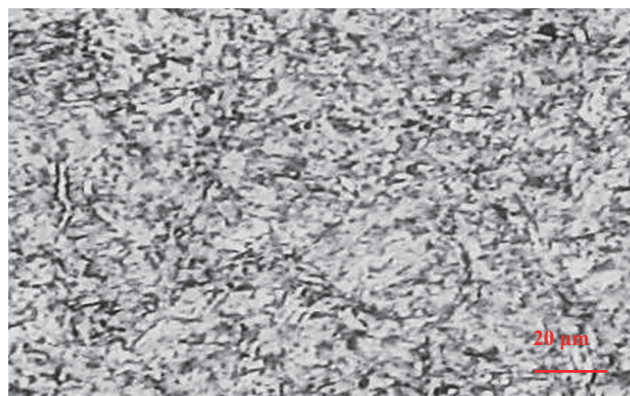
Figure 14 Results of microstructure investigations: a) Surface zone; b) Subsurface zone; c) Specimen bulk

The results of the test with a magnification of 100× are given in Fig. 14. The microstructure in the surface and subsurface zone of the tested piece, at a depth of 3 (mm) from the surface, consists of martensite (Figs. 14a and 14b), and the microstructure in the bulk of the test piece sample, at a depth of 10 mm from the surface, consists of bainite and martensite, Fig. 14c.
