ANALIZA VELIKOG KVARA U TRAFOSTANICI NA OTOKU KRETI

THE STUDY OF A MAJOR 2008 SUBSTATION INCIDENT IN THE EPS OF CRETE

Emmanuel Thalassinakis – Thales M. Papazoglou, Iraklio, Crete, Greece

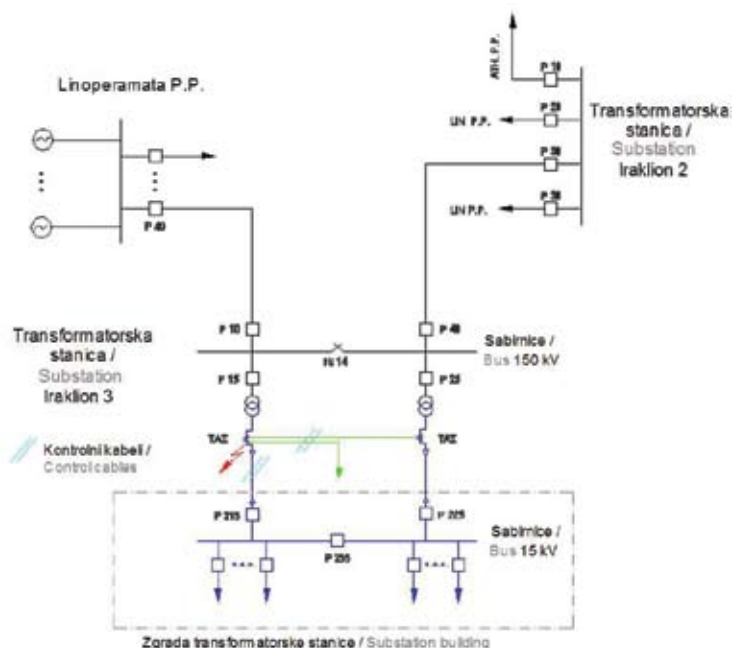
Slika 1 — Jednopolna shema TS Iraklion 3 s veznim stanicama
Figure 1 — Single-line diagram of SS Iraklion 3 with connecting stations

Crvene strelice na slici 1 pokazuju mjesto kvara. Kvar je očito počeo kao jednofazni kratki spoj koji se zbog posljedičnog uništenja dijela zaštite u 24 sekunde razvio u trofazni kratki spoj (slika 3).

The red arrows in Figure 1 show the position of the fault. The fault apparently started as a single-phase fault which due to the resulting destruction developed in 24 seconds into a three-phase fault (Figure 3).

Ubrzo nakon toga kvar se razvio u trofazni kratki spoj i izazvao da diferencijalna zaštita transformatora otvori prekidač P215 (slika 1) na sekundarnoj strani transformatora, no nije uspjela otvoriti prekidač P15 (ista slika) zbog uništenja pripadajućeg okidača strujnog kruga. Drugim riječima, kvar nije bio uklonjen. Procjenjuje se da su struje kratkog spoja iznosila 4 933 A. Te su struje tekle neprekidno 16 minuta, stvarajući destruktivnu toplinu koja je rezultirala raširenim požarom na instalacijama transformatorske stanice. Krajnji je rezultat bila značajna šteta na energetskom transformatoru broj 1 transformatorske stanice, te uništenje sve kontrolne i zaštitne opreme, uključujući jedan interni transformator za servisni napon, tri audio-frekvencijska transformatora, itd.

Shortly afterwards, the fault developed into a three-phase fault causing the differential transformer protection to open the circuit breaker P215 (Figure 1) on the transformer secondary side, but, it failed to open the breaker P15 (same figure) due to the destruction of the corresponding trip-circuit. In other words, the fault failed to be cleared. The fault currents have been estimated to 4 933 A. These currents were sustained for 16 continuous minutes, producing destructive heat that resulted in extensive fires in the substation installations. The end result was that Power Transformer # 1 of the substation suffered extensive damage, as had all the control and protection equipment, including one internal service transformer, three audio-frequency transformers, etc. which were destroyed.

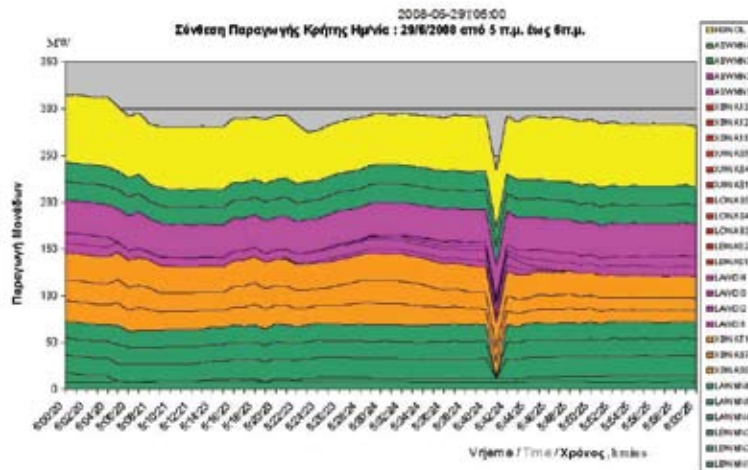
Na slici 2, različite boje, odozdo prema gore, odgovaraju parnim jedinicama, kombiniranom ciklusu, dizelskim jedinicama, plinskim turbinama i vjetroelektranama.

In Figure 2, different colors, from base upwards, correspond to steam units, combined cycle, diesel units, gas turbines, and wind generation.

Σлика 2 — Opskrba opterećenjem (vremenski graf u h:min:s) uključujući i poremećaj po incidentu
 Figure 2 — Load supply (time-graph in h:min:s) including the incident disturbance

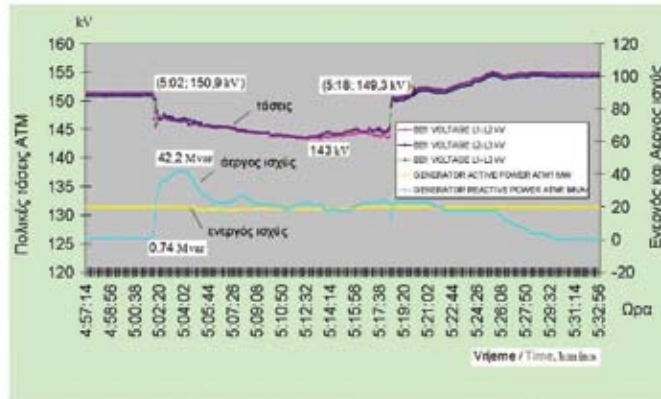
130,61 kV, dok je u Atherinolakosu (zapadna strana otoka) pao na 143 kV gdje je parna jedinica broj 1 (nominalne snage 50 MW) proizvodila 20 MW i 0,74 Mvar prije kvara – porasla je na 42,2 Mvar nakon kvara i kasnije se ustalila na 20 Mvar. Mogućnost proizvodnih jedinica da povećaju proizvodnju jalove snage pomogla je održanju prihvatljivih razina napona i tako je izbjegnuto opći raspad. Na slici 3 se mogu vidjeti linijski naponi kod jedinice Atherinolakos broj 1 kao i proizvodnja djelatne i jalove snage u vremenu oko kvara.

erinolakos (west-side of the island) fell to 143 kV where the steam unit #1 (nominal power 50 MW) was generating 20 MW and 0,74 Mvar before the incident – went up to 42,2 Mvar after the incident and leveled-off at 20 Mvar later. The capacity of the units to increase their reactive generation helped in sustaining voltage levels acceptable and to avoid a general blackout. In Figure 3 we can see the line-voltages at the Atherinolakos unit #1 as well as the real and reactive power generation around the incident.

Slika 3 – Linijski naponi, djelatna i jalova snaga parne jedinice 1 u elektrani Atherinotakos
 Figure 3 – Line voltages, real and reactive power of steam unit 1 – Atherinotakos PS

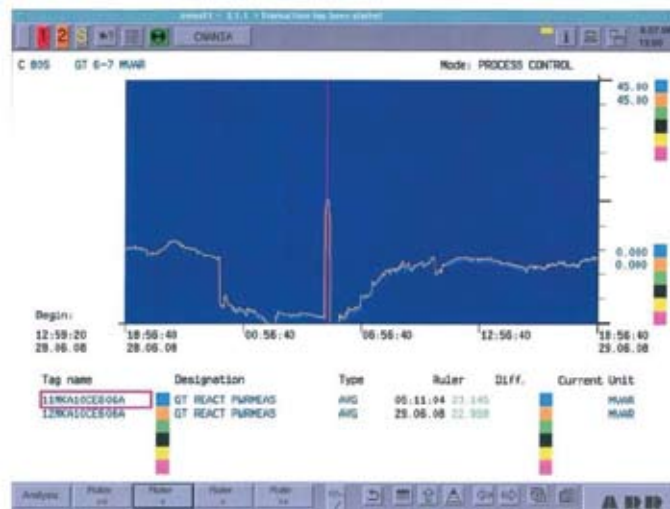
Na slici 4 može se vidjeti proizvodnja jalove snage dvije plinske turbine u postrojenju kombiniranog ciklusa Xylokamara (istočna strana Krete). Ponovno se može vidjeti povećanje proizvodnje jalove snage u kritičnom razdoblju – koje je išlo gotovo od 0 Mvar na 23,145 Mvar i 22,998 Mvar za pojediniu plinsku turbinu.

In Figure 4 we can see the reactive power generation of the two gas turbines of the combined-cycle unit at Xylokamara power station (east-side of Crete). Again we see the increased reactive power generation at the critical period, which increased from close to 0 Mvar before the incident to 23,145 Mvar and 22,998 Mvar for each turbine.

Slika 4 – Jalova snaga plinskih turbina u postrojenju kombiniranog ciklusa u Xylokamari
 Figure 4 – Reactive power of GTs of Combined cycle unit at Xylokamari

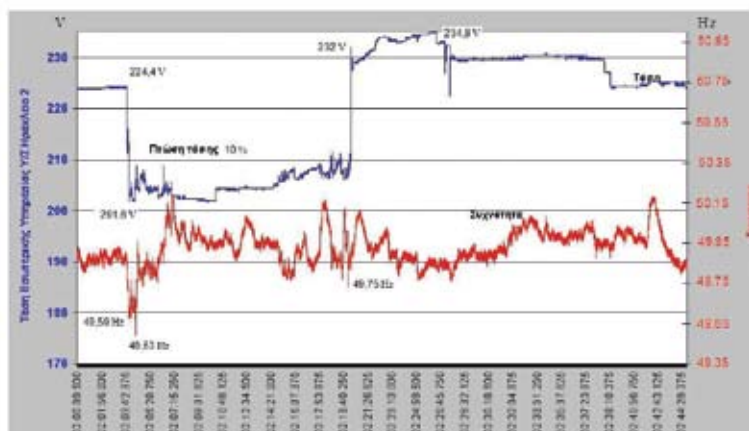
Na slici 5 može se vidjeti napon i frekvencija izmjereni na TS Iraklio 2. Vidi se da je na početku kvara, zbog gubitka dvije jedinice (parne jedinice broj 3 Linoperamata sa 7 MW opterećenja, i dizelske jedinice broj 4 Linoperamata s 10,5 MW opterećenja), frekvencija pala na minimum od 49,53 Hz.

In Figure 5 we can see the voltage and the frequency measured at the SS Iraklio 2. We see that at the beginning of the incident, because of the loss of two power units (steam unit #3 Linoperamata with 7 MW load, and Diesel unit #4 Linoperamata with 10,5 MW load), the frequency dropped to a minimum of 49,53 Hz.

Slika 5 – Vremenski grafovi napona i frekvencije izmjereni na TS Iraklio 2
 Figure 5 – Voltage and frequency time-graphs measured at Iraklio 2 substation
