Analysis of Tree Damage Caused by Rockfall at Forest Road Construction Works

Selcuk Gumus, Burak Aricak, Korhan Enez, H. Hulusi Acar

Abstract – Nacrtak

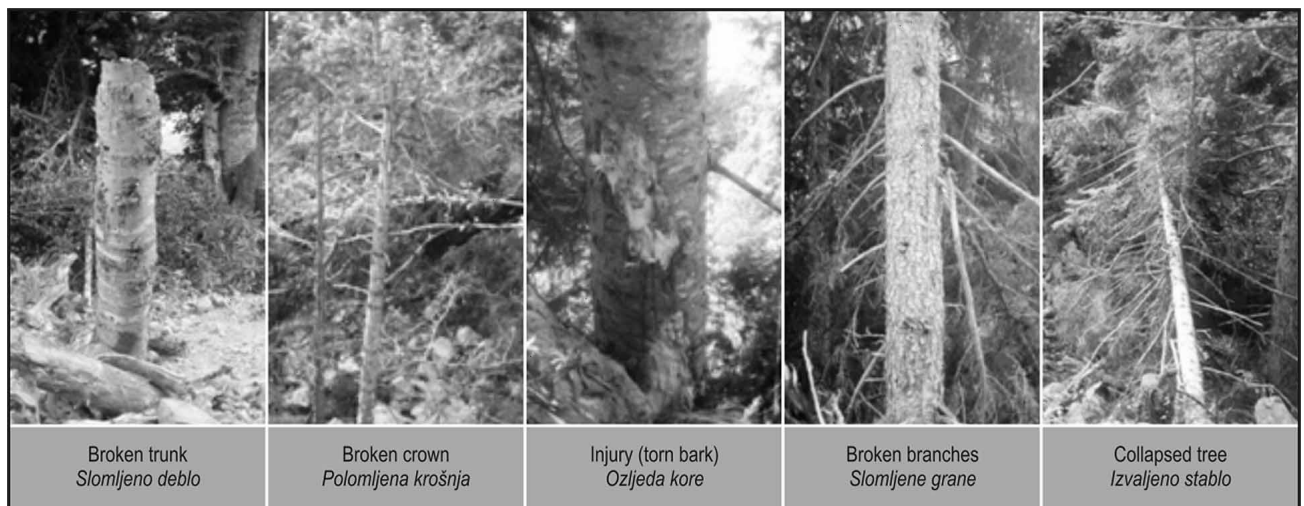
Forest road constructions produce many rock pieces. If these rock pieces are not carefully placed on the embankment slope, they roll down it. This situation is unavoidable during bulldozer digging or blasting of rock mass. Stone and rockfalls cause tree damage such as torn bark, collapse, broken branches – crown – trunk. Fig. 2 shows samples of such tree damage.

Fig. 2 Samples of tree damage in study area

The damages were defined as injuries, broken branches, broken crown, wounded trunks and collapse of trees. Those were determined in the study area of this investigation. The results show that the main injuries occurred in the first 10 m from the road embankment slope. This is a very important result in terms of forest protection. Preventative measures such as wooden obstructions or synthetic holders to block rockfall or slow it down must be implemented to protect tree trunks especially for up to 1 m from the surface.

The technique of forest road construction causes different types of tree damage. Blasting with dynamite for rock excavation resulted in increased branches and crown brokenness. When this technique is used, action should be taken to block the 'popping-out' of stones and rocks. Use of dynamite for rock excavation causes approximately double damage to trees than bulldozers do. Excavator is the machine that can provide protection to trees. The excavator should be the choice for forest road construction.

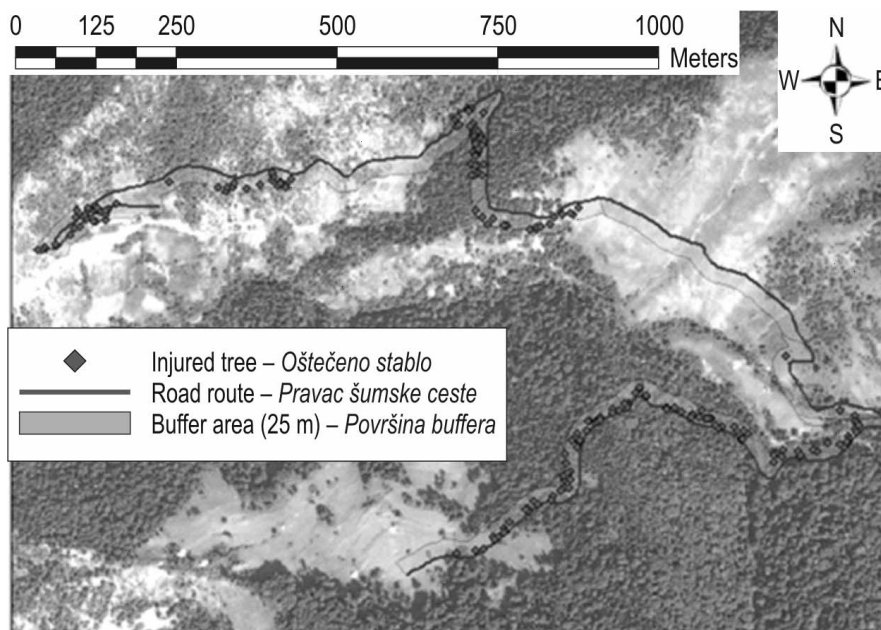
Fig. 3 Damage to trees and its geographical disturbance

It has been determined that 90.48% of injured trees are in the first 10 m after the beginning of the embankment slope. Weighted average of the injured surface area on these trees has been calculated as 1,081 cm². Specific measurements also show as follows: the average height of the injured area is 56 cm, the average diameter of trees is 22 cm, the average tree height is 12 m, and the average slope gradient is 74% (Table 2). It has been determined that tree collapse and fractured branches – trunk – crown are effective for the first 10 m, like the injury area.
