THE ANALYSIS OF DEFECTS ON CONTINUOUS CAST BILLETS

Received - Primljeno: 2004-05-26

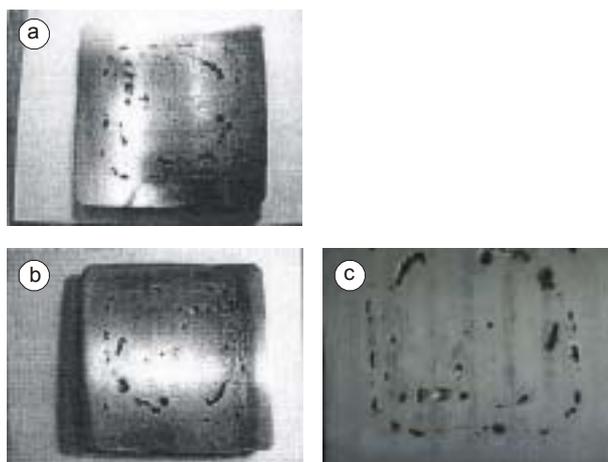
Figure 1. **Macrophoto Specimen 1. (no mag.)**
Slika 1. **Makrosnimak uzorka 1 (bez povećanja)**

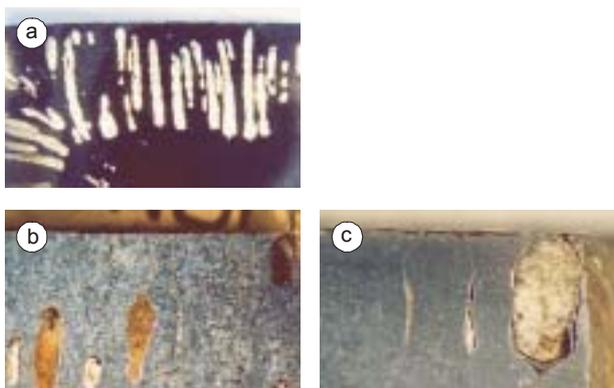
Figure 2. **Macrophoto - Specimen 2.** a mag. 2,5×, 2.b mag. 8×, 2.c mag. 20×
Slika 2. **Makrosnimak uzorka 2.** a povećanje 2,5×, 2.b povećanje 8×, 2.c povećanje 20×

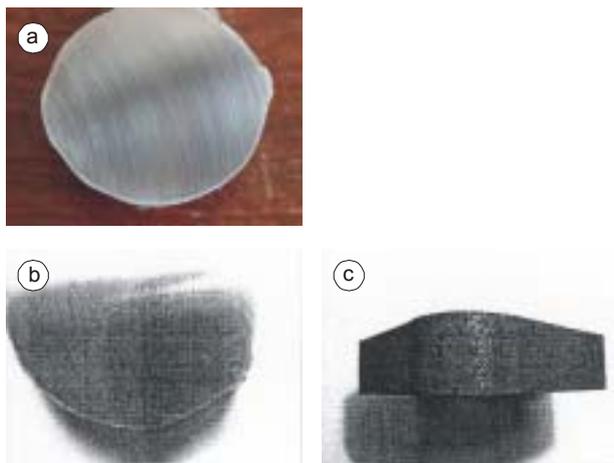
Figure 3. **Macro photo (no mag.)**
Slika 3. **Makrosnimak uzorka 3 (bez povećanja)**

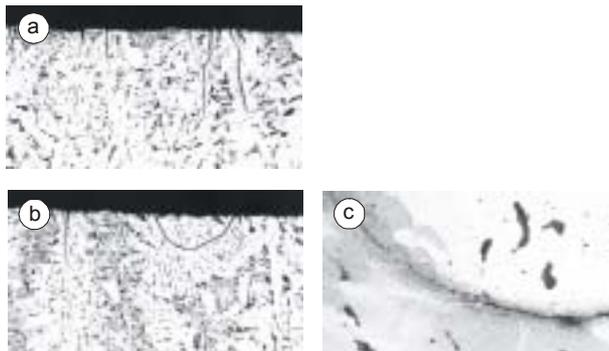
Figure 6. **Microstructure of various cracks:** 6.a mag. 50×, 6.b mag. 50×, 6.c mag. 500×
Slika 6. **Mikrostruktura raznih pukotina:** 6.a povećanje 50×, 6.b povećanje 50×, 6.c povećanje 500×

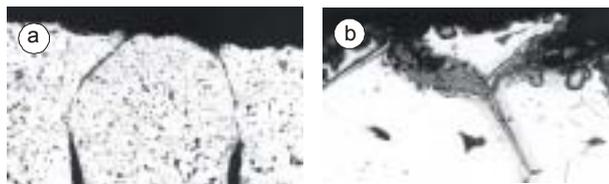
Figure 7. **Micro photo of connection crack-blow hole-billet surface** 7.a mag. 50×, 7.b mag. 500×
Slika 7. **Mikrosnimak spoja pukotina - mjehur - površina gredi-** ce: 7.a povećanje 50×, 7.b povećanje 500×

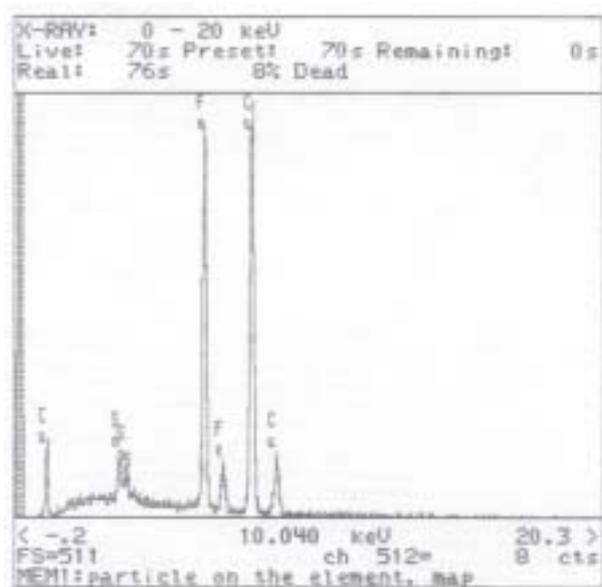
Figure 8. The analysis of inclusions by method EDX
Slika 8. Analiza uključka EDX-metodom

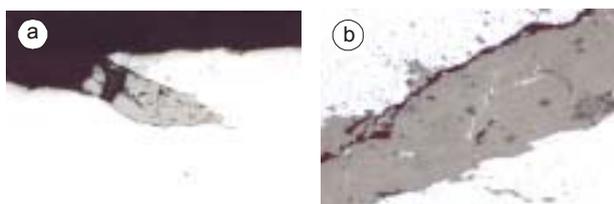
Figure 9. Microscope picture of a small crack (without the etching):
9.a magnified 50×, 9.b magnified 500×
Slika 9. Mikroskopska snimka male pukotine (bez nagrivanja):
9.a povećanje 50×, 9.b povećanje 500×

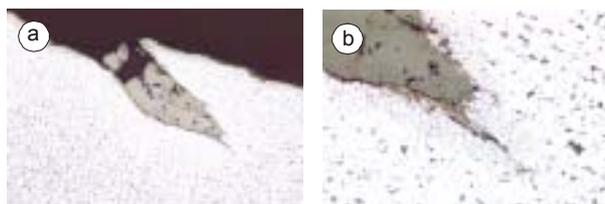
Figure 10. Microscope picture of the surrounding area of the crack:
10.a magnified 50×, 10.b magnified 200×
Slika 10. Mikroskopska snimka okoline pukotine: 10.a povećanje
50×, 10.b povećanje 200×

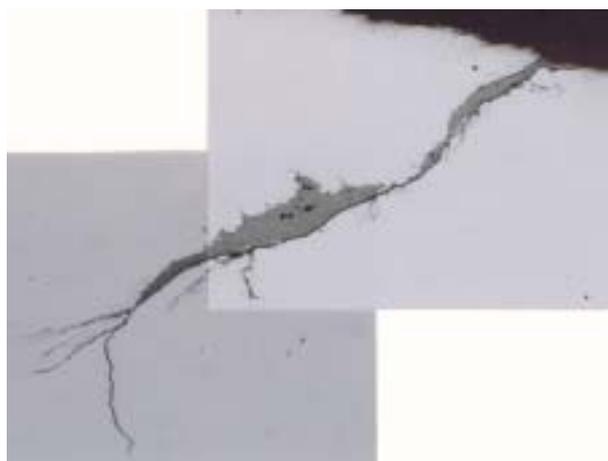
Figure 11. Microscope photo of a great crack: magnified 50×
Slika 11. Mikroskopska snimka velike pukotine: povećanje 50×

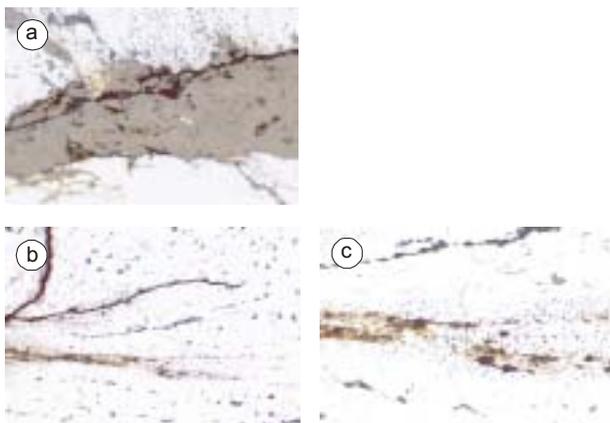
Figure 12. A microscope photo of a great crack: 12.a mag. 500×, 12.b mag. 200×, 12.c mag. 500×

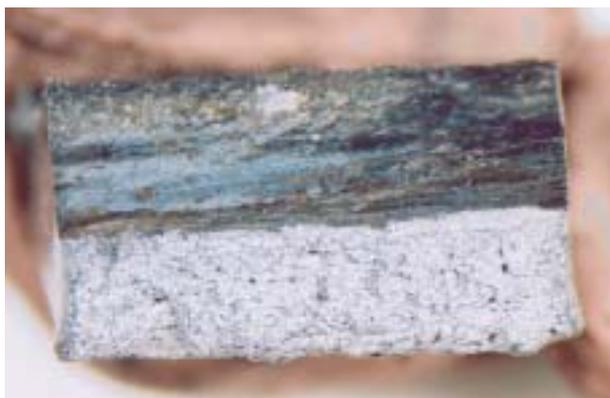
Figure 13. Presentation of an opened crack: mag. 12×

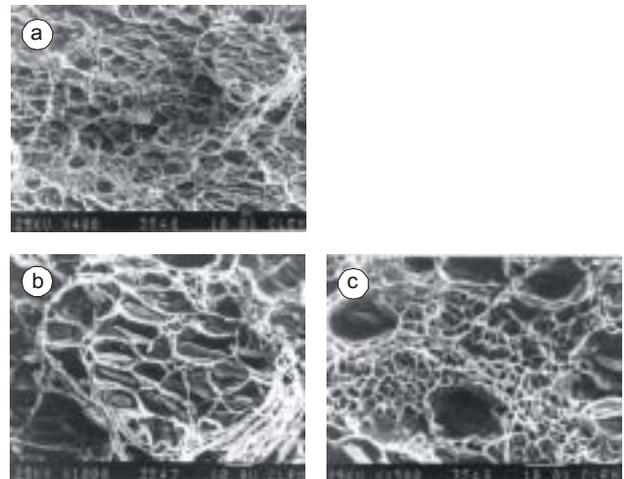
Figure 15. Microscope photo of big and small inclusions

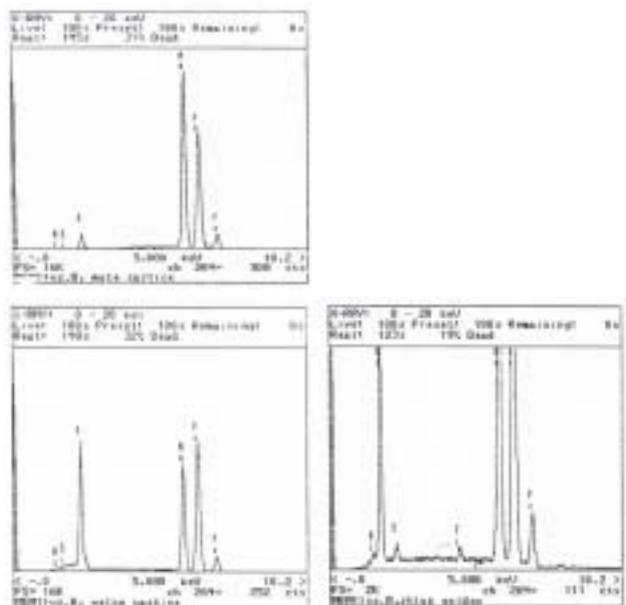
Figure 16. Analysis of inclusions by EDX-method
