Early dysfunction of an implanted pacemaker in a patient with complete atrioventricular block

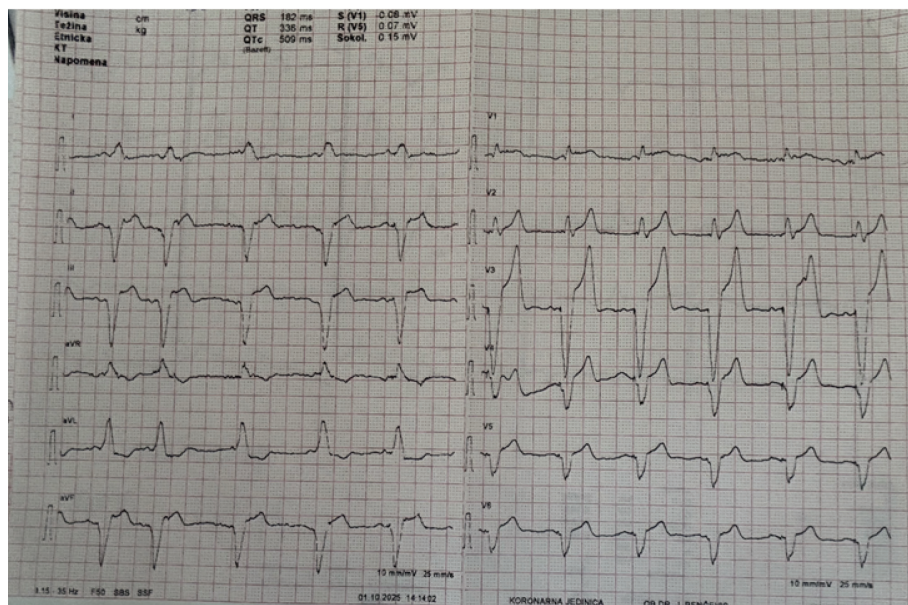
FIGURE 2. 12-lead electrocardiogram after pacemaker implantation.

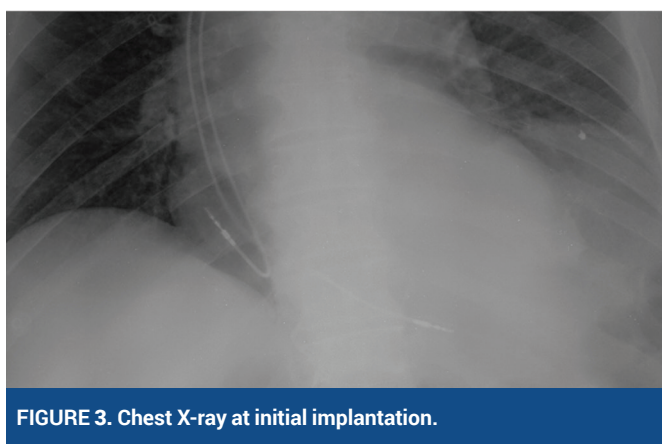
FIGURE 3. Chest X-ray at initial implantation.

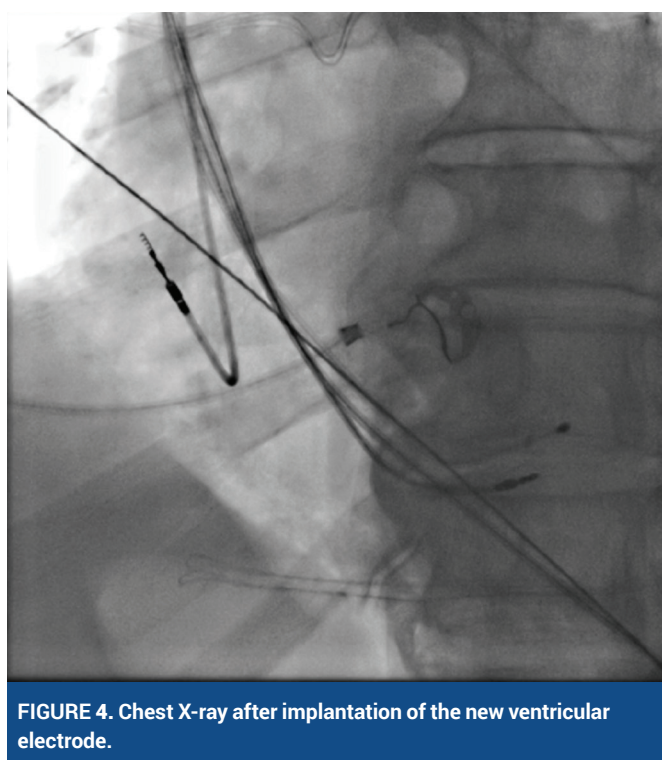
Conclusion: Dysfunction of the ventricular electrode may have been due to a microfracture of the electrode, which was not visible radiographically, or a microtear into fibrotic tissue².

FIGURE 4. Chest X-ray after implantation of the new ventricular electrode.

imaging revealed no displacement of the electrode, with identical positioning and normal electrode impedance. The ventricular electrode failed to transmit impulses even when connected to the programmer. Therefore, a new ventricular electrode was implanted via the left subclavian vein (Figure 4).
