EFFECT OF SOLUTION ANNEALING ON PROPERTIES OF USED REFORMER CENTRIFUGALLY CASTED TUBES PRIOR TO REPAIR BY WELDING

The specimens of damaged tubes, ASTM A297 HK 40, are repaired by welding. Before repairing, solution annealing is used as a procedure for properties restitution. This paper explores the influence of used solution annealing procedure (1 050 °C / 2h) on mechanical and micro-structural properties. The emphasis is put on specific procedures at repair by welding.

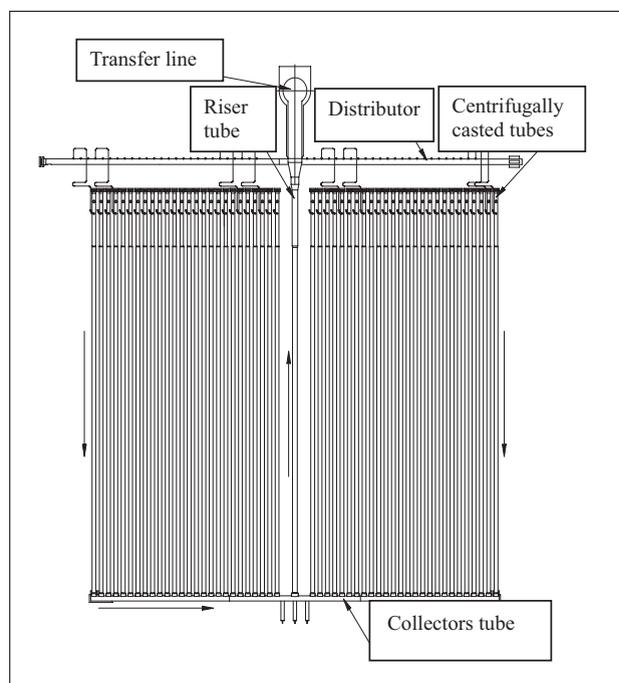
Reformer catalyst tubes used by the petrochemical industry for fired heaters are commonly manufactured from high strength, creep, and corrosion resistant alloys. They are of relatively thick wall and usually produced by centrifugal casting (Figure 1). Their exploitation is limited by creep, driven by combination of internal pressure stress and through-wall thermal stresses generated by operational transients. Creep life exhaustion may happen by progressive grain boundary cavitation, depending on the microstructure of materials and exacerbated by micro-structural degradation processes, such as accompanied sigmatization.

Figure 1 Reformer catalyst tubes register of 52 tubes

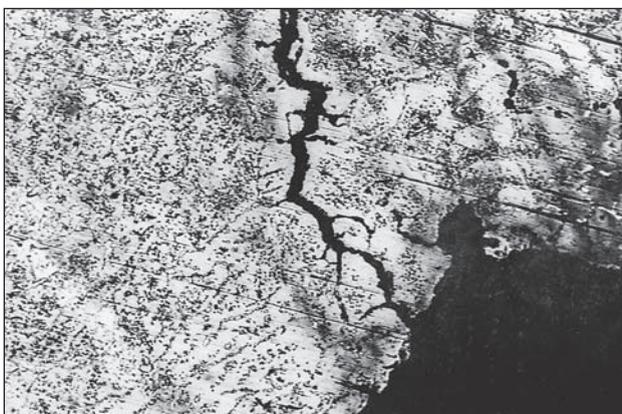
Figure 2 WHAZ cracks propagation (magnific. 10 x)

After 50 000 work hours on temperature in range of 830 - 880 °C, the tubes are inspected with eddy current method. Metallographic analysis of damaged tubes is performed on several examples with eddy current registered cracks. Evaluated damages are metallographically confirmed. Weld heat affected zone (WHAZ) crack propagation is shown on Figures 2 and 3.

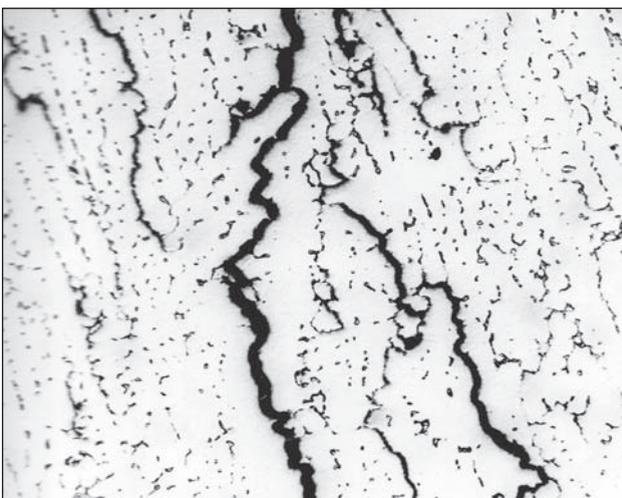
Figure 3 Middle area of fissures (magnific. 50 x)

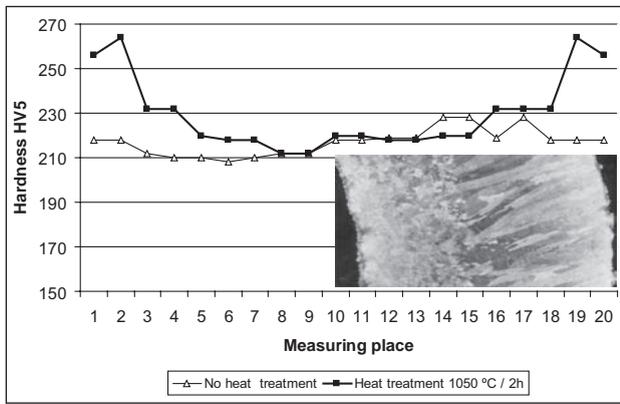
Figure 4 Diagrams of \bar{X} measurements HV5

measuring places of three samples. Figure 4 presents average HV5 values (\bar{X}) of performed measurements with tube macrostructure, as shown in the Table 3.

Hardness HV5 has higher values on tube thickness edges (outer because of oxidation and inside caused by carburization).

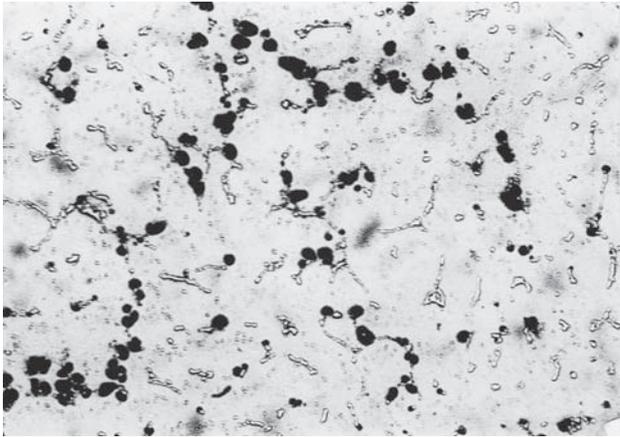
Figure 5 Microstructure in the middle of the tube thickness (magnific. 100 x)

Structure is characteristic for centrifugally cast process, i.e. the 2/3 of outer side of tube thickness consists of columnar grains and the following 1/3 of thickness has equiaxed grains.

From the metallographic point of view, the state of material is classified in several stages. The presence of intermetallic phases, carbides, voids, and cracks is confirmed (Figures 5-7). The fissures propagate from inside

through equiaxed grains and end after entrance in columnar grain structure.

Annealing temperature should be higher for min. 100 °C in order to solute carbides on grain boundaries and intermetallic phases, which will be suitable for materials ductility.

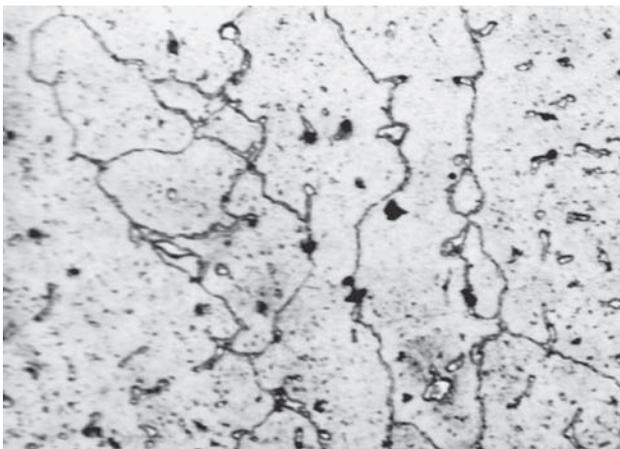
Figure 6 Microstructure of the gas heated tube outside (magnific. 100 x)

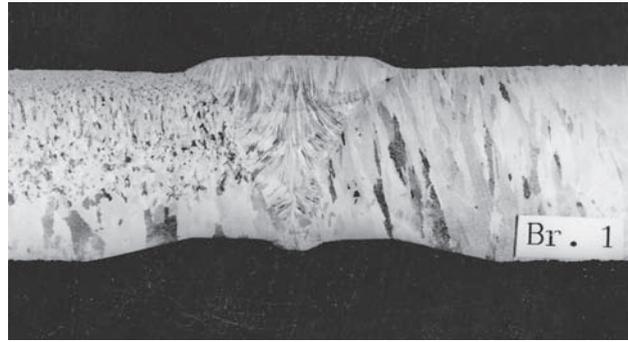
Figure 7 Macrostructure of repaired tube by welding

Despite of the mentioned facts, repair of solution annealed samples is successfully performed by GTA+SMA welding using (Figure 6) addition tube rotating device in flat position. ERNiCrMo-3 and ENiCrMo-3 filler metal are used. In intention to reduce hot fissures tendency of austenitic welds, heat energy input is limited on max. 1,6 kJ/mm. Root welds protection is performed with argon flow of 6 - 8 dm³/min.
