## STRUCTURAL MODIFICATIONS WHICH APPEAR IN THE AREA OF WELDS OF WELDED STRUCTURES MADE OF ST 52.3 STEEL

Original Scientific Paper – Izvorni znanstveni rad

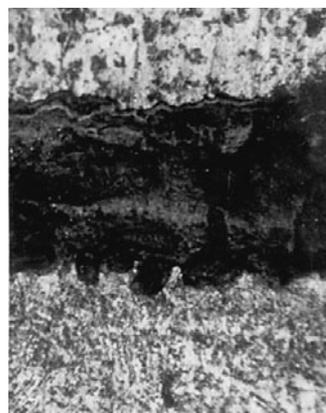
Figure 4 Metallographic structure of the material in the impenetrable area of the weld between the base materials

in Figure 1, welding corner in T. Thus in Figure 3 is shown the structure of the base material in zone 1 or zone 2 in Figure 1. In Figure 4 is shown the structure corresponding to zone 3 in Figure 1 the corresponding to the impenetrable area of the weld in the base material. The metallographic structure of filler material, zone 4 in Figure 1, is shown in Figure 5. At the edge of the melting crater has been identified in an area with strong oxidation, zone 5 in Figure 1 and the corresponding metallographic structure of this area is shown in Figure 6. Structural modifications are produced in the heat affected zone, zone 6 Figure 1, as appropriate material metallographic structure of this area is shown in Figure 7.

strong oxidation with craters and projections deformation occurred as a result of mechanical action. Metallographic structure of the material in the impenetrable area of weld, Figure 4 and Figure 9, shows the oxidation craters in both base materials.
