AGGRESSIVE GRANULOMATOSIS AFTER CEMENTLESS TOTAL HIP ARTHROPLASTY AS A RESULT OF INFLAMMATORY REACTION TO METAL DEBRIS: CASE REPORT

Key words: *Hip prosthesis; Prosthesis failure; Osteolysis; Granuloma, plasma cell; Case report*

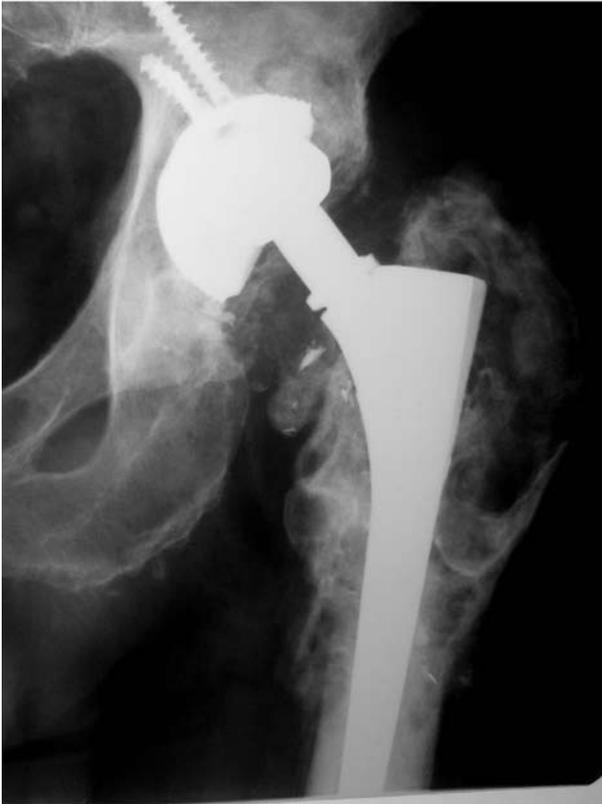
Fig. 1. Pseudotumour with massive osteolysis of proximal femur.

age of 60, he had undergone cementless total hip arthroplasty (metal on polyethylene surface) for osteoarthritis. He was pain free for the next 9 years. Radiologic follow up showed pseudotumors with massive osteolysis of proximal femur due to massive

granulomatosis with stable distal part of the femoral stem (Fig. 1). Intraoperatively, extensive metallosis (Fig. 2) with significantly worn metal head was found (Figs. 3 and 4). Only a small portion of the polyethylene insert was worn (Fig. 5). Acetabular and femoral parts of the prosthesis were stable. After removal of the altered tissue, bone defect at the edge of the acetabulum and at the proximal part of the femur were filled with autologous and allogeneic cancellous bone. At the end of the procedure, the polyethylene insert and femoral head were replaced with new ones. Postoperatively, the patient was normotensive². Upon extraction, parts of the affected tissue and bone that were in direct contact with the prosthesis were sent for histopathologic analysis. Microscopic examination showed necrotic soft and bone tissue, mainly bone marrow with numerous histiocytes and multinucleated giant cells containing lots of pigmented particles (presumed to be metal particles as a result of wear of the femoral head surface). Polarized light microscopy demonstrated the presence of free foreign material in the specimen, as well as incorporated in some histiocytes that were speculated to be conglomerates of metal worn from the implant surface. The analysis also concluded that it was aggressive granulomatous reaction to wear debris, mainly of the femoral head, as a consequence of inflammation.

(metal, polyethylene) used in hip implants. The fact that most of osteolysis and granulomatosis in this case occurred around the proximal part of the femoral stem (Fig. 1) and extreme wear of the femoral head (Figs. 3 and 4), as well as histopathologic findings suggest that the primary cause was inflammatory reaction to metal debris.

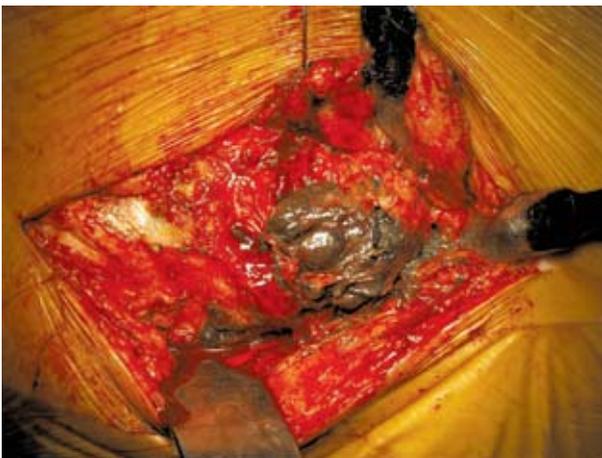
Fig. 2. Extensive metallosis of the surrounding soft tissue.

In this case, a significant wear of the prosthesis head was found (surgical stainless steel, AISI 316L with 16-18% Cr, 10-14% Ni and extra-low carbon, which have high resistance to corrosion but low wear resistance). Due to the low wear resistance of 316L stainless steel head, abrasion and extensive metallosis occurred. It is presumed that the presence of foreign molecular particles (mainly metal) cause an inflammatory reaction. This inflammatory reaction was responsible for massive bone resorption and pseudotumor on radiographs.

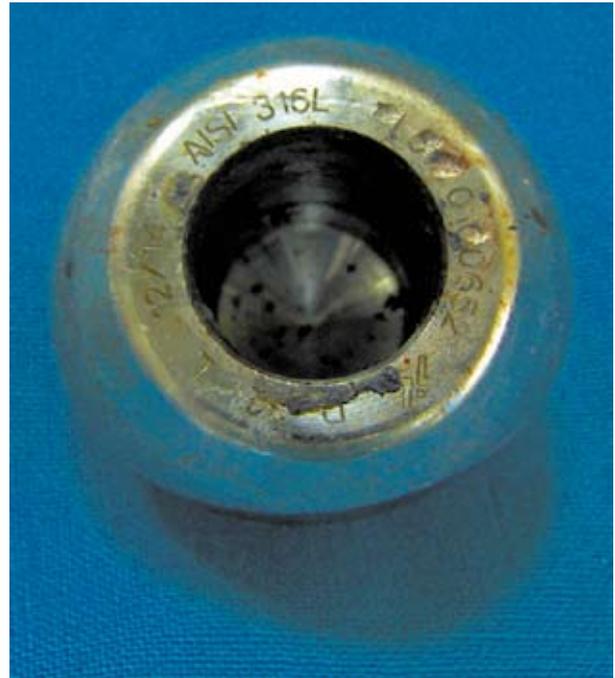
Fig. 3. Worn metal head type AISI 316L.

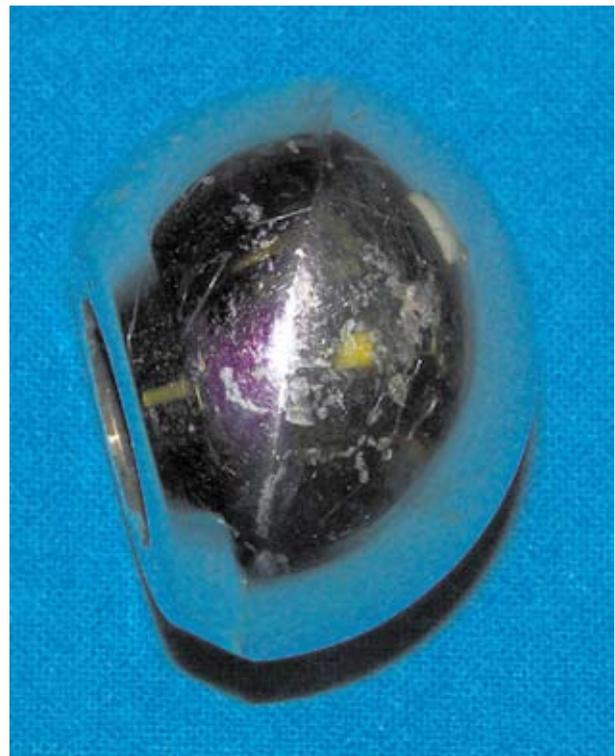
Fig. 4. Elliptic head as a result of wear.

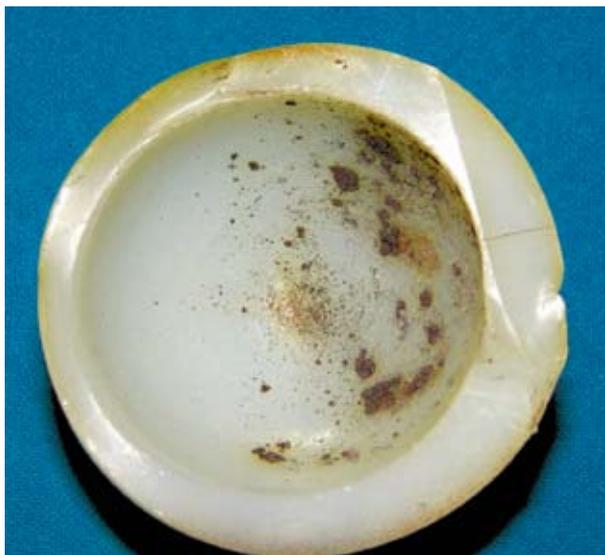
Fig. 5. Worn polyethylene insert with metal debris.
