ANALYSIS OF CALCULATED AND OBSERVED SETTLEMENTS OF THE SILO ON LOESS

Subject review

This paper presents the analysis of the results of observed and calculated settlements for the silo, due to load and partial saturation of the loess. In a dry state loess has high strength and low compressibility, however, highly porous layers of loess due to saturation lose structure, reduce volume and strength extremely. This feature of loess is known as structural collapse, or hydro collapse, making it one of the meta-stable soils, which are very unfavourable in terms of foundation. During the construction of the silo, due to inadequate protection during the intense rainfall, partial saturation of the surface layers has occurred, which undermined the initial structure of the loess and caused additional settlements that were registered during the first filling of the silo. To assess the development of settlements in these changed circumstances, the settlement calculations were performed, based on the collapse potential, increase of moisture, wetting depth and available quantity of rainfall for given location according to data from the National Hydro Meteorological Institute. Prediction of the ex

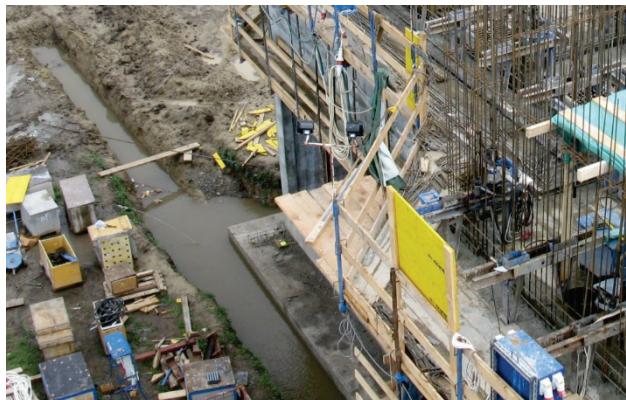
Figure 1 Heavy saturation of the foundation pit

Construction of the building began in late March 2010. During and after the excavation of the foundation pit, weather conditions were very unfavourable with a very large amount of rainfall resulting in difficult construction conditions. It should be noted, that the foundation pit, especially for the silo, was open and unprotected for a long period of time. The water infiltration was further facilitated through gravel-sand cushion, so in a short time the base of the pit had water

several decimetres deep. The volume of flooding is shown in Figs. 1 and 2. This event reoccurred at the beginning of July. With few exceptions, water was always present in the foundation pit.

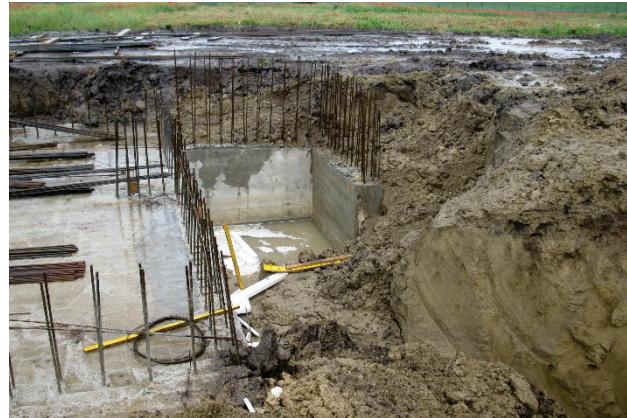
Figure 2 Saturation and sliding ground around the foundation pit

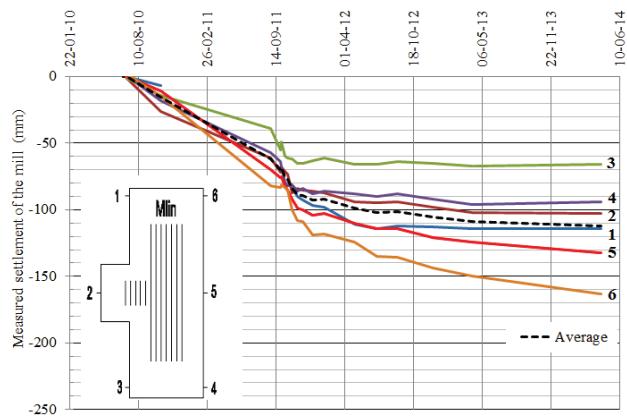
At the mill, 6 geodetic marks ($1 \div 6$) were embedded. All stayed intact except 1 that was damaged in the 4th and restored in the 9th measurement series. At the silo, 6 marks ($7 \div 12$) were embedded. Settlements over time are shown in Figs. 3 and 4 for the mill and for the silo. The first filling of the silo was at the end of Oct. 2011. There were 20 measurements over the time period of 45 months [7].

The mean value and the standard deviation of the last observed settlements of the mill was $109 \pm 33\text{mm}$, and of the silo it was $175 \pm 38\text{mm}$.

Figure 3 Measured settlements of the mill

The average observed settlement of the empty silo was 15 mm (28 %) less than calculated, but for the last series of measurements for a full silo it was 39 mm (29 %) higher. The average observed settlement of the mill

for the last series was 12 mm (12 %) higher than calculated.

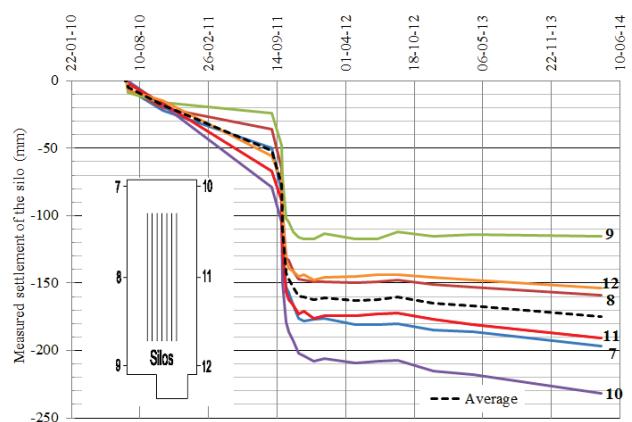
Figure 4 Measured settlements of the silo

After initial filling of the silo, symmetrically, cell by cell, the observed settlements were greater than the calculated, so the question arose regarding the cause of higher settlements, the expected settlements rate and the reduction of the silo capacity.

- Continue to measure settlements once weekly within next month. Afterwards, depending on the settlements, once a month, once in 3 and once in 6 months.
- For each measurement, record the cells occupancy and calculate the differential settlements, alternate the discharging and charging regime of the cells in order to reduce differential settlements.
- Carry out emergency repair of damaged coating of the dilatation joints, in order to prevent the water reaching the subsoil and to cause additional wetting.
- Change the current design of the underground draining of the water from the nose to the sewer, with a surface discharge into gutter and their discharge from facility.
- Review and if necessary, repair the internal-external joints of the hydro-technical installations.

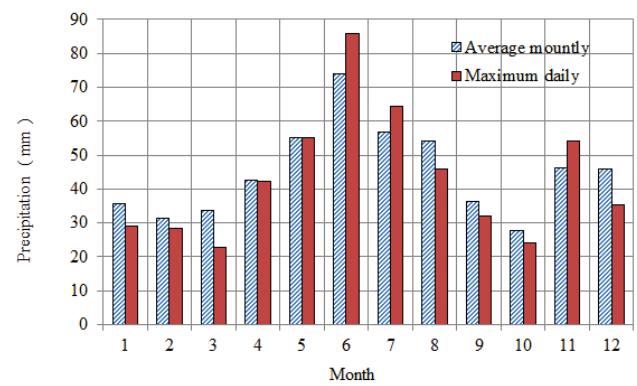
Figure 5 Amount of precipitation HMS - Palić

The data refers to the average hydrological year. It shows that the max. daily rainfall in June ÷ July is $85 \div 64\text{ mm}$.

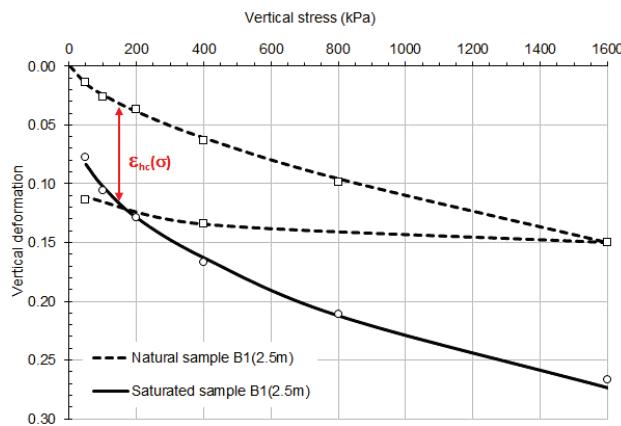
Figure 6 Double oedometer test on natural and saturated sample

Deformation parameters for undisturbed sample are $m=61,0$ and $a=0,64$, while for saturated one they are $m=28,0$ and $a=0,34$. According to Fig. 6, loess collapse potential at vertical pressure of $\sigma=100 \div 200 \text{ kPa}$, is estimated by:

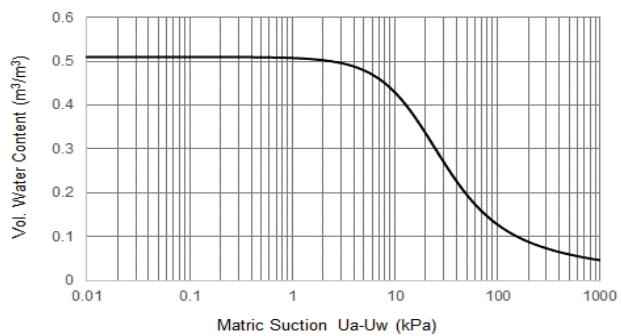
Figure 7 Volumetric water content (storage) function

Based on laboratory tests, the loess porosity at a depth of 2,0 m is 0,512, the saturated hydraulic conductivity is $k_x = 1,2 \times 10^{-7} \text{ m/s}$ and the hydraulic anisotropy is $k_y/k_x \approx 5$. The storage curve seen in Fig. 7, is predicted using the basic properties of the silt-type material [19].

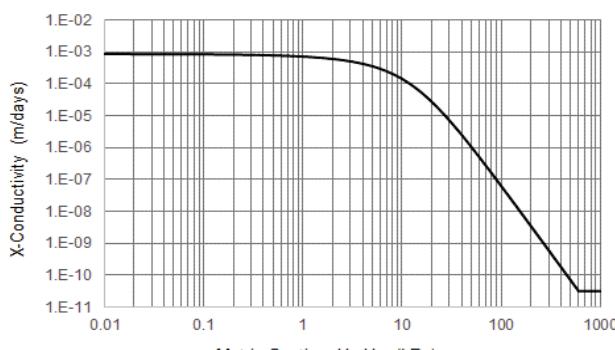
Unsaturated hydraulic conductivity of the soil (Fig. 8) is predicted from storage curve (Fig. 7) and its saturated hydraulic conductivity [19].

Figure 8 Hydraulic conductivity function

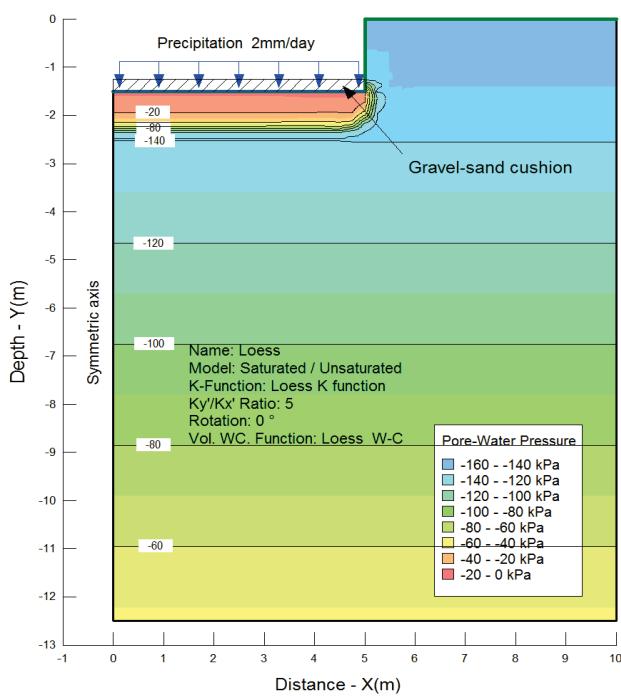
Figure 9 Pore water pressure isolines

Because the cross section is symmetric, only one half of the domain is used. The depth of the excavation is 1,5 m, and the thickness of the gravel-sand cushion is 0,25 m. The domain of the filtration is divided into finite elements with size $0,25 \times 0,25$ m. Convergence study showed that results with other finite element sizes ($0,5 \times 0,5$ m and $0,15 \times 0,15$ m) result in negligible differences.

The amount of precipitation at the foundation baseline is 2 mm/daily, or totally $0,18 \text{ m}^3$ for April, May and June. The results of the pore water pressure estimation due to wetting of the foundation pit through a gravel-sand cushion over 90 days, are shown in Fig. 9.

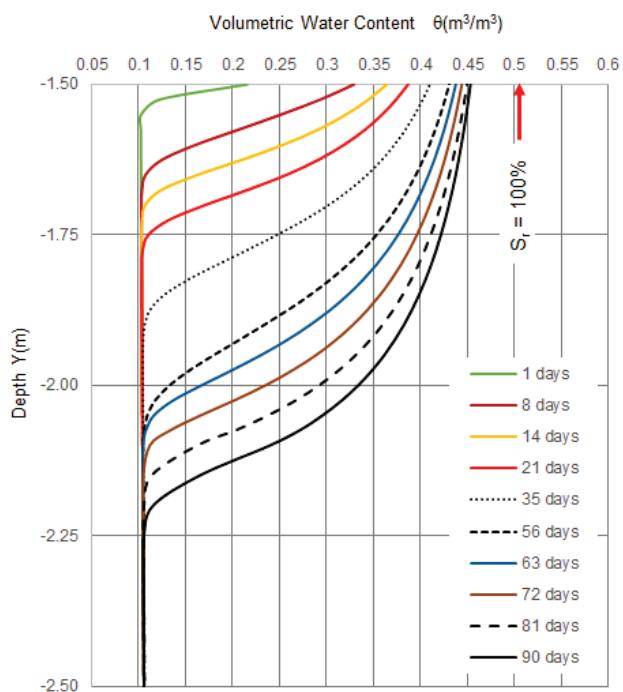
The water from the flooded foundation pit infiltrates into deeper layers, decreasing suction and increasing hydraulic conductivity. Based on the results of transient flow analysis, the bulk soil moisture in time and depth are estimated (Fig. 10). The computational depth, above which a significant increase in soil moisture occurred is roughly 1,0 m below the foundation.

Figure 10 Isochrones of volumetric water content

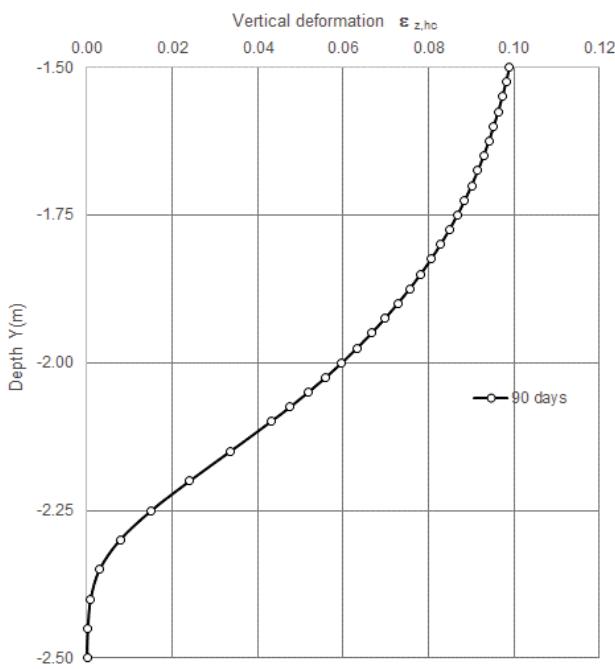
Full collapse can even occur at moistures slightly less than full saturation ($0,95 \div 1,0$). Based on the adopted values of the saturation $S_r^* = 0,95$ and collapse potential of 9,6 %, the vertical deformation versus depth is estimated, as presented in Fig. 11. Applying the numerical integration method to Eq. (5), the settlement caused by hydro collapse is $s_{hc} = 47$ mm.

Figure 11 Vertical deformation caused by hydro-collapse
