INDUCTION MOTOR ROTOR CAGE FAULTS AS IGNITION SOURCES OF EXPLOSIVE ATMOSPHERE - RESEARCH ON HEATING

Original scientific paper

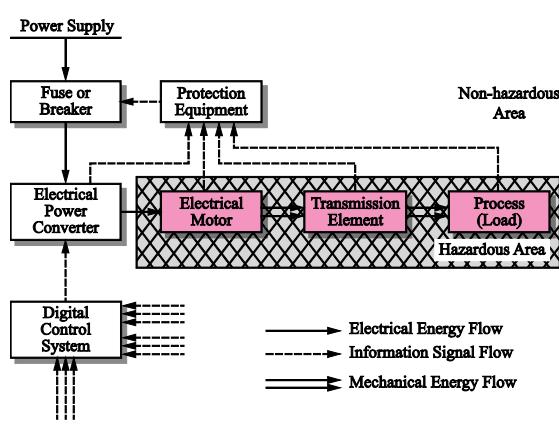
Today's plants at risk of explosive atmospheres are equipped with a large number of electric motor drives (EMD). Use of such drives in explosive atmospheres increases the risk of occurrence of ignition sources (e.g. overheating). A typical structure of EMD in the area at risk of explosive atmosphere is shown in Fig. 1 [1].

Figure 1 EMD in a hazardous area

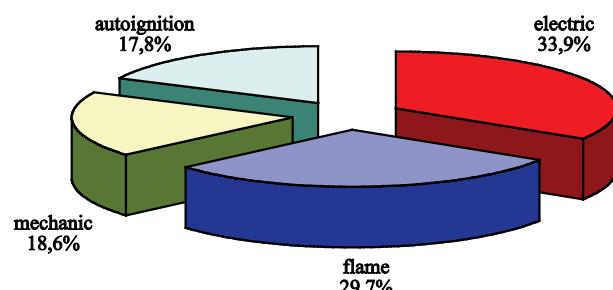
This paper considers the induction motor as a central part of an EMD in a hazardous area and as one of the most important potential sources of ignition. Fig. 2 shows the contribution of different sources of ignition in U.K. on-shore non-process areas [2].

Figure 2 Contribution of different sources of ignition in plants

Fig. 2 shows clear evidence that electrical sources are the most frequent independent sources of ignition, and the induction motor is one of them. Fig. 3 shows contribution of specific faults in induction motors [3]. Rotor and stator winding faults are declared as frequent faults (around 45 % of the total number of faults in induction motors) [4, 5].

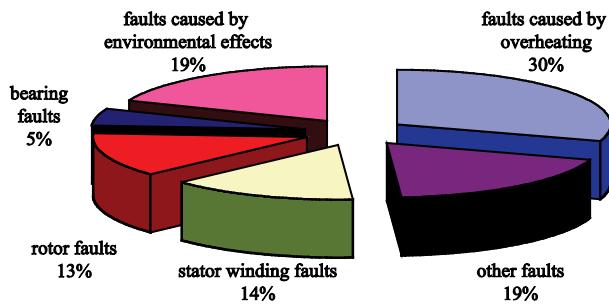
Figure 3 Contribution of specific faults in induction motors

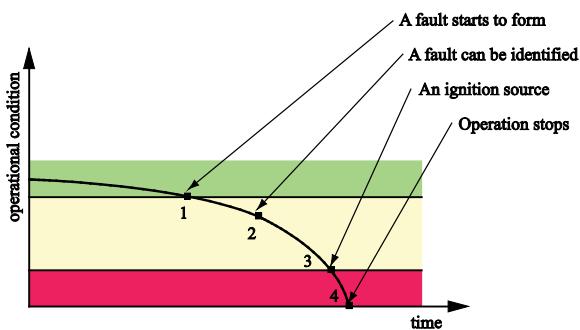
The central part of this work is the research into the possibility of the generation of effective ignition sources in the form of hot surfaces due to fault conditions of the induction motor rotor. The fault condition in the rotor cage does not necessarily lead to a formation of an effective ignition source. Fig. 4 shows a typical curve of a progressive fault. It is clear from this curve that only a specific level of fault leads to an effective ignition source.

Figure 4 A curve of a progressive fault

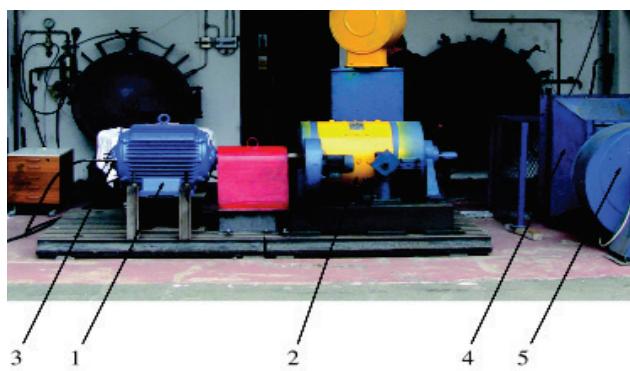
Figure 5 A system for thermal testing of the induction motor: 1 - motor tested, 2 - loading machine of the motor, 3 - test mixture inlet (not relevant for thermal testing), 4 - electrical load of the loading machine (heaters) and 5 - cooling fans for the heaters.

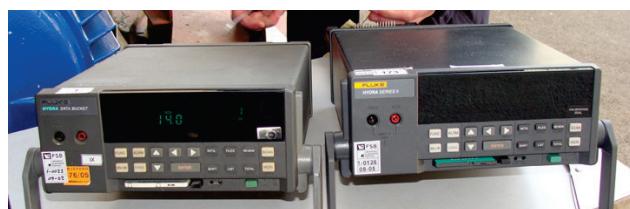
The test equipment used for the thermal measurements on the motor (FLUKE Hydra Data Bucket and Hydra Series II) is shown in Fig. 6, while Fig. 7 shows positions of thermal sensors (T - Cu / Cu - Ni) for rotor thermal testing. Motor load current was measured by FLUKE True RMS Clamp Meter 337. The voltage at the motor terminals was measured by multimeter FLUKE True Multimeter 189. Ambient temperature was measured by RotronicHygrolog device.

Figure 6 Test equipment for the thermal measurements of the motor

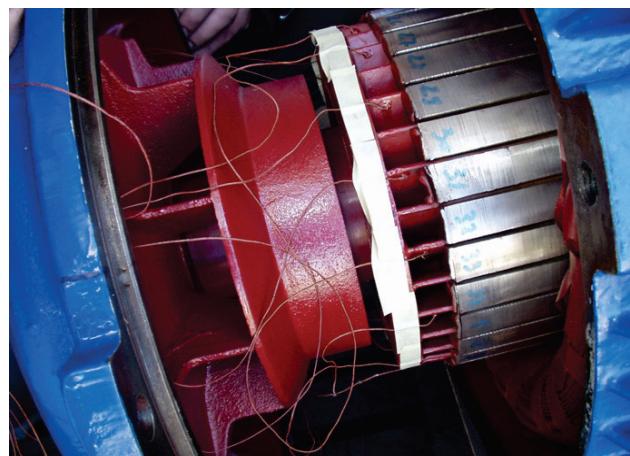
Figure 7 Positions of thermal sensors for thermal testing of the rotor

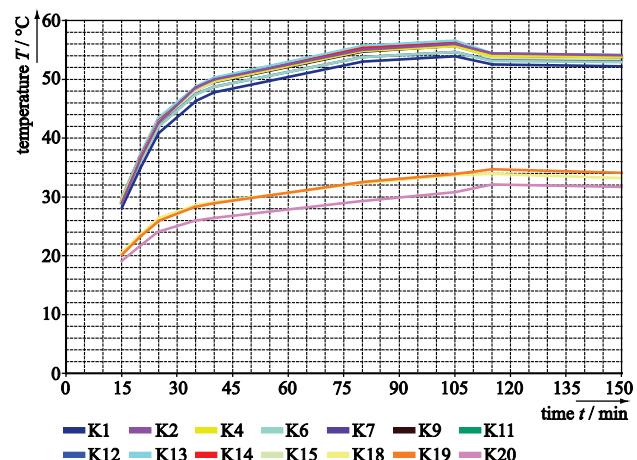
The results of thermal tests completed on the motor with no damage are shown in Fig. 8.

Figure 8 Heating effect on a motor with no damage

The temperature was measured on the rotor cage bars and the stator winding. Measuring channel marks (K) of test equipment correspond to measurements on the following spots: K1 - bar 1, K2 - bar 3, K4 - bar 7, K6 - bar 11, K7 - bar 13, K9 - bar 17, K11 - bar 21, K12 - bar 23, K13 - bar 25, K14 - bar 27, K15 - bar 29, K18 - stator winding, K19 - stator winding and K20 - stator winding.

Thermal tests of rotor cage bars with no damage and thermal tests on the stator winding were conducted with the rotor at reduced voltage and stalled. In order to speed up the heating process, testing was initiated with the voltage reduced to 45,0 V and current of 54,4 A, which were subsequently decreased to 21,6 V and 25,6 A, causing the temperature curve to slow its increase (the final rate of temperature change less than 0,5 °C / hour). Ambient temperature during the measurement was between 13,6 °C and 17 °C.

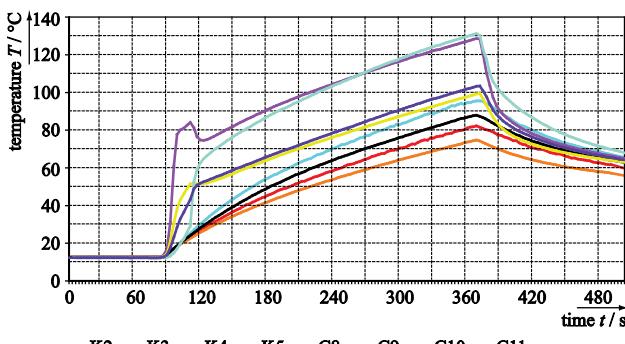
Thermal tests on the bars of the rotor cage with level I damage and the stator winding with no damage were conducted with the rotor stalled. The first test was performed at the voltage reduced to 119,0 V and current of 140 A. The second test was done at 200,0 V and 250 A. Ambient temperature during the measurement was 6,0 °C. Results of thermal tests completed on the motor with level I damage using the current of 140 A are shown in Fig. 9, while the results with 250 A are shown in Fig. 10.

The temperature was measured on rotor cage bars. Measuring channel marks (K) of test instrument 1 and marks (C) of test instrument 2 correspond to measurements on the following spots: K2 - bar 7(C), K3 - bar 7(B), K4 - bar 8(C), K5 - bar 8(B), C8 - bar 13(A), C9 - bar 23(A), C10 - bar 6(A) and C11 - bar 1(A).

Figure 9 Heating effect on the motor with level I damage and 140 A

Temperature sensors (thermal couples) on rotor bars, marked with an (A) following the number, were positioned at the part of the bar inside the rotor package (at the edge of the package close to a non-drive end). Thermal couples on rotor bars, marked with a (B)

following the number, were positioned at the part of the damaged bar in the vicinity of the rotor package. Thermal couples on rotor bars, marked with a (C) following the number, were positioned at the part of the damaged bar in the vicinity of the rotor ring close to the non-drive end.

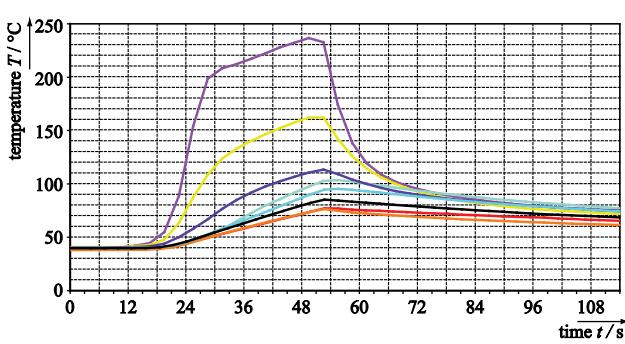
Figure 10 Heating effect on the motor with level I damage and 250 A

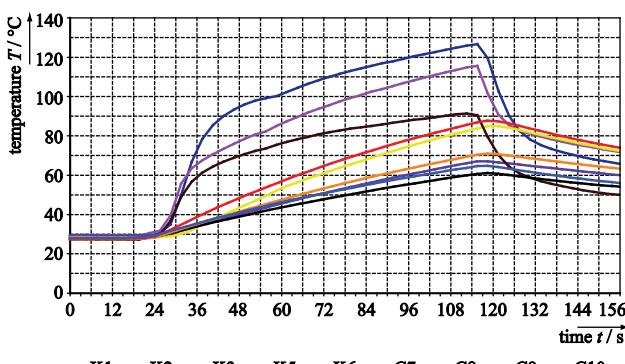
Thermal tests on the bars of the rotor cage with level II damage and stator winding with no damage have been conducted with the rotor stalled. The first test was performed at the voltage reduced to 117,0 V and the current of 140 A. The second test was done at 200,0 V and 250 A. Ambient temperature during the measurement was 11,0 °C. Results of the thermal tests completed on the motor with level II damage using the current of 140 A are shown in Fig. 11, while the results at 250 A are shown in Fig. 12.

Figure 11 Heating effect on the motor with level II damage and 140 A

The temperature was measured on the rotor cage bars and the ring close to the non-drive end. Measuring channel marks (K) of test instrument 1 and marks (C) of test instrument 2 correspond to the measurements on the

following spots: K1 - bar 7(C), K2 - bar 6(C), K3 - bar 10(C), K5 - bar 1(A), K6 - bar 6(B), C7 - bar 23(A), C8 - bar 13(A), C9 - ring in the vicinity of bar 7 and C10 - ring in the vicinity of bar 23.

Thermal sensors (thermal couples) on rotor bars, marked with an (A), were positioned at the part of the bar in the vicinity of the ring close to the non-drive end. Thermal couples on the rotor, marked with a (B), were positioned at the part of the damaged bar in the vicinity of the rotor package, and those marked with a (C) were positioned at the part of the damaged bar in the vicinity of the ring close to the non-drive end.

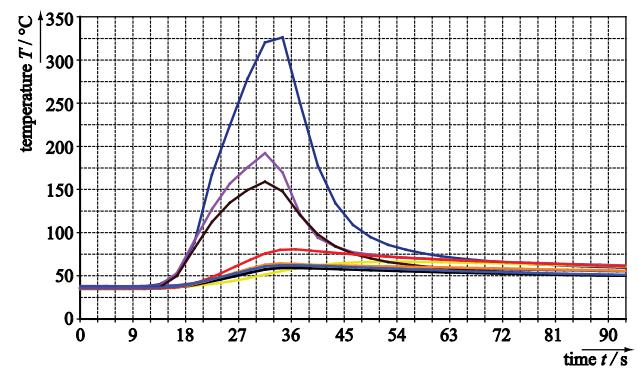
Figure 12 Heating effect on the motor with level II damage and 250 A.

Bar No. 7 reached the maximum temperature at level II damage, which was 338,2 °C. The temperature was not recorded by a multichannel instrument due to the limited sampling frequency (here a maximum temperature of 325,9 °C was recorded). The temperature of 338,2 °C was observed by the IR camera with continuous monitoring and recording. Maximum temperature at the location of the damage was measured after time t_E passed, which is 8,1 s for motor used in research and for T3 temperature class.
