## USE OF SEM AND EDS ANALYSIS IN THE INVESTIGATION OF Al-Si-Cu PISTON ALLOY CAST POROSITY

*Key words:* casting, porosity, piston, SEM, EDS

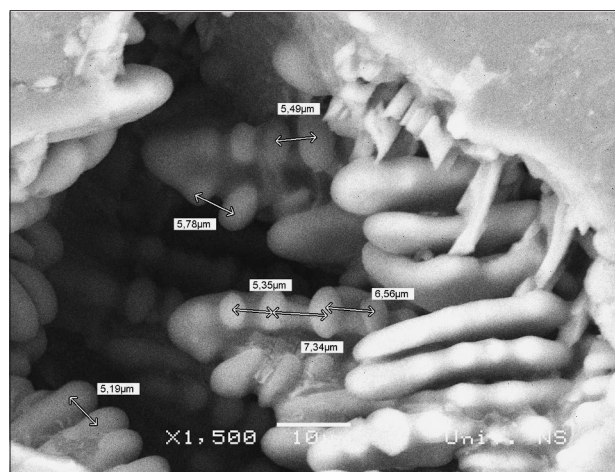
Secondary electron image of type B porosity is shown in Figure 7. Although found in proximity of A type porosity its morphology indicates different formation mechanism. Pores inner surface is clearly dendritic. Oxide bifilm is not visible and entrainment process is therefore not probable cause. The pore is most likely formed due to solidification shrinkage.

Figure 7. Secondary electron image of the type B porosity
