# Arhitektura i arhitektonska plastika burga Vrbovca kraj Huma na Sutli

## Architecture and Architectural Stonework of the Mediaeval Castle of Vrbovec near Hum na Sutli

Izvorni znanstveni rad  
Srednjovjekovna arheologija

Original scientific paper  
Medieval archaeology

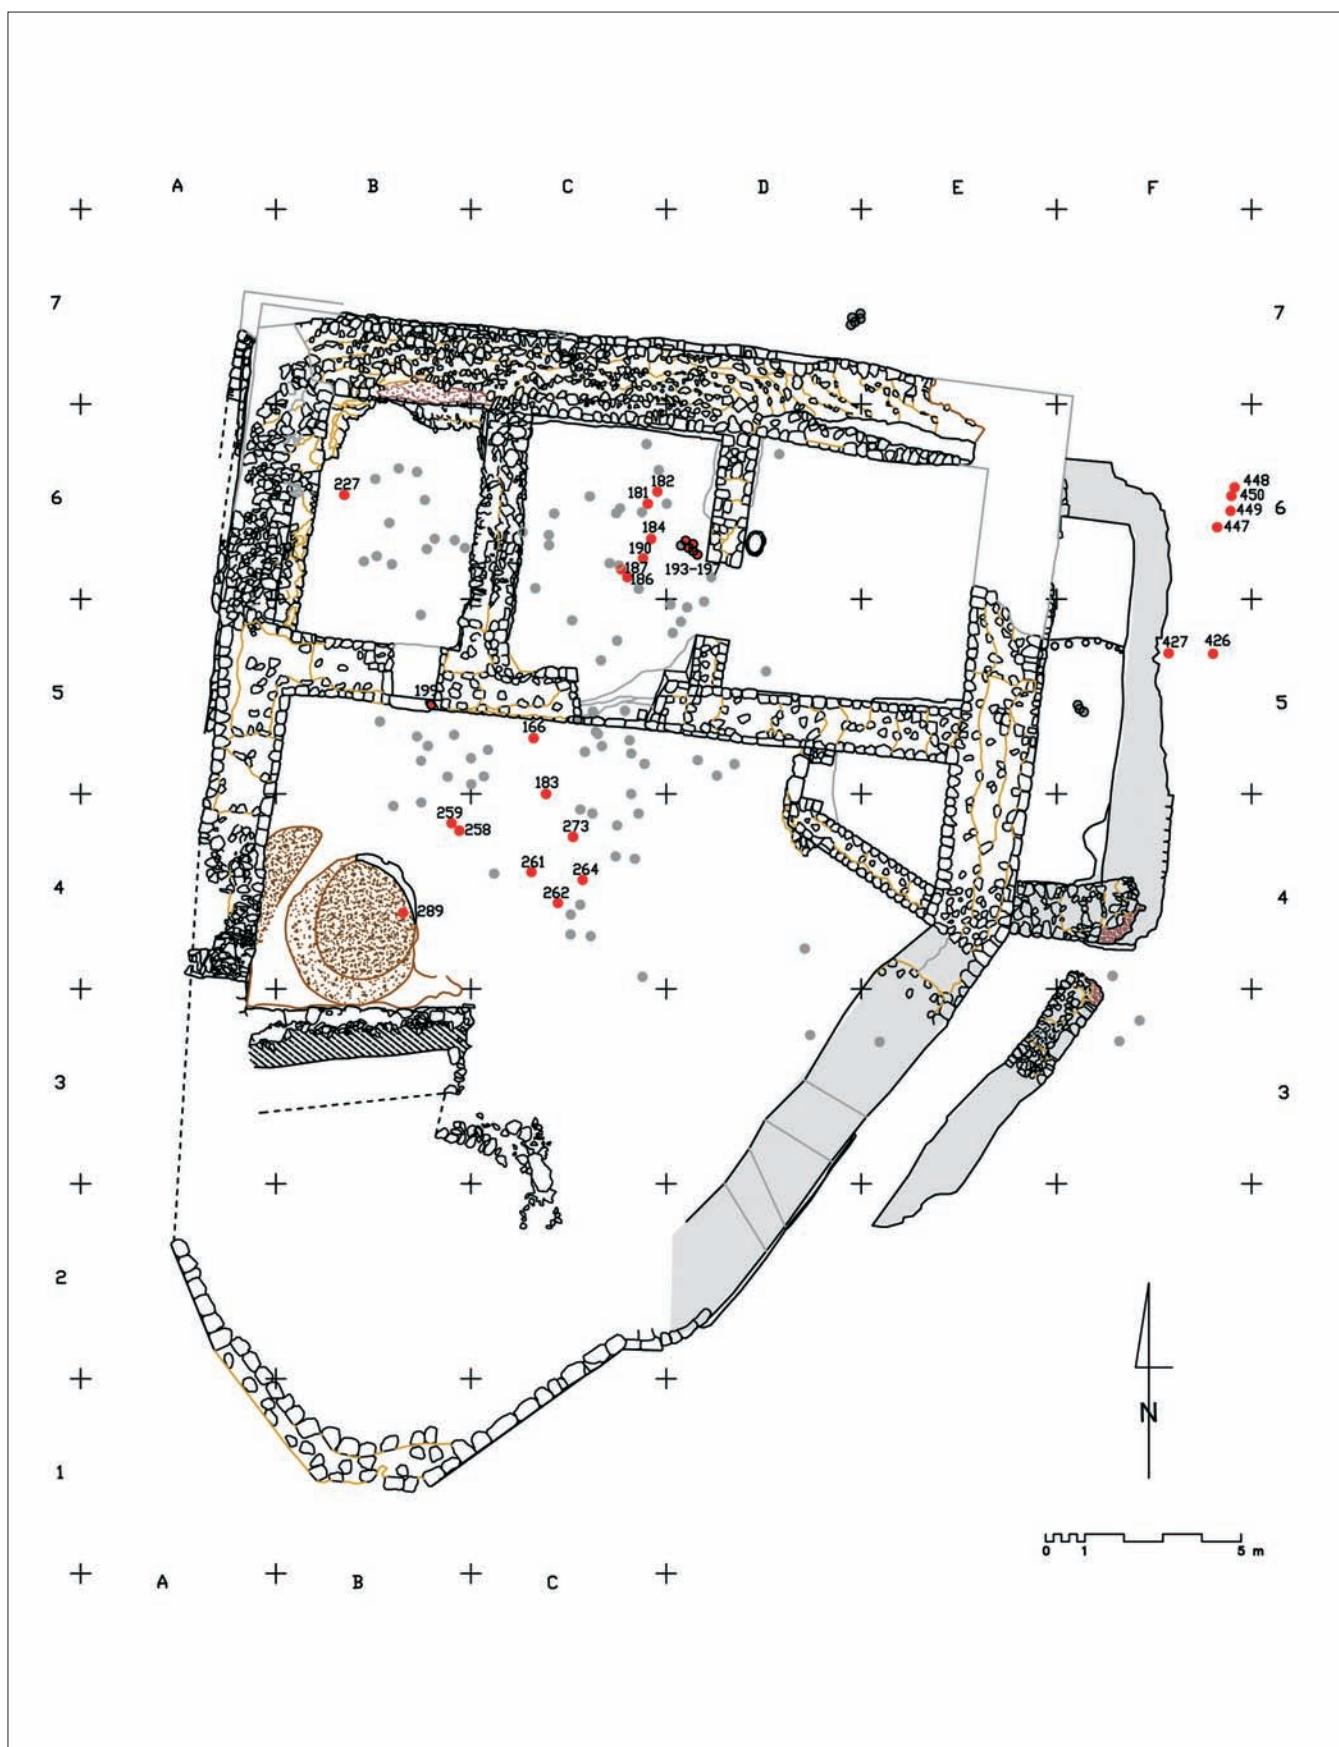
Plan 1 Burg Vrbovec, Klenovec Humski, situacijski plan 2008. g. (crtež: M. Vojtić i K. Vujica; dorada i snimak arhitektonske plastike: T. Tkalčec)

Plan 1 Castle of Vrbovec, Klenovec Humski, situation plan in 2008 (drawing: M. Vojtić and K. Vujica; finishing and positioning of architectural stonework: T. Tkalčec)

U ukupnim dosadašnjim arheološkim istraživanjima definiran je tlocrt obodnog zida burga i istraženi su u cjelini ostaci i prostori prizemlja sjevernog dijela kompleksa (plan 1). Burg je poligonalnoga tlocrta, vanjskih dimenzija 21 m (istok-zapad) x 29,8 m (sjever-jug). Sastoji se od palasa na sjeveru (u prizmlju troprostorno podijeljenog), braničkule na jugu, tj. jugozapadu, cisterne u jugozapadnom dijelu dvorišta uz kulu te manje istočne prostorije nepravilnoga tlocrta (Tomićić et al. 2003a, 172, slika; Tomićić et al. 2003b, 135, sl. 1; Tomićić, Tkalcèc 2005, 69, sl. 2). Ulaz je (u nekoj graditeljskoj fazi burga) mogao biti na istočnoj strani, oko sredine istočnoga obrambenog zida. Na tome su prostoru pronađeni elementi (sjevernije pozicionirani tragovi drvenih stupova te zidovi izvan gabarita jezgre burga) koji bi se mogli tumačiti sustavom obrane ulaza (Tkalcèc 2009, sl. 1). Jedan burg je tijekom vremena svoje egzistencije mo-

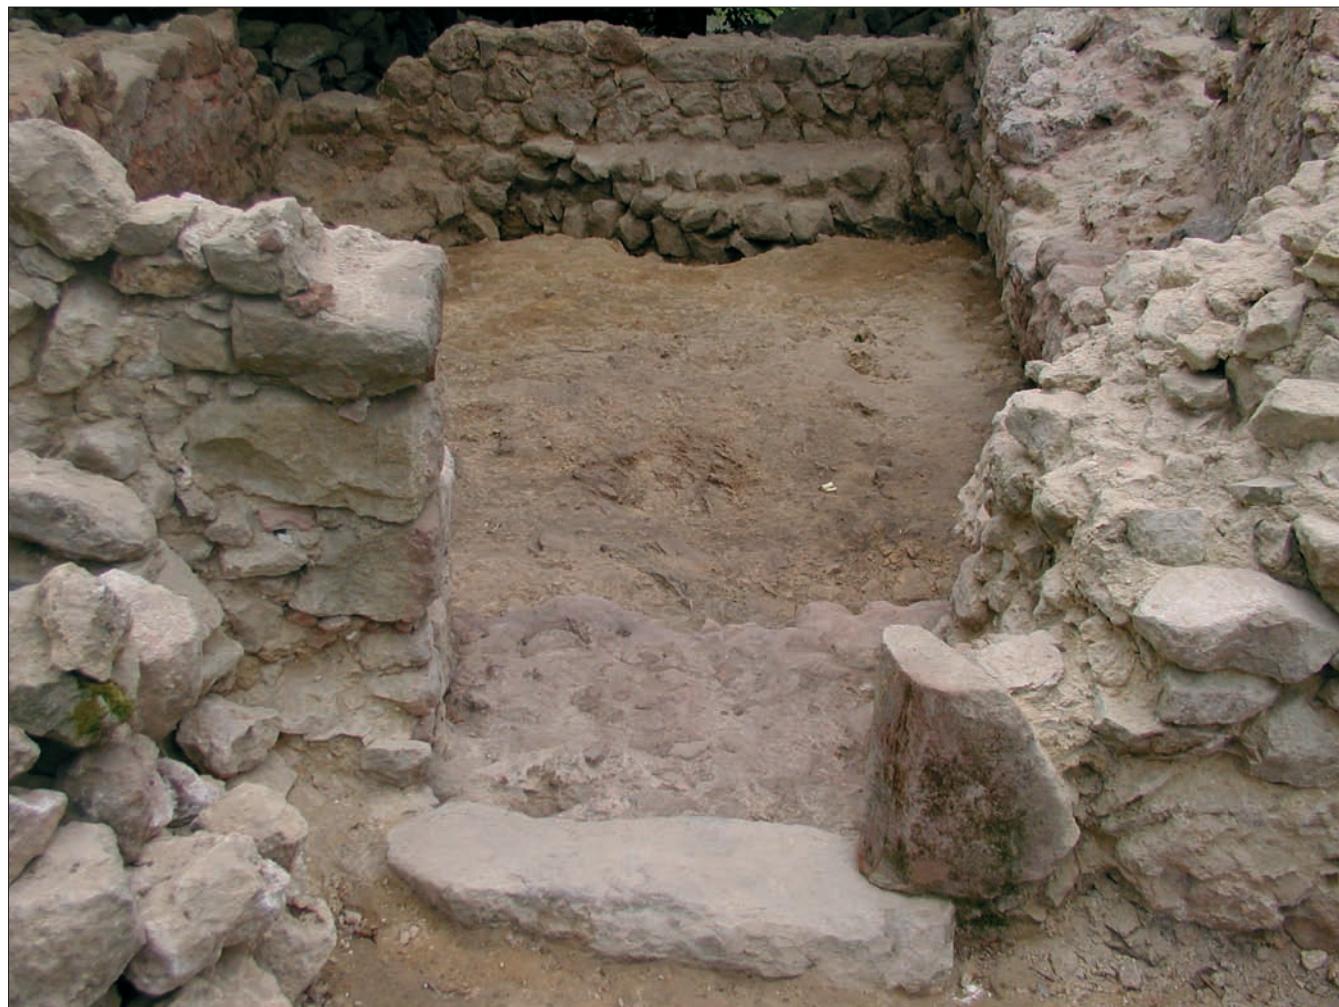
Sl. 1 Burg Vrbovec, pogled s juga na ulaz u kuhinju i dovratnik PN 199 tijekom arheoloških istraživanja 2003. g. (foto: M. Dizdar)  
Fig. 1 The castle of Vrbovec, a view from the south to the kitchen entrance and door jamb SF 199 during archaeological investigations in 2003 (photo: M. Dizdar)

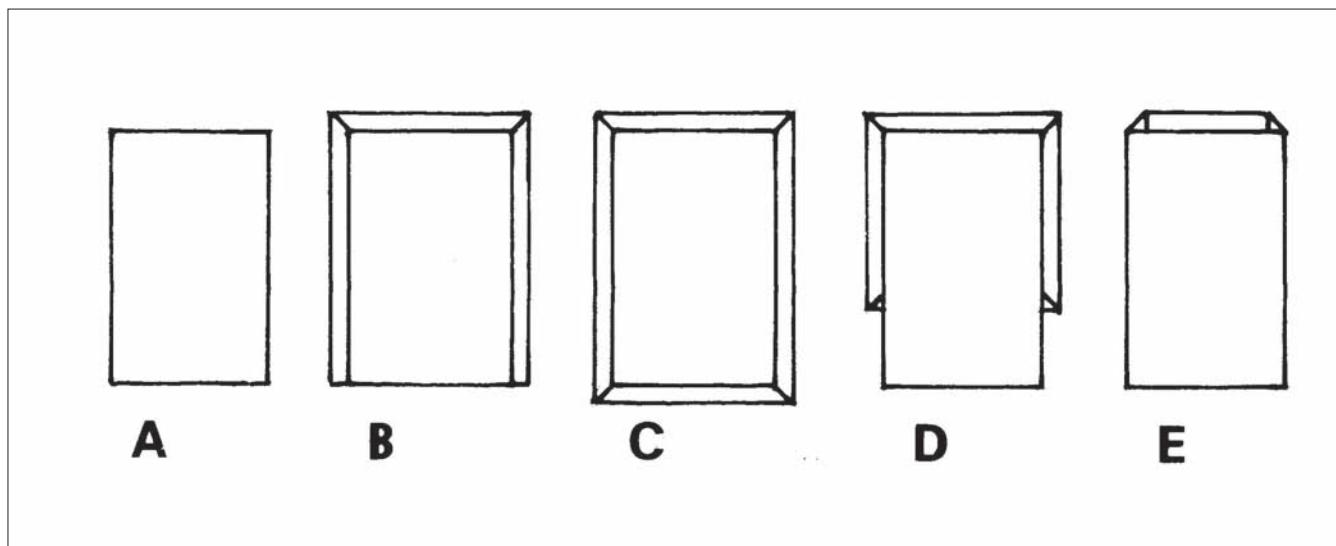
Sl. 2 Uobičajeno oblikovanje kamena doprozornika s ukošenim rubom (crtež: Z. Horvat)  
Fig. 2 The usual form of a stone window jamb with a beveled edge (drawing: Z. Horvat)

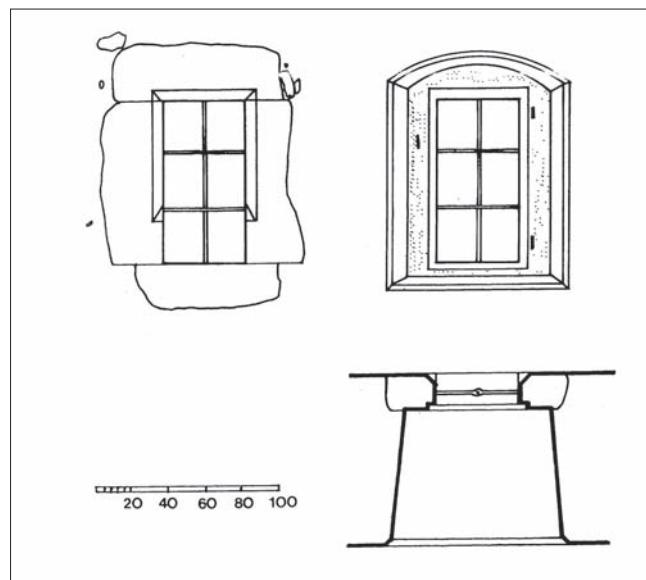
Sl. 3 Ozalj, burg i palas Nikole Zrinskog, prozor u zapadnom zidu prizemlja (pogled izvana, iznutra i tlocrt) (crtež: Z. Horvat)

Fig. 3 Ozalj, the castle and the palace of Nikola Zrinski, a window in the western wall of the ground-floor (a view from the outside, inside and a ground-plan) (drawing: Z. Horvat)

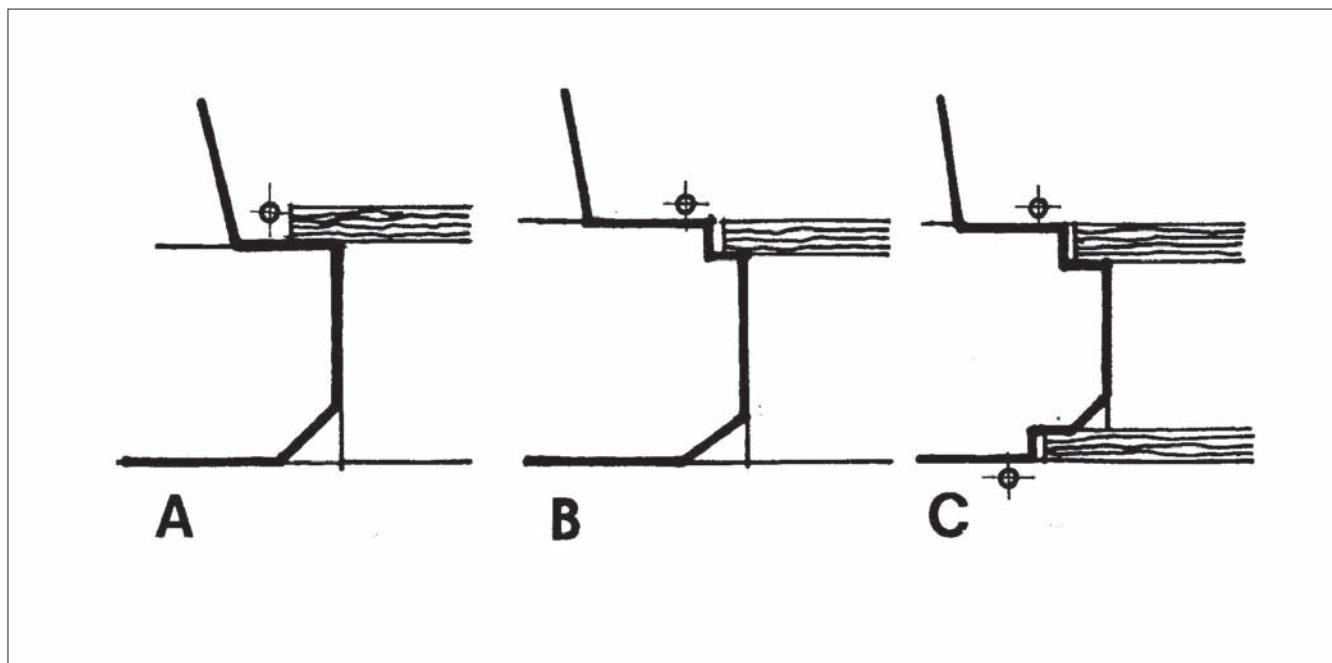
Sl. 4 Uobičajeni načini izvođenja utora za krilo na doprozornicima (A-bez utora, B-s jednim utorom; unutrašnja strana, C-s dva utora; vanjska strana (donji utor je za drveni kapak) (crtež: Z. Horvat)

Fig. 4 The usual forms of casement grooves on window jambs (A-without a groove, B-with one groove; interior, C-with two grooves; exterior (the lower groove is for a wooden casement) (drawing: Z. Horvat)

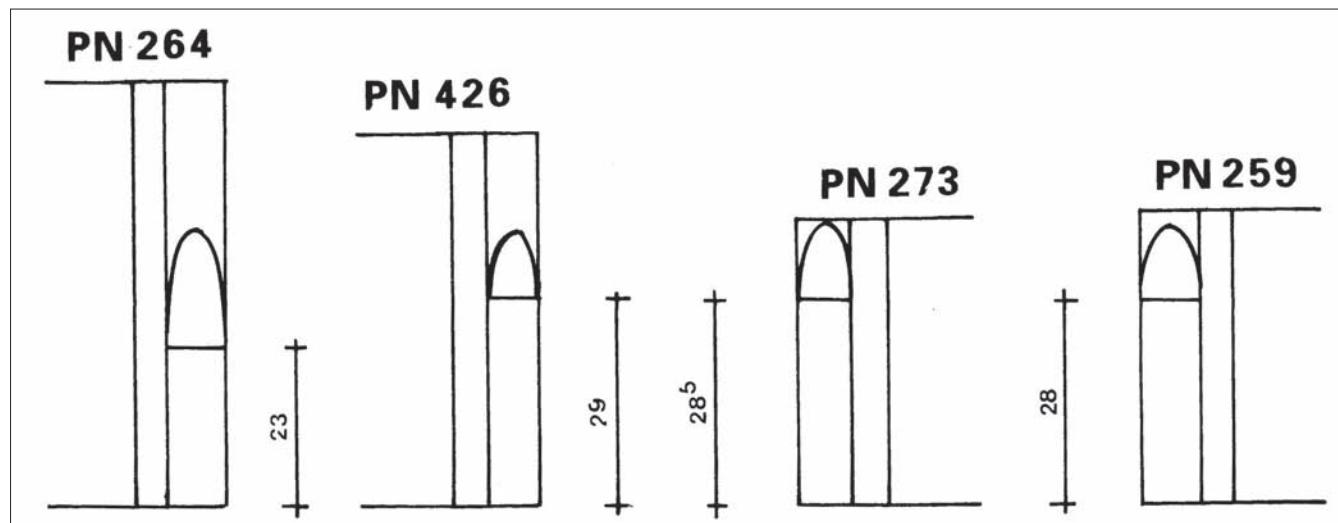
Sl. 5 Usporedni prikaz baza profilacija prozora srednje veličine (crtež: Z. Horvat)  
Fig. 5 A comparison of moulding bases of medium-sized windows (drawing: Z. Horvat)

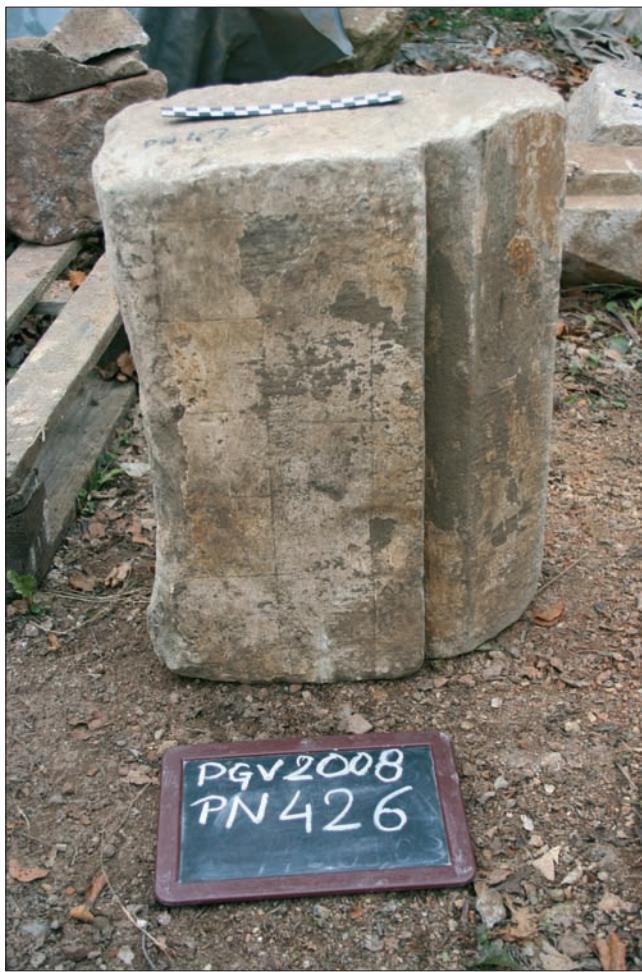
Sl. 6 Burg Vrbovec, PN 426 – lijeva baza profilacije prozora srednje veličine s ostacima žutog i oker bojanja kvadratičnih polja (foto: T. Tkalčec)

Fig. 6 The castle of Vrbovec, SF 426 – left base of the moulding of a medium-sized window with the remains of yellow and ochre painting of square fields (photo: T. Tkalčec)

Uломci PN 264 i PN 426 odgovaraju lijevoj (gleda li se prozor izvana) bazi profilacije doprozornika (T. 2:1–2). Osim toga, baza im nije iste visine, dakle, radi se o dva različita prozora, o čemu svjedoči i mjesto njihova nalaza – PN 264 je

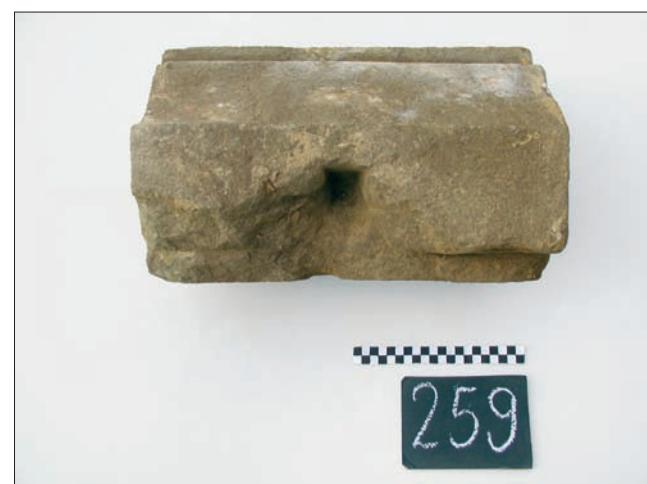
Sl. 7 Burg Vrbovec, PN 259 – desna baza profilacije prozora s tragovima naknadnoga nasilnog oštećenja utora za ugrađivanje željezne rešetke (foto: T. Tkalčec)

Fig. 7 The castle of Vrbovec, SF 259 – the right base of a window moulding with traces of subsequent violent damage of the groove for the iron railing (photo: T. Tkalčec)

mjeraka obrađenog kama (plan 1). Klesani detalji izrađeni su iz mekog pješčenjaka koji je vrlo pogodan za obradu. Pojedini klesanci pronađeni su *in situ* usitnjeni u više dijelova. Vjerojatno je velikim dijelom do takvih oštećenja došlo zbog stradavanja u požaru, tj. uslijed visoke temperature koja je razorno djelovala čak sve do jezgre pješčenjaka, u kombinaciji s padom i urušavanjem te stoljetnoj izloženosti vlazi unutar zemlje i ruševine kojom su bili prekriveni. Pojedini su se, pak, klesanci već kod samoga urušavanja razdvojili te im dijelove ne nalazimo jedno pored drugoga već u krugu od nekoliko metara. Valja računati da je velik dio materijala pri padu otklizao niz strminu brijege te da u arheološkim istraživanjima nije ni pronađen. Također, jasno je kako su srednjovjekovni burgovi nakon svoje propasti tijekom kasnijih stoljeća predstavljali svojevrsne kamenolome okolnogme stanovništva. Stoga možemo pretpostaviti da je dio materijala i namjerno otpremljen i iskoristi u gradnji seoskih kuća, podruma, gospodarskih objekata pa i dvoraca. O naknadnim intervencijama na lokalitetu i o korištenju, tj. recikliranju građe sa srednjovjekovnog burga svjedoče i tragovi nasilnog oštećivanja pojedinih klesanaca radi uzimanja željeznih rešetki (kao kod PN 259, PN 273 i PN 426).

A total of 127 special finds of stone have been registered in the archaeological investigations. A smaller part were distinguished as dressed stone, while the majority obviously belonged to door and window frames. All the finds were mapped, and here we provide a ground plan with the position of each find, with highlighted positions of selected pieces of dressed stone that are published in the paper (Plan 1). Carved details were made of soft sandstone suitable for working. Several pieces of dressed stone were found *in situ*, broken into several fragments. Damage of this type most likely occurred due to exposure to fire, i.e. high temperature that had a devastating effect even to the sandstone core, in combination with collapse and century-long exposure to humidity within the ground and debris they were covered with. In some cases the stone split at the moment of collapse and parts thereof are found not one next to the other but within a radius of several metres. One should also reckon with the fact that a lot of material slid down the hill slope upon the collapse, and consequently was not found in the archaeological investigations. Moreover, it is clear that in the centuries following the collapse of mediaeval castles they represented stone quarries of sorts for the surrounding population. We can therefore assume that part of the material had been deliberately shipped and used in the building of village houses, cellars, economic facilities and even castles. A telltale signature of subsequent interventions on a site and of the use or recycling of the material from a mediaeval castle are traces of violent damaging of dressed stones in order to take hold of iron bars (as in the case of SF 259, SF 273 and SF426).

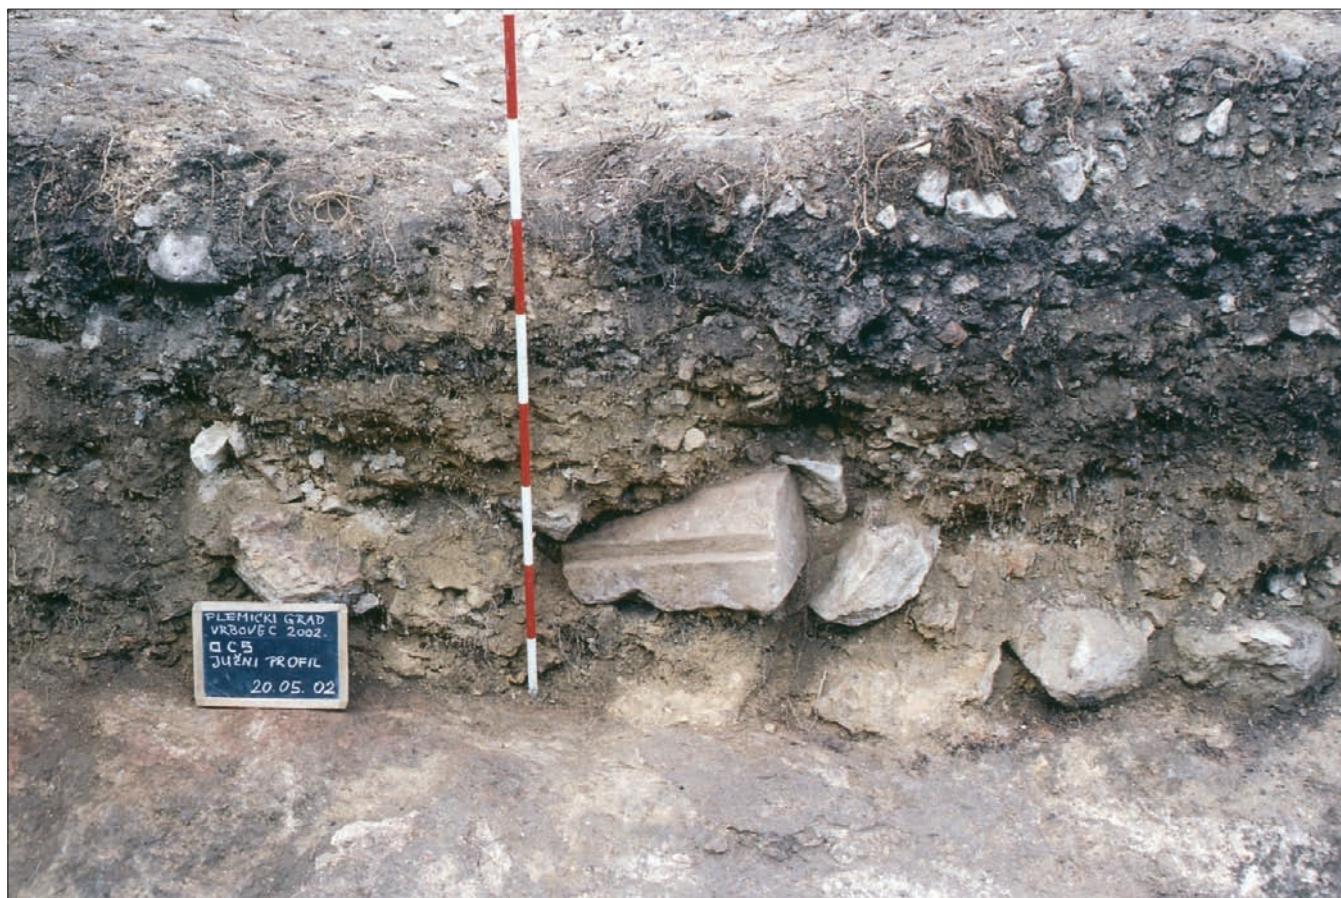
Sl. 8 Burg Vrbovec, položaj ulomka prozora srednje veličine PN 183 *in situ* u sloju ruševine SJ 003 (foto: T. Tkalčec)

Fig. 8 The castle of Vrbovec, the position of a fragment of a medium-sized window SF 183 *in situ* in the debris layer SU 003 (photo: T. Tkalčec)

Fragment SF 183, from a stone frame of a medium-sized window, formerly with a railing within the opening, may have had an outer and interior casement. A carver's mark was incised on the back surface, like on SF 184. Instead of a groo-

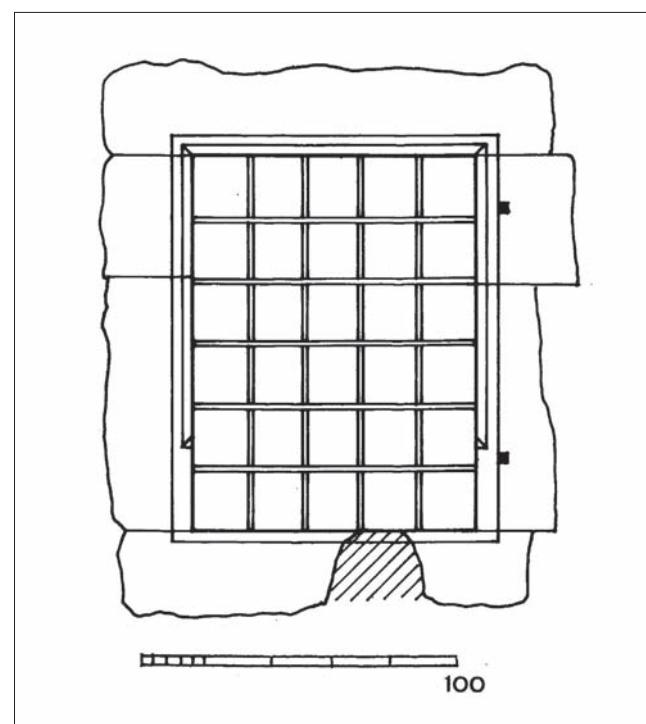
Sl. 9 Varaždin, prozor kuhinje u prizemlju Staroga grada (crtež: Z. Horvat)

Fig. 9 Varaždin, a kitchen window in the ground-floor of the Old Town (drawing: Z. Horvat)

Examples of medium-sized windows are found on the castles of Samobor, Valpovo, Ozalj, Đurđevac, Brinje, the castle in Ogulin and Old Town Varaždin (Fig. 9). Another niche was situated behind the window. It probably reached the floor, while inside the niche there may have been built-in stone benches. Windows of this type had a fairly substantial moulding, and may have been of the "Bohemian" type, with glazing bars. However, not one fragment that would corroborate this assumption has been found at that place. Besides, the "Bohemian windows" would not have had a railing

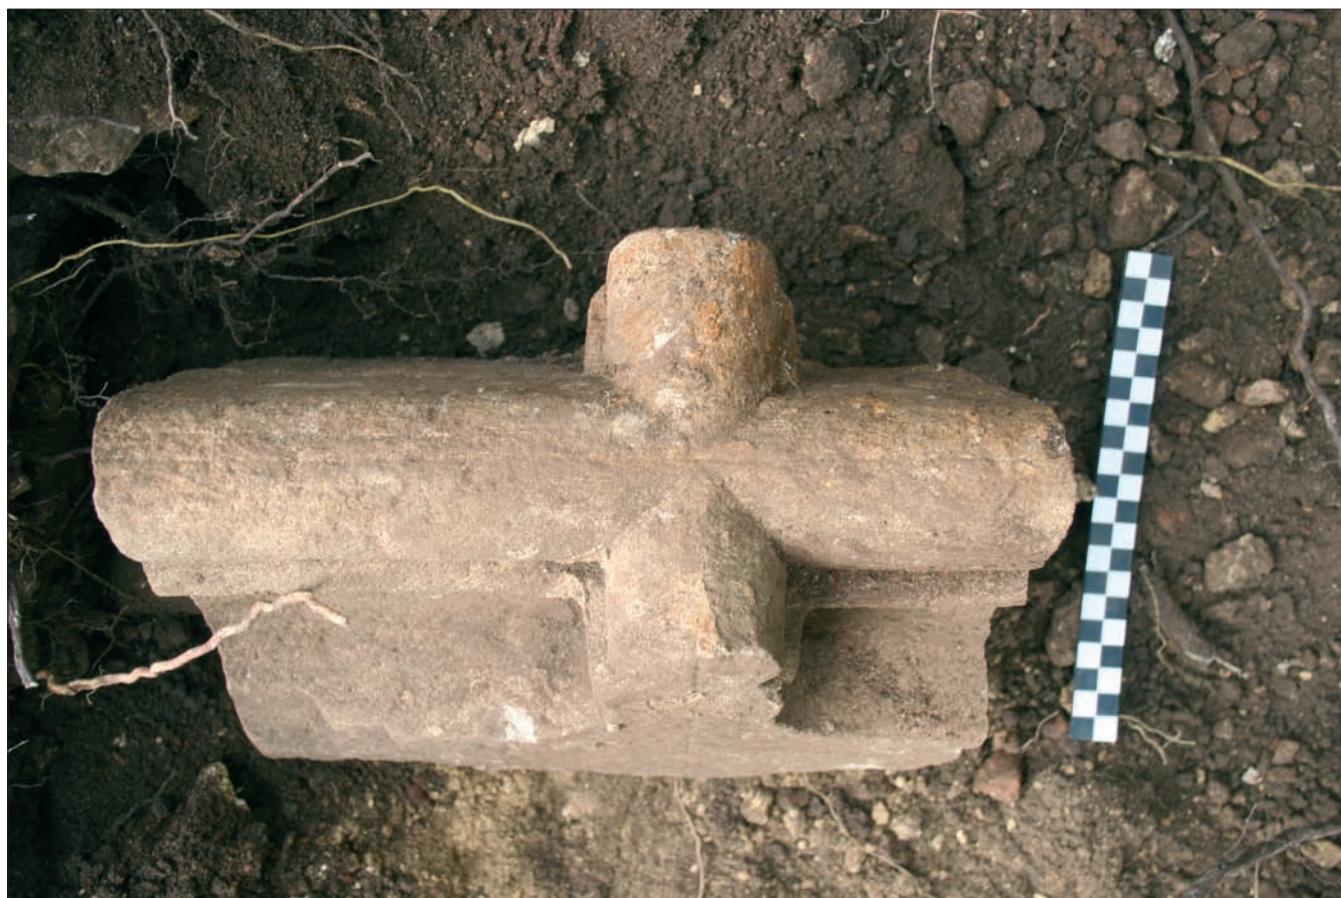
Sl. 10 Burg Vrbovec, ulomak horizontalnog šprljka "češkog prozora" PN 448 (foto: T. Tkalčec)

Fig. 10 The castle of Vrbovec, a fragment of a horizontal glazing bar of a "Bohemian window" SF 448 (photo: T. Tkalčec)

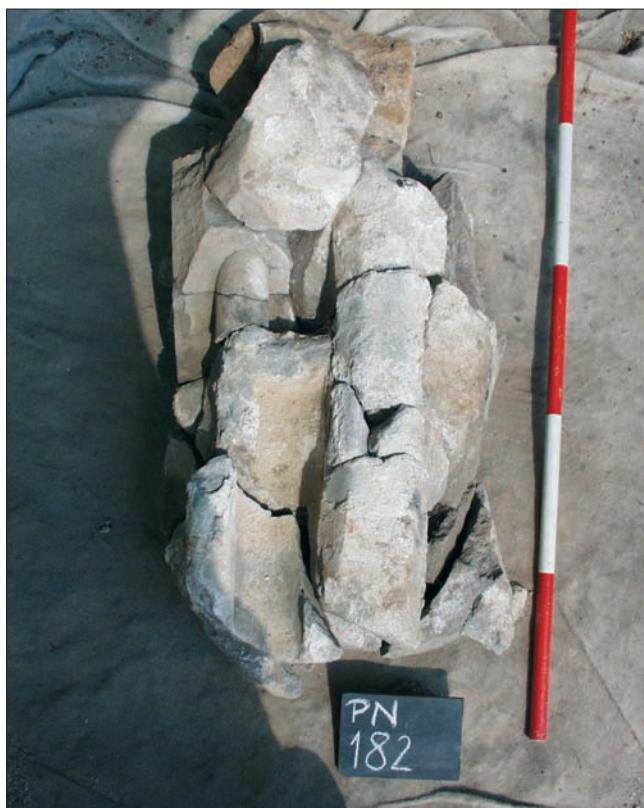
Sl. 11 Burg Vrbovec, PN 182 – "češki prozor" pronađen razmrvljen u mnoštvo ulomaka (foto: T. Tkalčec)

Fig. 11 The castle of Vrbovec, SF 182 – a "Bohemian window" preserved in a number of fragments (photo: T. Tkalčec)

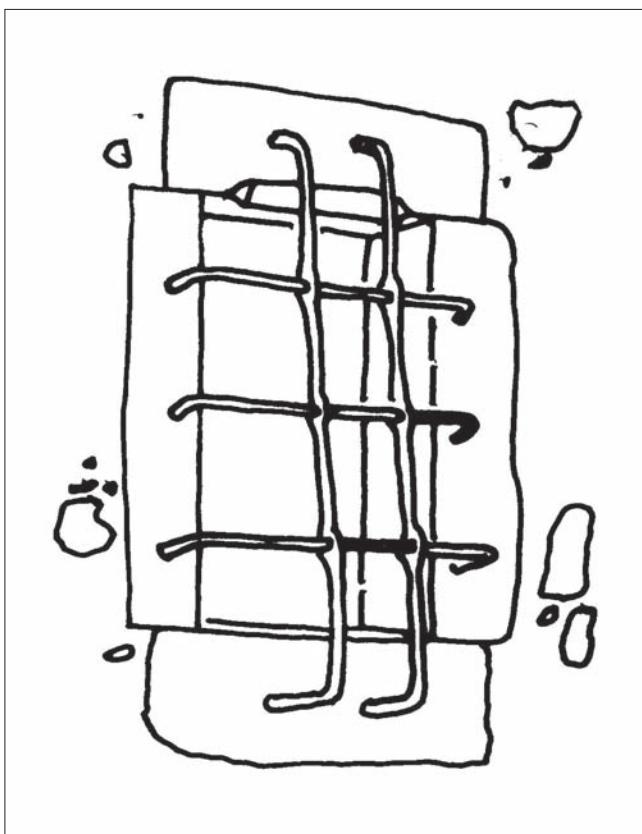
Sl. 13 Zrin, pokušaj rekonstrukcije košaraste rešetke na manjem prozoru (crtež: Z. Horvat)

Fig. 13 Zrin, a reconstruction of a basket-shaped railing on a smaller window (drawing: Z. Horvat)

<sup>14</sup> Rešetke na većim prozorima stambenih prostorija znalo se stavlјati s vanjske strane zida, tako da su stršale izvan plohe pročelja, tj. imale su košarasti oblik.

<sup>14</sup> Railings on larger windows of residential quarters were sometimes placed on the outside of the wall, so that they protruded outside the façade plane, i.e. they were basket-shaped.

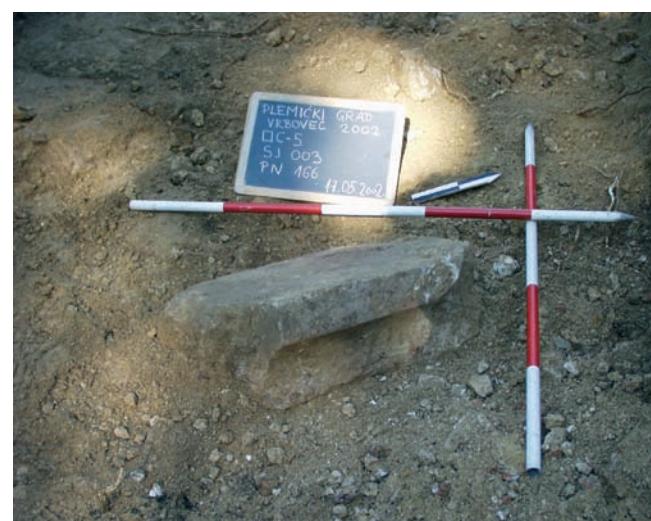
Sl. 14 Burg Vrbovec, ulomak vanjske prozorske klupčice PN 166 *in situ* (foto: T. Tkalčec)

Fig. 14 Vrbovec castle, a fragment of an exterior stone bench SF 166 *in situ* (photo: T. Tkalčec)

<sup>16</sup> The fragment of a bench could not have arrived in that place in the Modern period, because it was found in intact layer SU 003, a layer of collapse of the medieval fortified town. In the courtyard, this layer was covered with an undisturbed layer from the Modern period. This means that a contamination of that layer in the long period following the collapse of the fortified town could not have taken place.

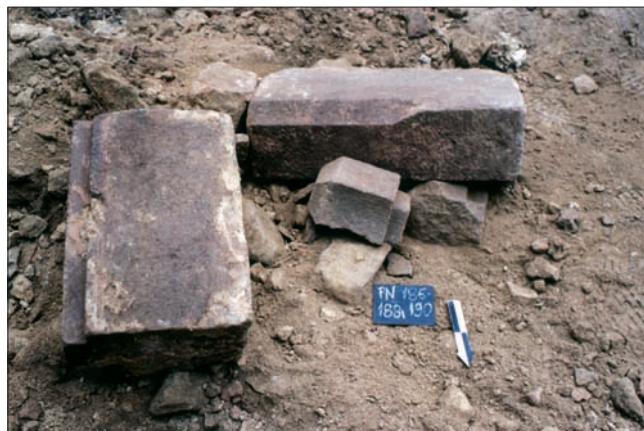
Sl. 16 Burg Vrbovec, dijelovi okvira vrata – lijevo PN 190, u sredini PN 187, gore PN 186 (foto: T. Tkalčec)

Fig. 16 Vrbovec castle, fragments of a door frame – left SF 190, centre SF 187, above SF 186 (photo: T. Tkalčec)

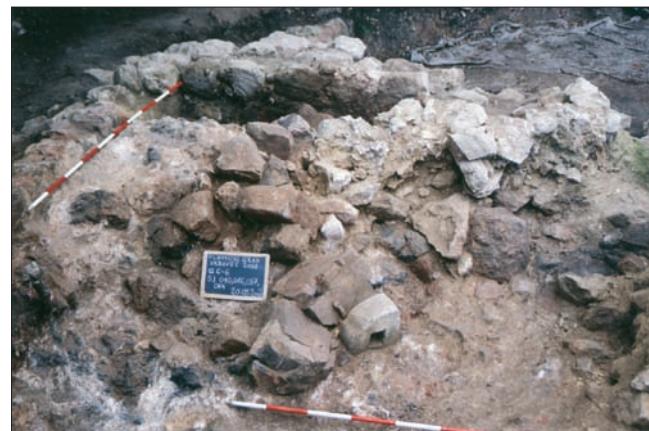
Sl. 17 Burg Vrbovec, pronalazak spolije PN 181 i neposredno do ne "češkog prozora" PN 182 (foto: T. Tkalčec)

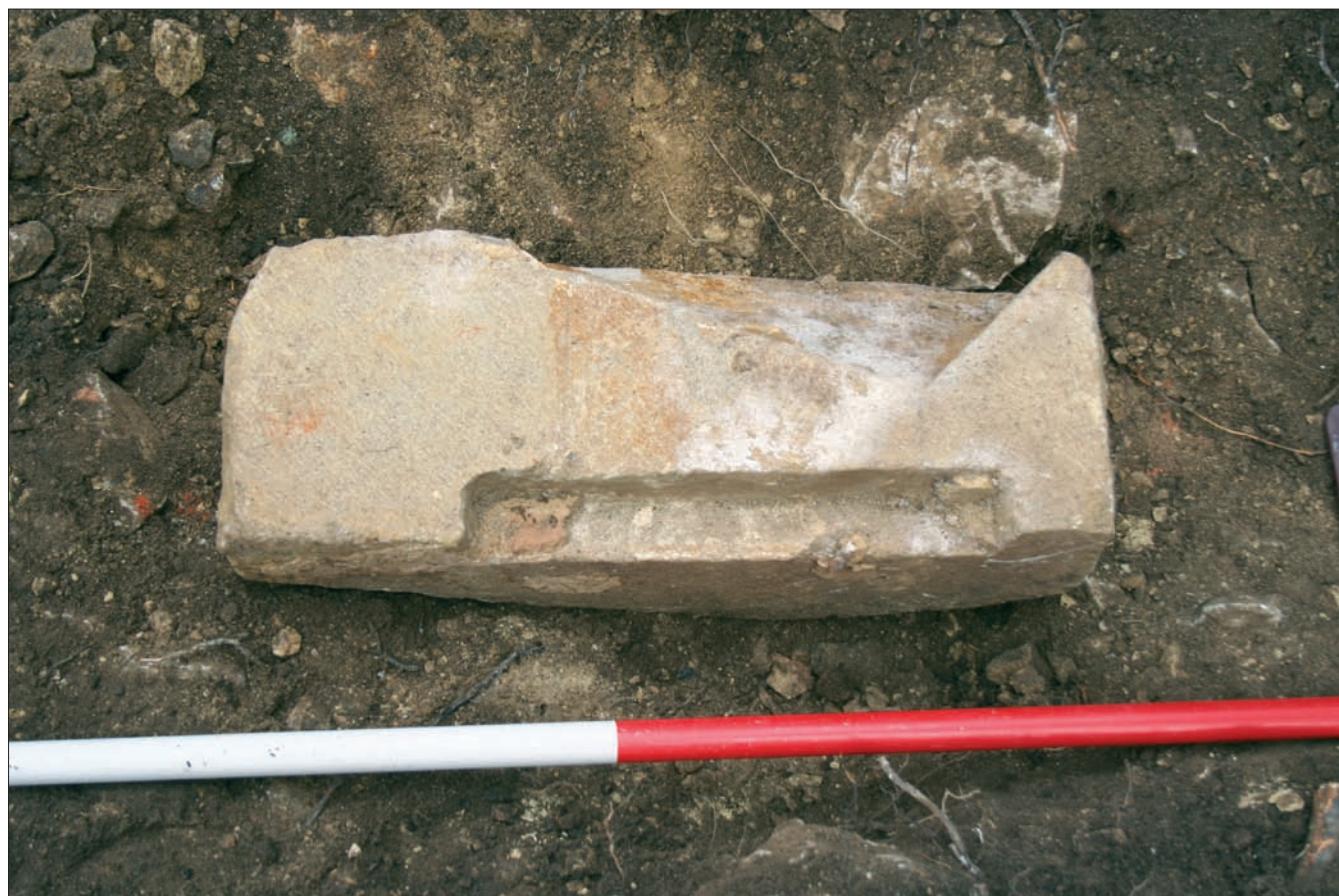
Sl. 18 Burg Vrbovec, pronalazak okvira manjeg prozora PN 447 (foto: T. Tkalčec)  
Fig. 18 Vrbovec castle, a find of a frame of a smaller window SF 447 (photo: T. Tkalčec)

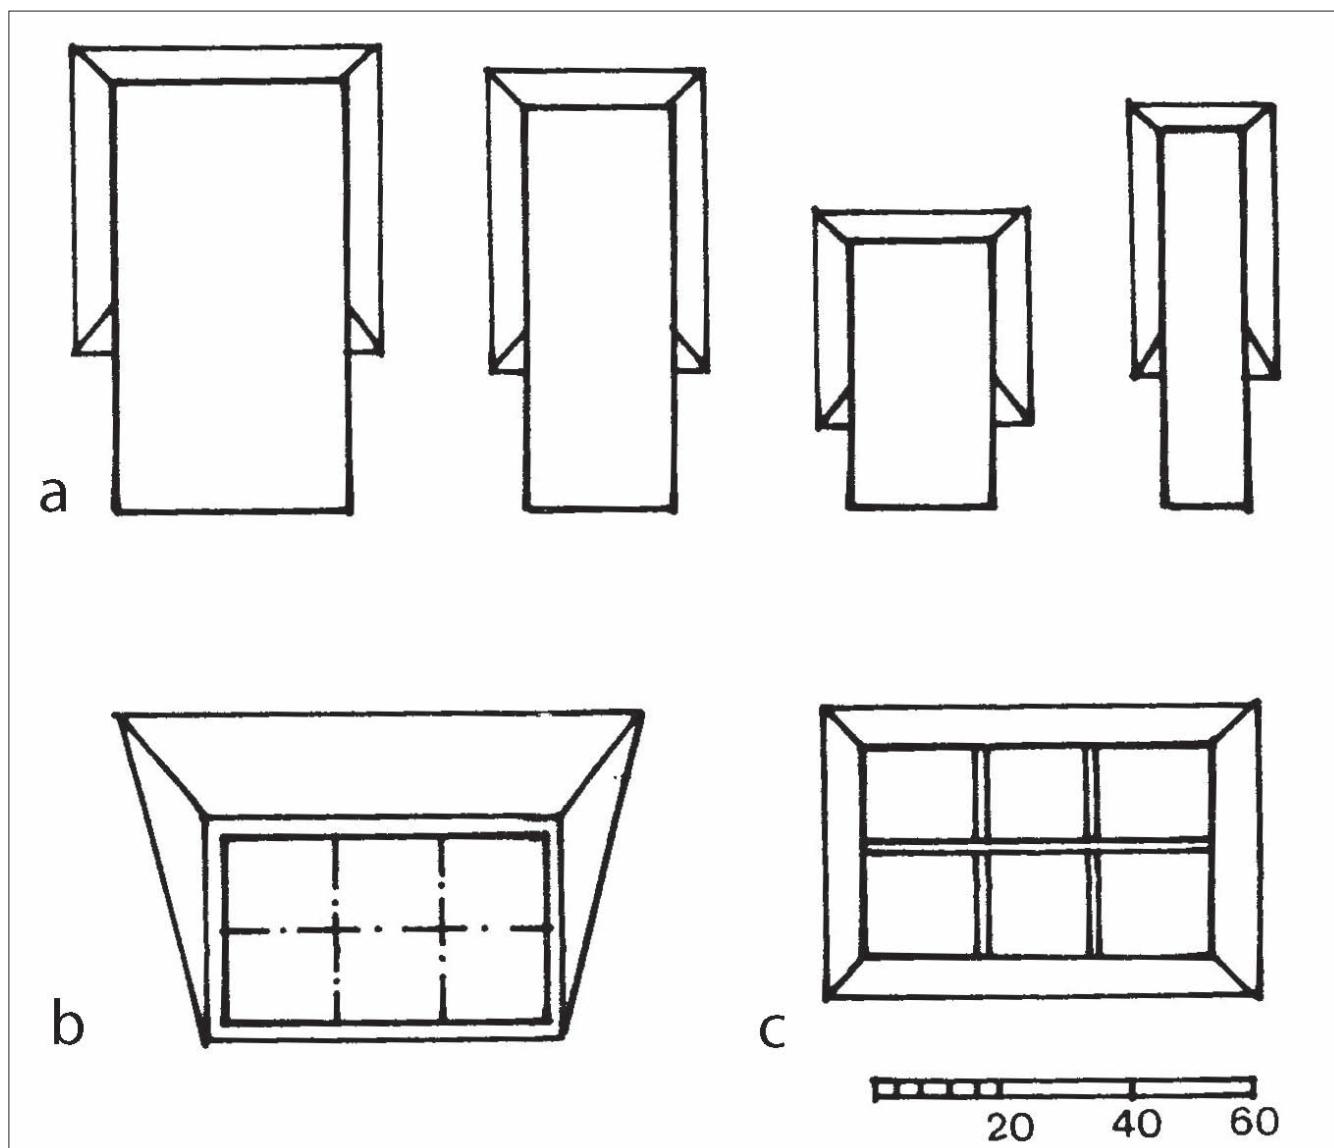
Sl. 19 Ribnik, prikaz prozora s burga: a-tipični prozori 15. st.; b-prozor podruma s ekscentričnim oblikom prema gore otvorenog okvira; c-prozor gospodarskih prostorija sa sva četiri skošena ruba (crtež: Z. Horvat)

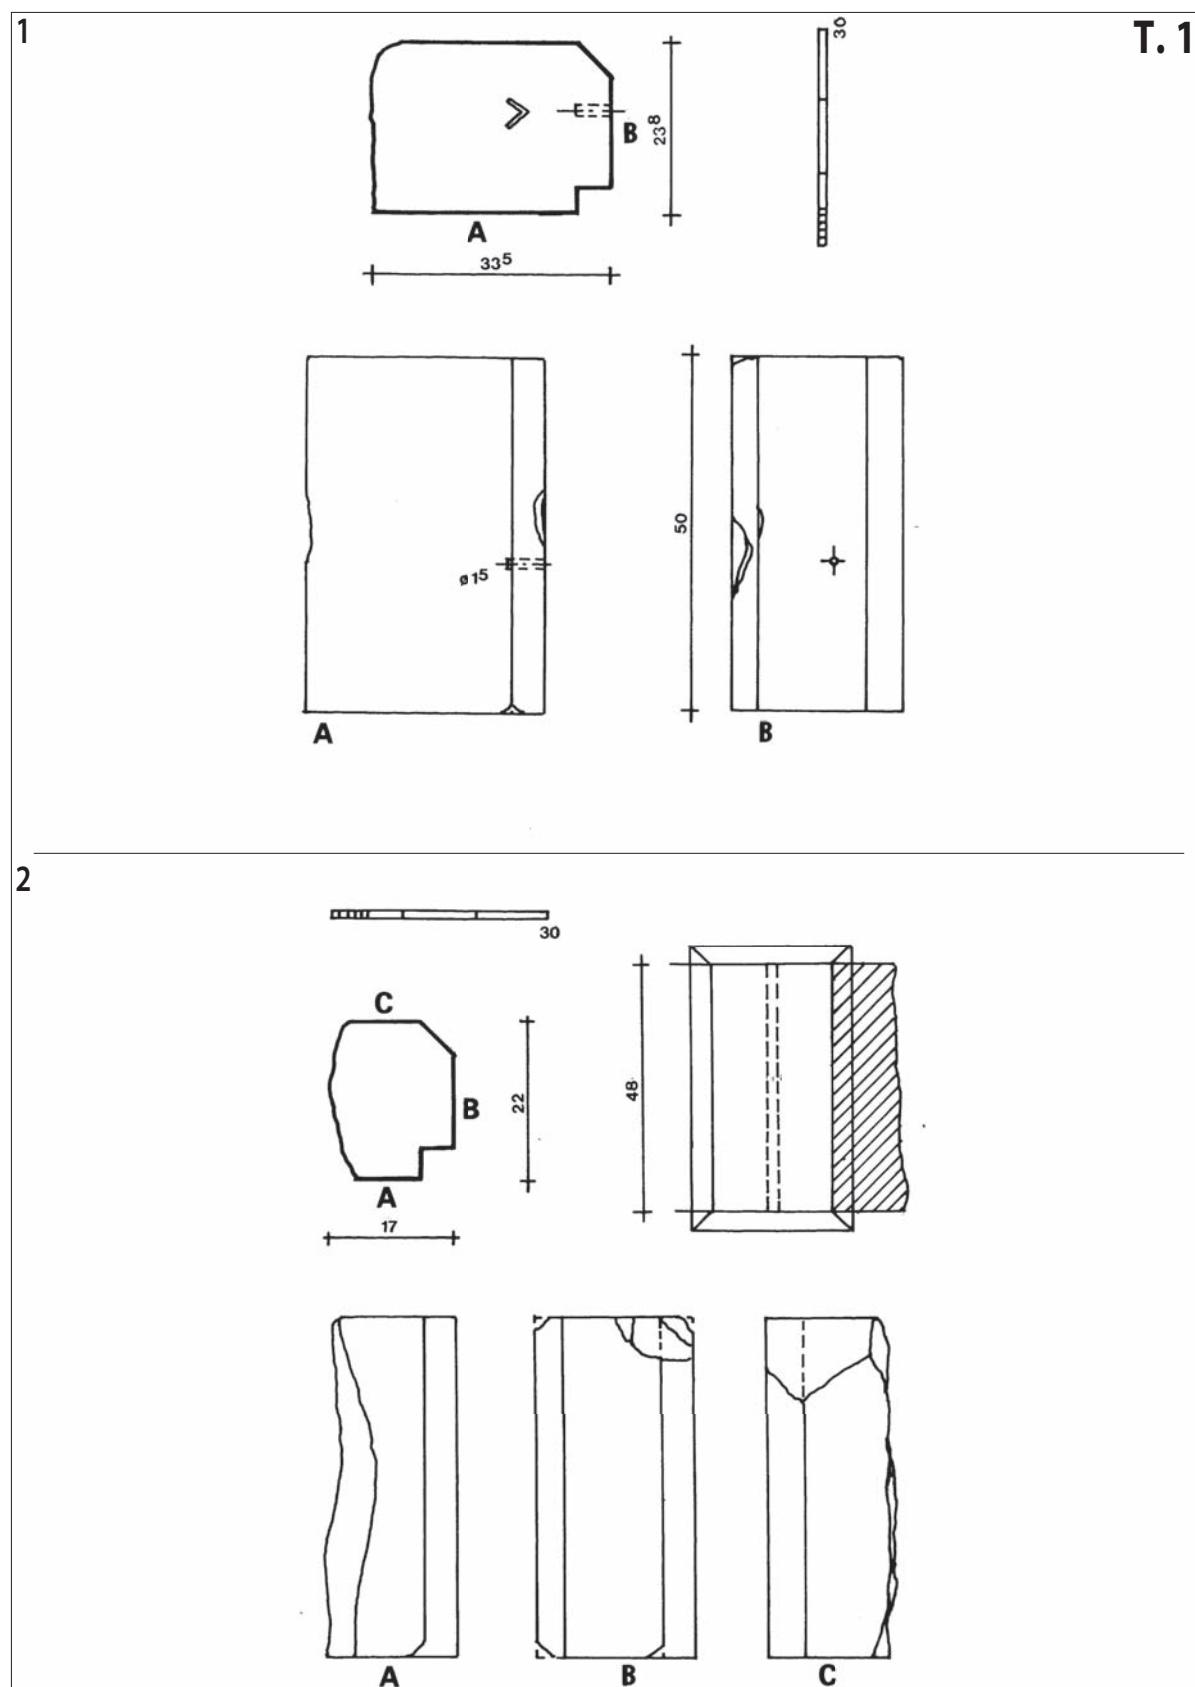
T. 1 Manji prozori – 1: PN 184; 2: PN 227 (desno gore – mogući izgled prozora i pozicija ulomka) (crtež: Z. Horvat)  
 Pl. 1 Small-sized windows – 1: SF 184; 2: SF 227 (above right – a possible appearance of a window and positions of fragments)  
 (drawing: Z. Horvat)

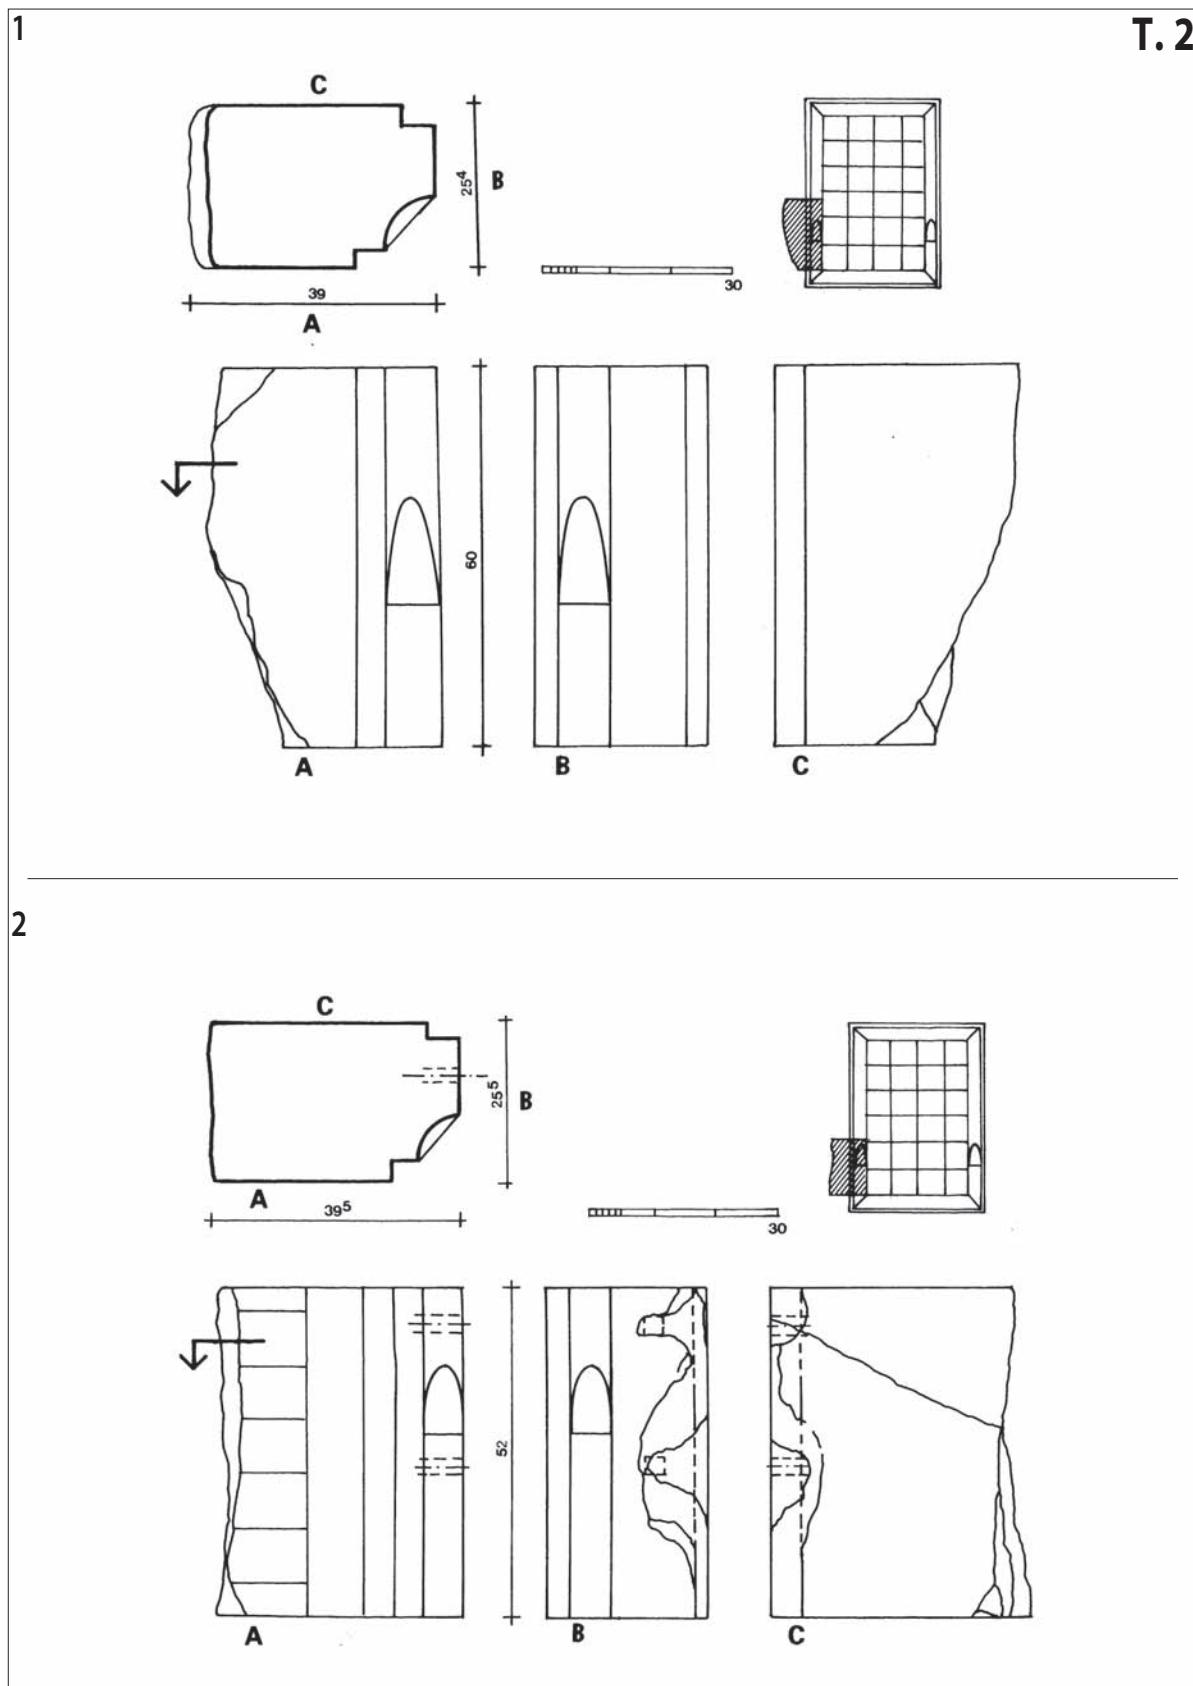
T. 2 Prozori srednje veličine – 1: PN 264; 2: PN 426 (crtež: Z. Horvat)  
Pl. 2 Medium-sized windows – 1: SF 264; 2: SF 426 (drawing: Z. Horvat)
