# Arhitektura i arhitektonska plastika burga Vrbovca kraj Huma na Sutli

## Architecture and Architectural Stonework of the Mediaeval Castle of Vrbovec near Hum na Sutli

Izvorni znanstveni rad  
Srednjovjekovna arheologija

Original scientific paper  
Medieval archaeology

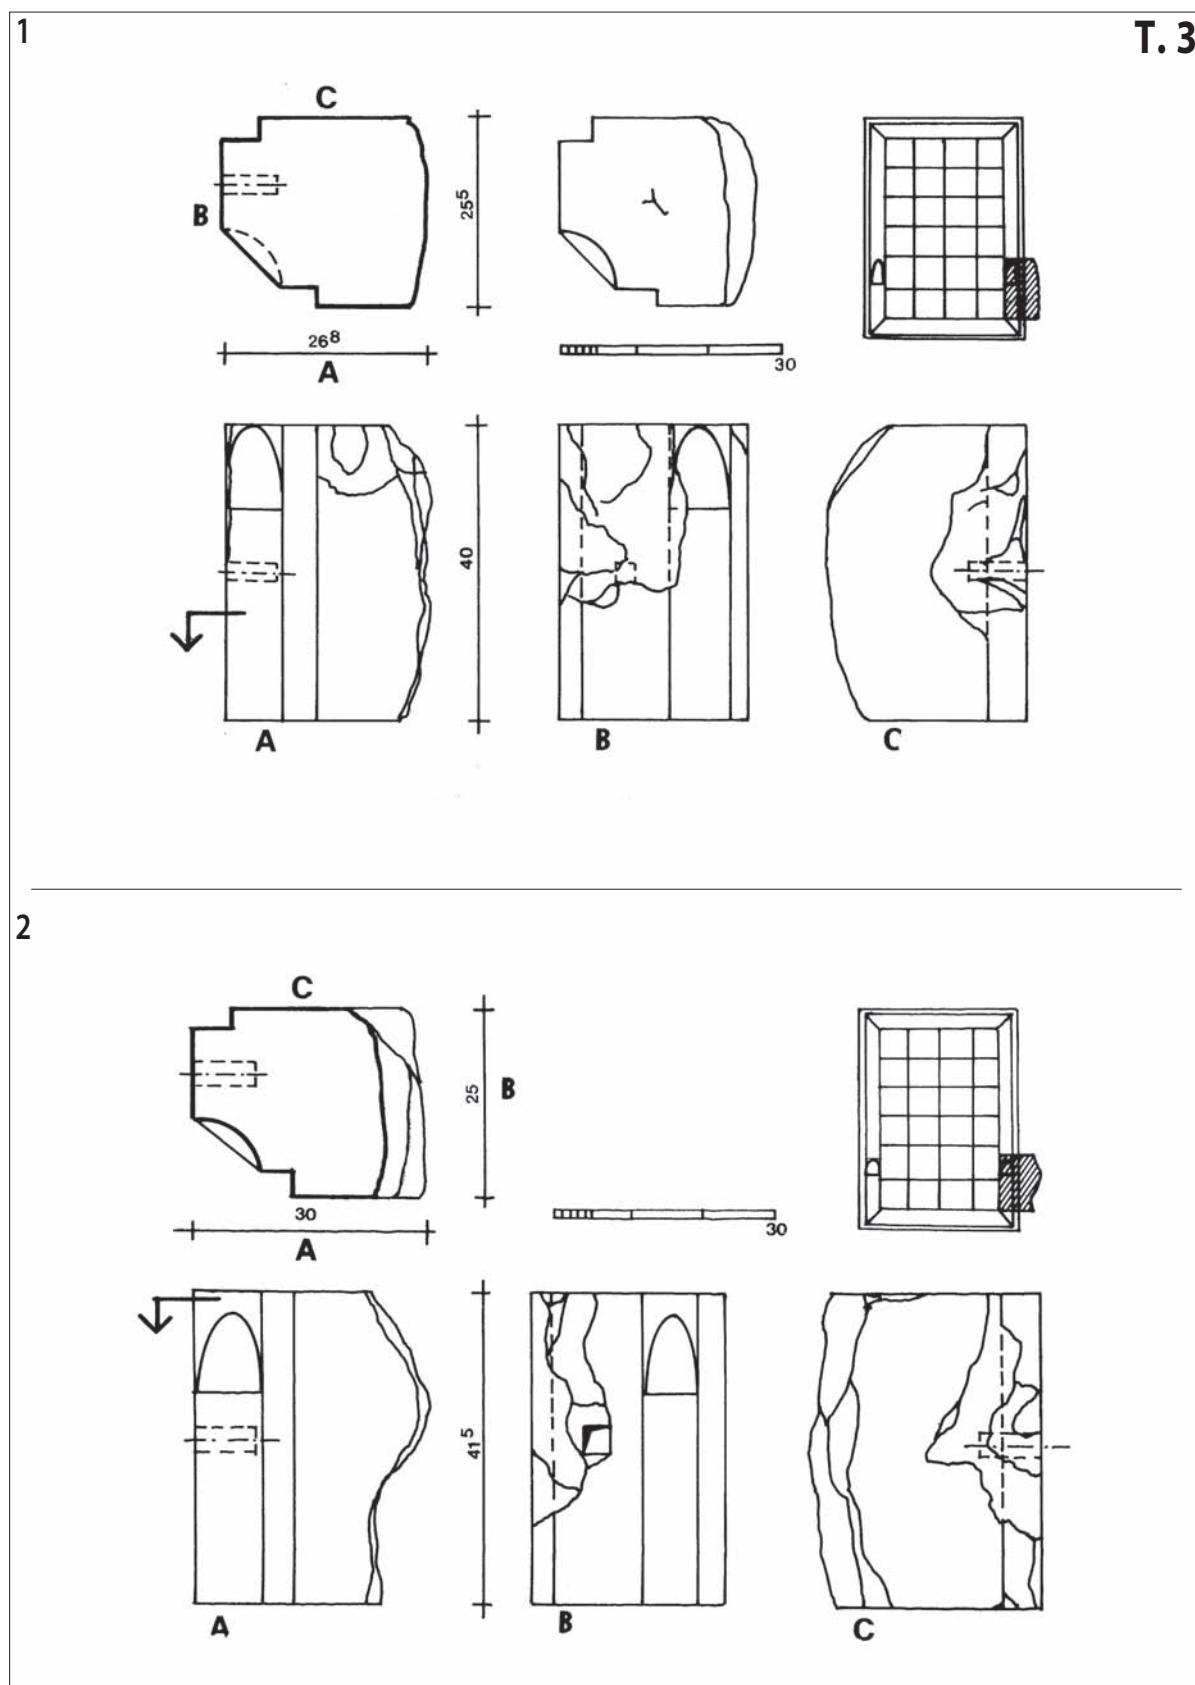
T. 3 Prozori srednje veličine – 1: PN 273; 2: PN 259 (crtež: Z. Horvat)  
 Pl. 3 Medium-sized windows – 1: SF 273; 2: SF 259 (drawing: Z. Horvat)

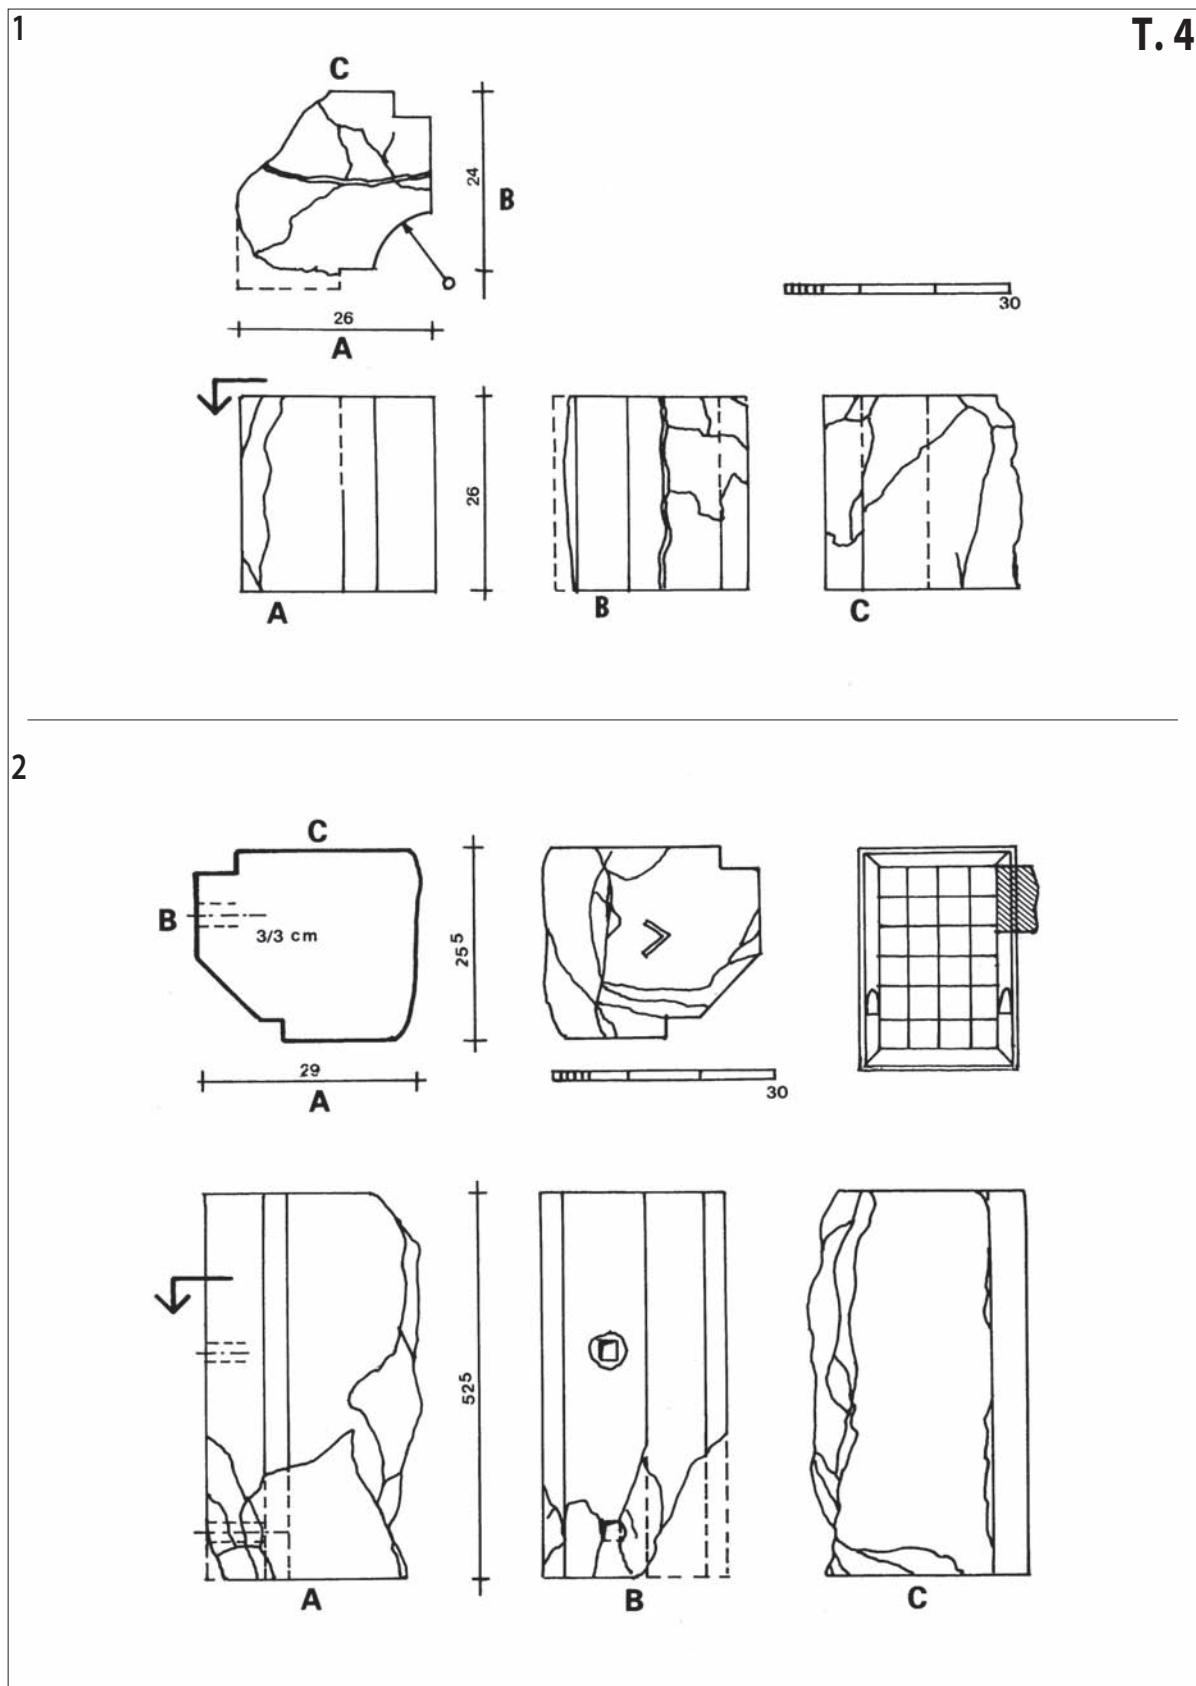
T. 4 Prozori srednje veličine – 1: PN 258; 2: PN 183 (crtež: Z. Horvat)  
Pl. 4 Medium-sized windows – 1: SF 258; 2: SF 183 (drawing: Z. Horvat)

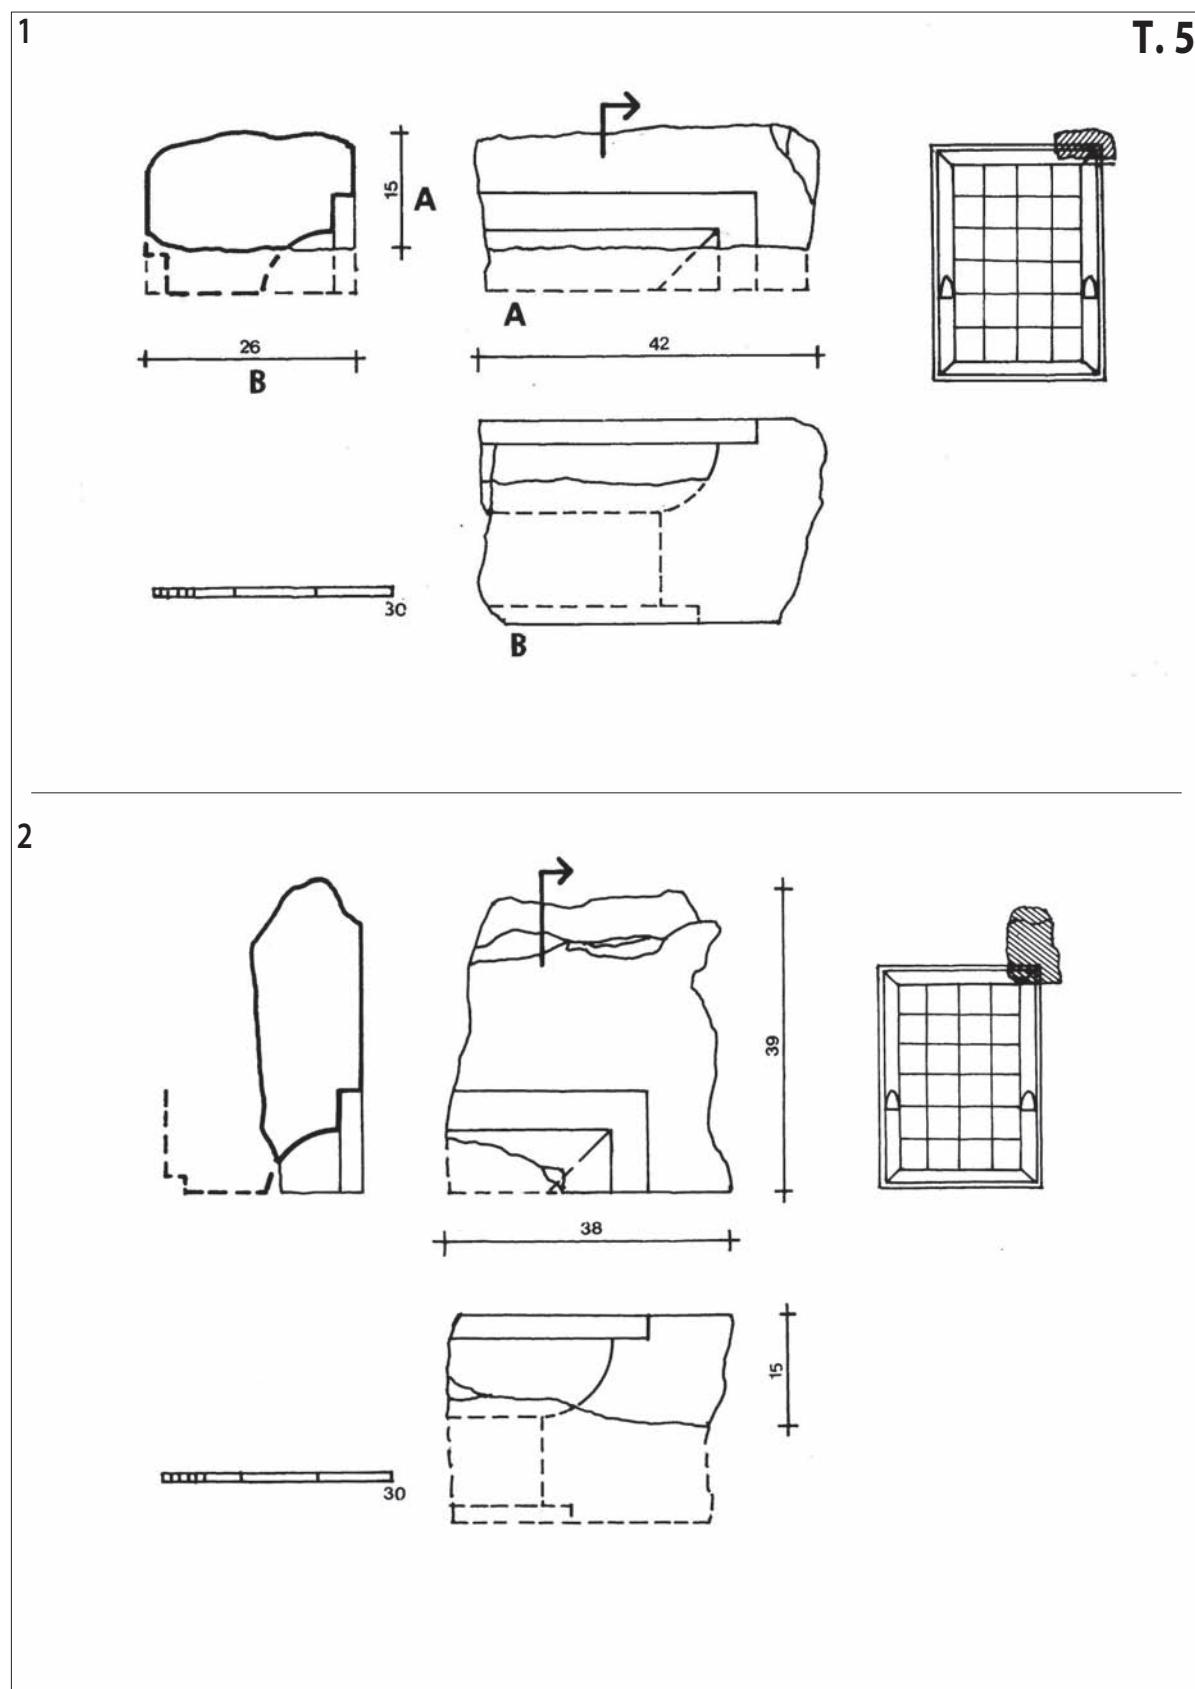
T. 5 Prozori srednje veličine – 1: PN 261; 2: PN 262 (crtež: Z. Horvat)  
Pl. 5 Medium-sized windows – 1: SF 261; 2: SF 262 (drawing: Z. Horvat)

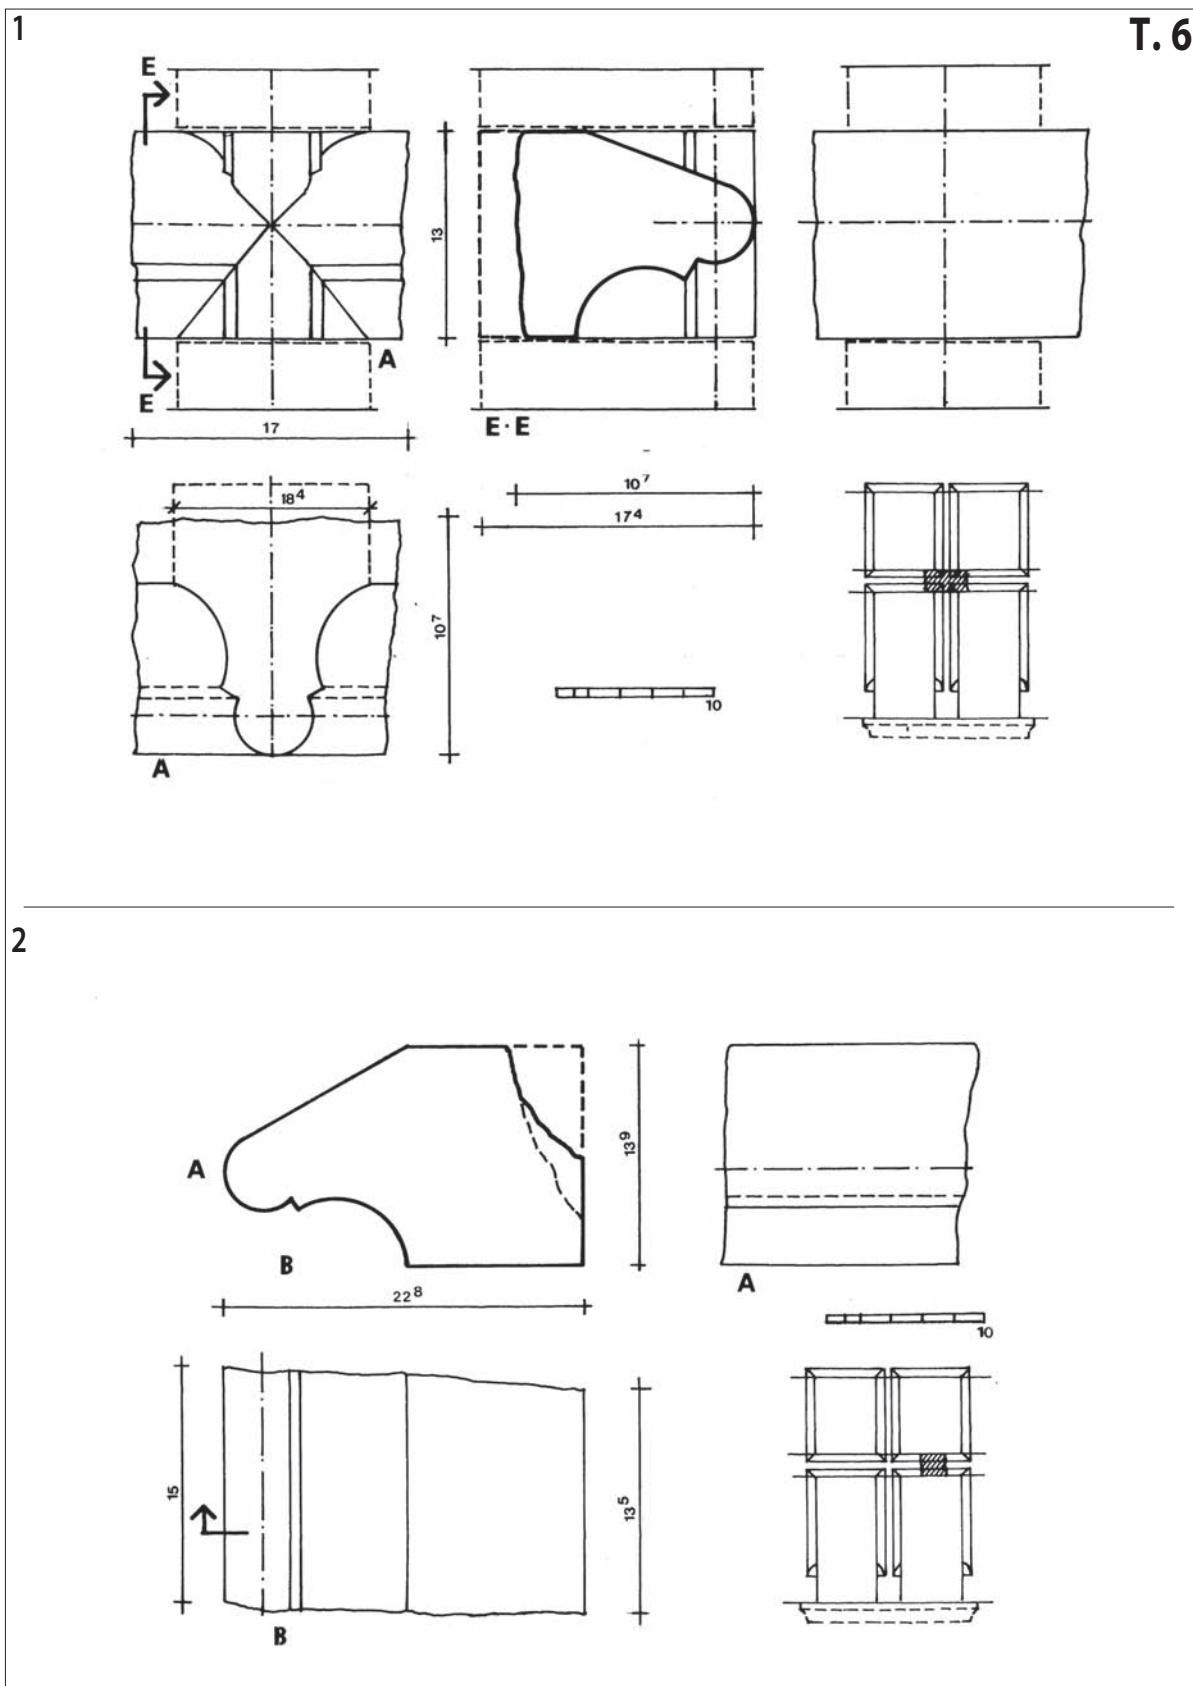
T. 6 "Češki prozori" – 1: PN 448; 2: PN 450 (crtež: Z. Horvat)  
Pl. 6 "Bohemian windows" – 1: SF 448; 2: SF 450 (drawing: Z. Horvat)

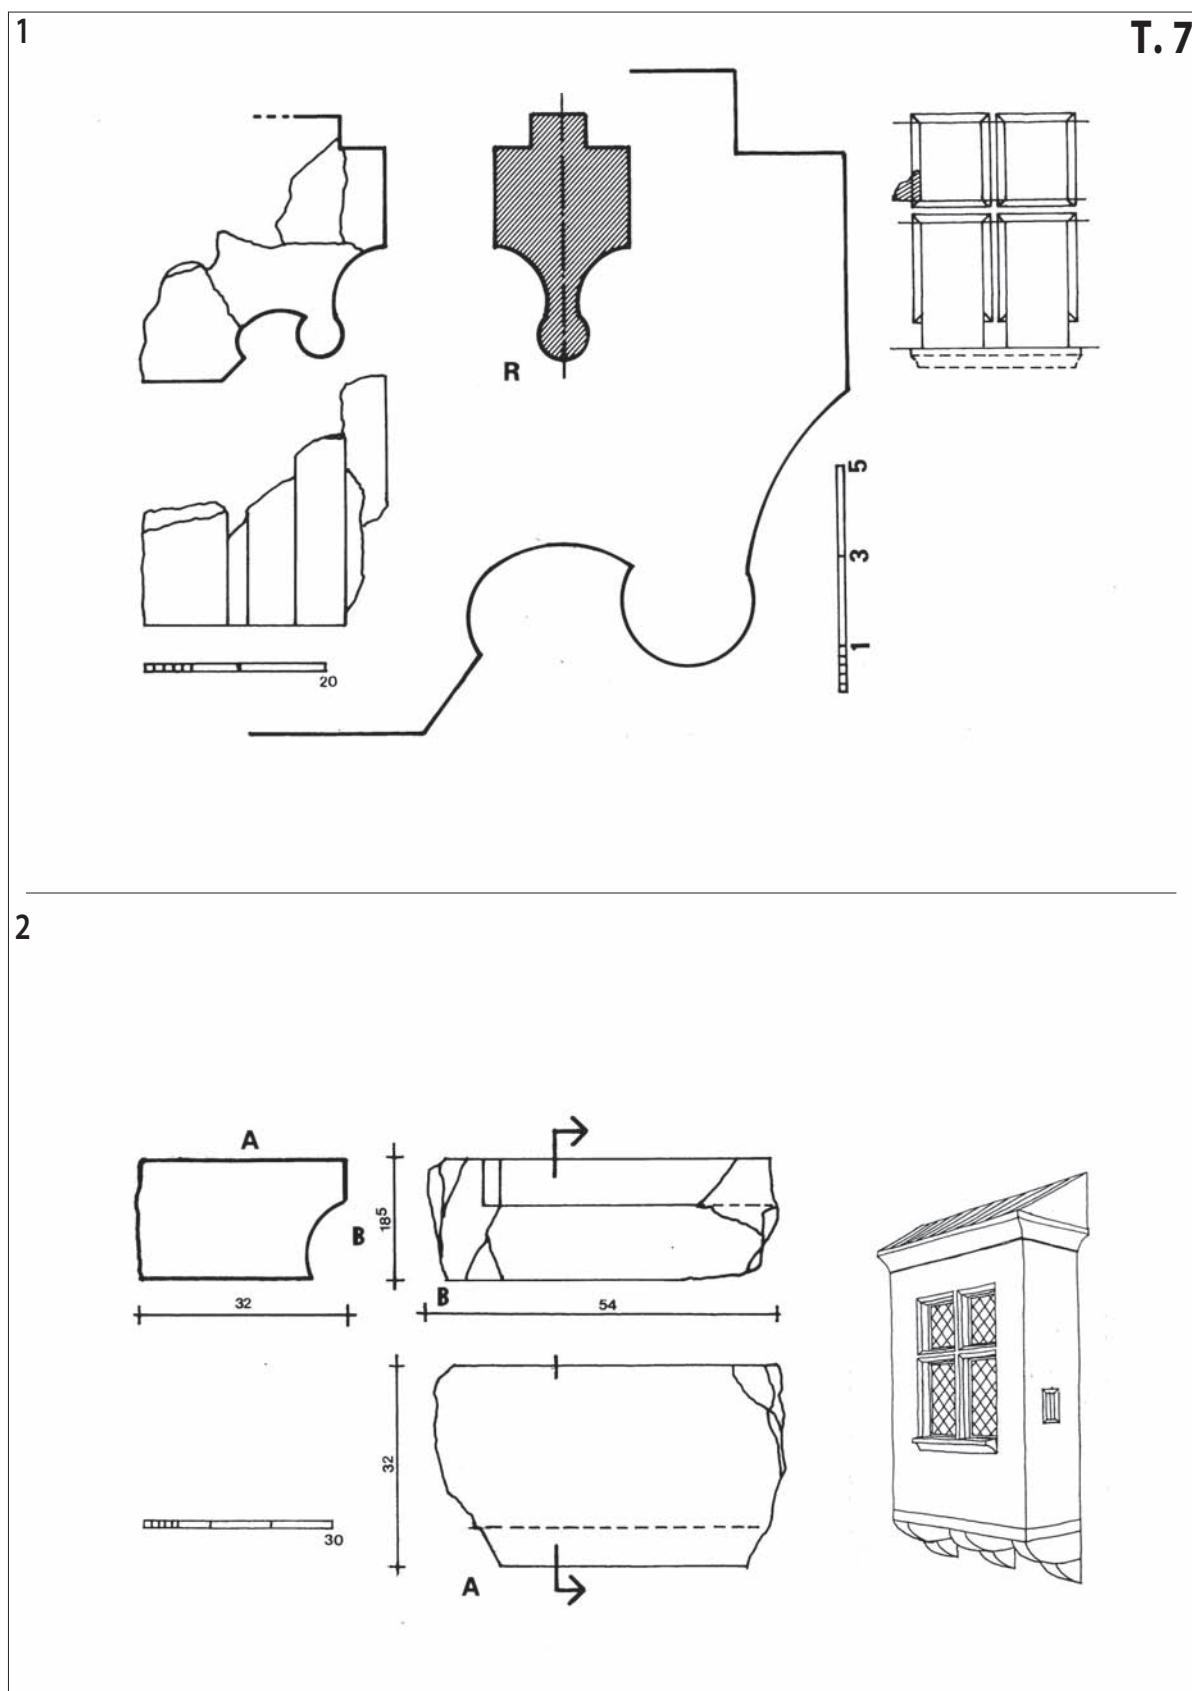
T. 7 "Češki prozor" – 1: PN 193–197; 2: ulomak klupčice PN 166 (crtež: Z. Horvat)  
 Pl. 7 "Bohemian window" – 1: SF 193–197; 2: fragment of a small bench: SF 166 (drawing: Z. Horvat)

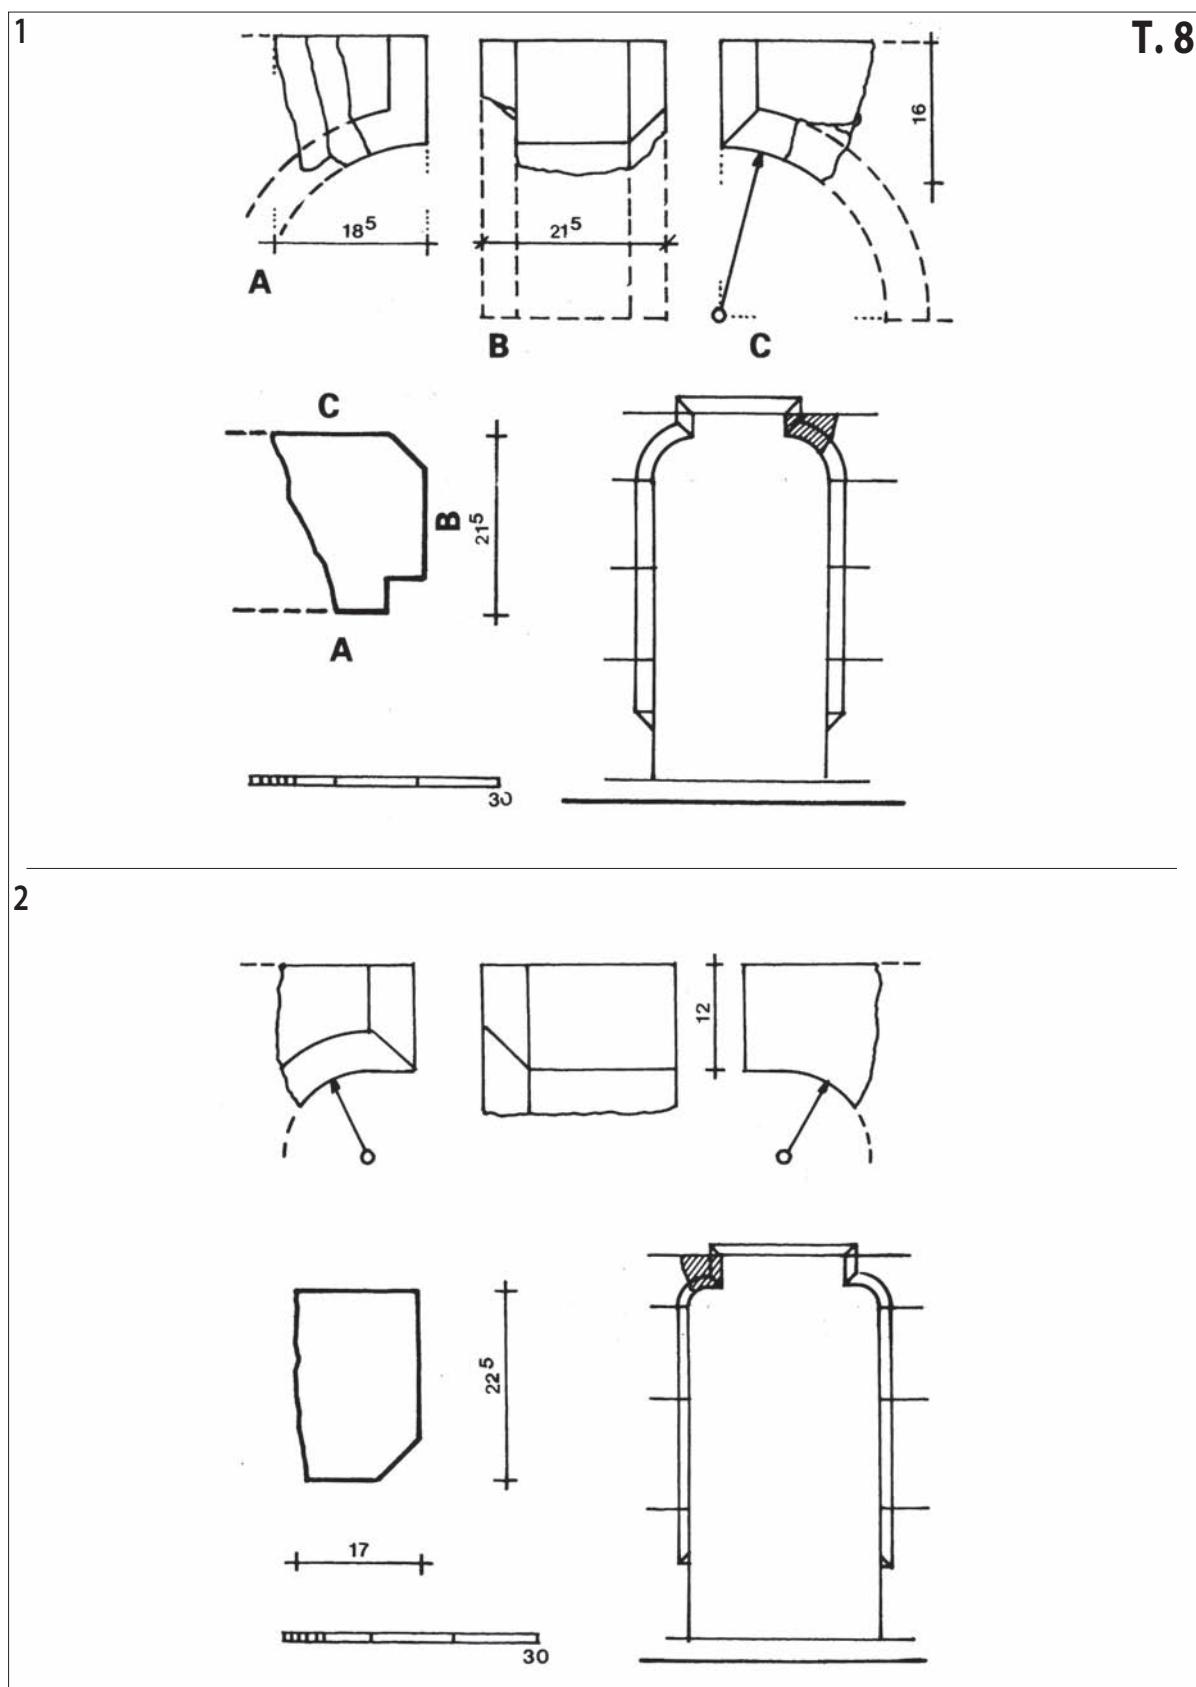
T. 8 Dovratnici – 1: PN 187; 2: PN 150 (crtež: Z. Horvat)  
Pl. 8 Door jambs – 1: SF 187; 2: SF 150 (drawing: Z. Horvat)

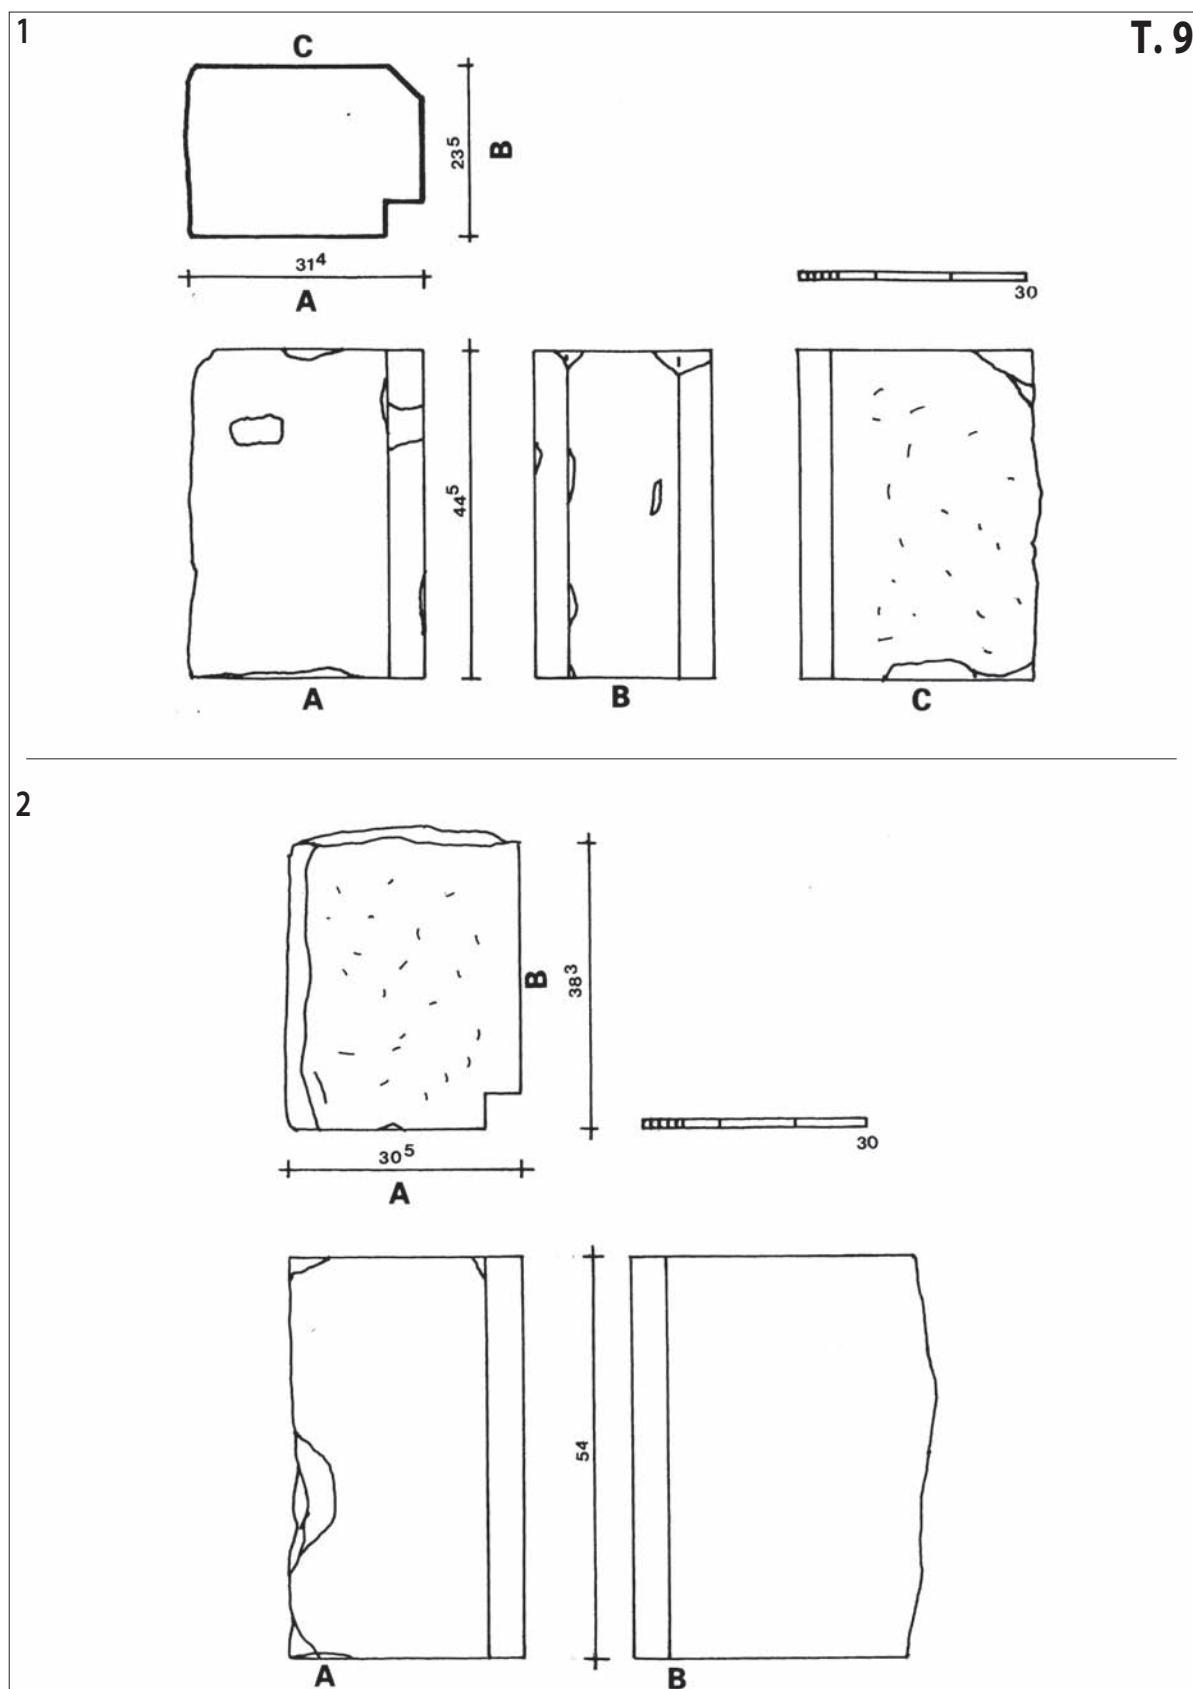
T. 9 Dovratnici – 1: PN 190; 2: PN 289 (crtež: Z. Horvat)  
Pl. 9 Door jambs – 1: SF 190; 2: SF 289 (drawing: Z. Horvat)

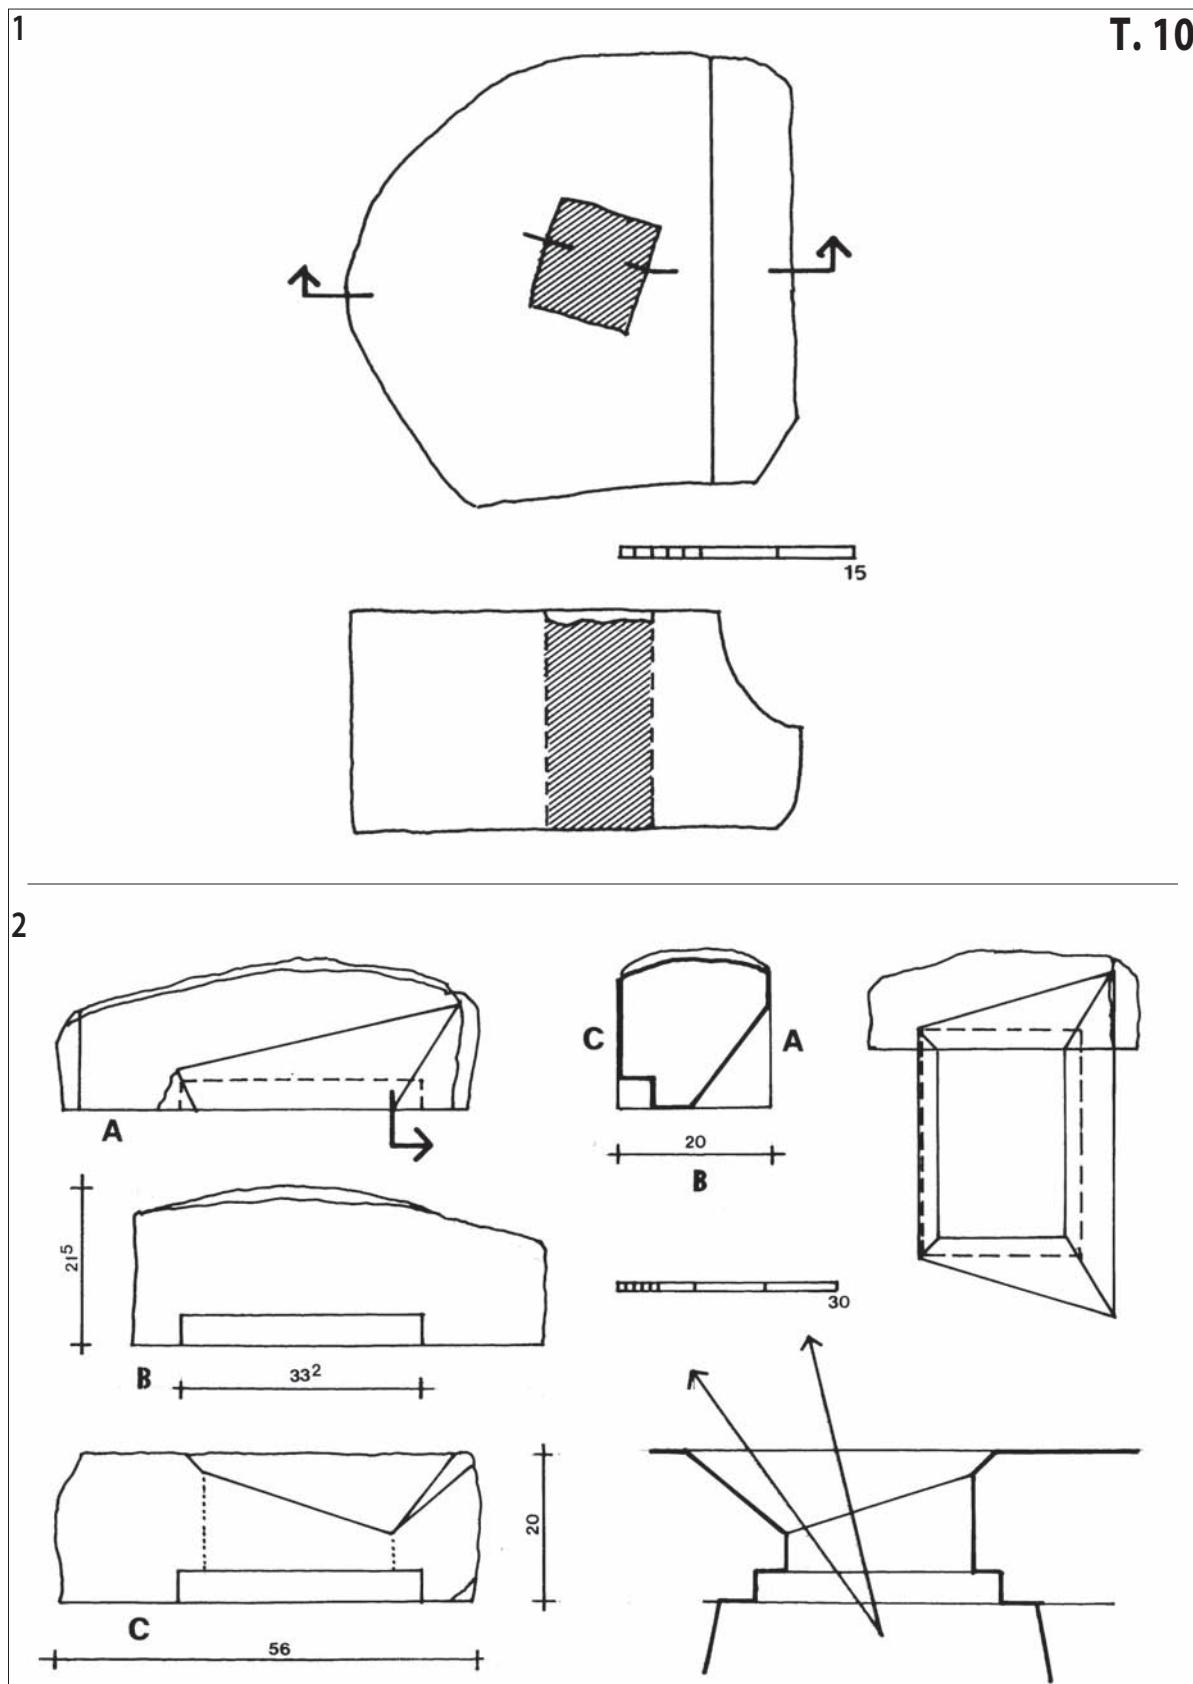
T. 10 Ulomci specifične namjene – 1: PN 181 – brusni kamen korišten kao spolij; 2: PN 447 – mali prozor specifične namjene (crtež: Z. Horvat)
