# CUTTING TOOL LIFE TESTS OF CERAMIC INSERTS FOR CAR ENGINE SLEEVES

Original scientific paper

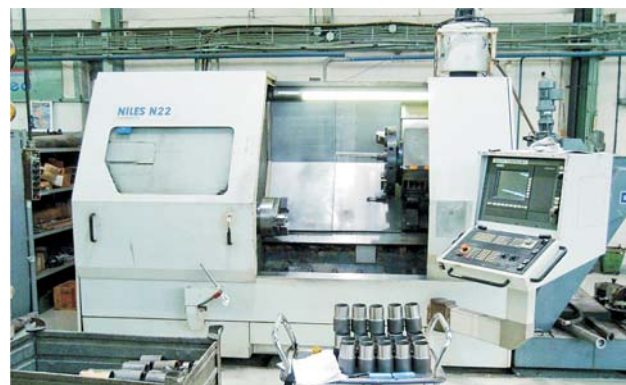
The machine tool CHEMNITZ NILES N22 (Fig. 1) was used for test sample machining. The machine tool has rigid structure and it provides a sufficient clamping condition. Jaws have recessed cone with the same apical angle as the cast iron sleeves.

Figure 1 Machine tool CHEMNITZ NILES N22  
Slika 1. Alatni stroj CHEMNITZ NILES N22

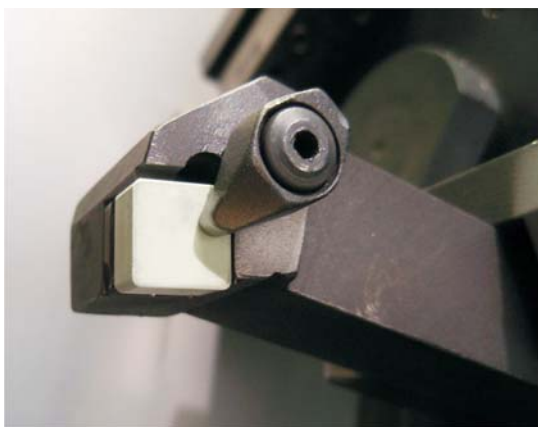
Figure 4 The tool-holder with clamped ceramic cutting insert  
Slika 4. Držać alata s pričvršćenim keramičkim uloškom

A tool-holder CSSNR 2525 M12-K (Fig. 4) was used in accordance with ISO 3685, with defined by an angle  $\kappa_r = 45^\circ$ . Machining system is shown in (Fig. 5).

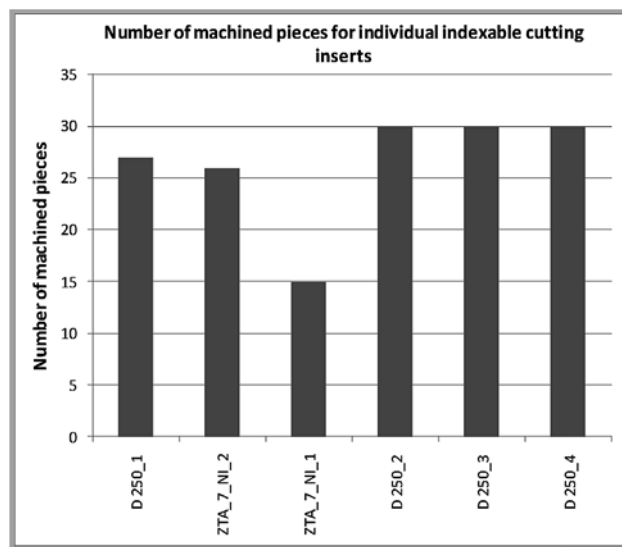
The number of machined pieces by individual ceramic cutting inserts is shown in the following graph (Fig. 7). D 250 series of cutting inserts machined the maximum number of 30 pieces except for D 250\_1 insert. The D 250\_1 insert probably reached this maximum as well. There was a crack of sleeve (at machining the 27<sup>th</sup> sleeve) and it resulted in cutting edge destruction. ZTA\_7\_NI inserts reached the criteria of tool wear at 26<sup>th</sup>, respectively at 15<sup>th</sup> machined sleeves. Fig. 8 shows the tool life of plates calculated according to formula (1) and (2) in minutes.

Figure 7 The number of machined pieces for individual indexable cutting inserts  
Slika 7. Broj obrađenih komada za indeksirane rezne uloške

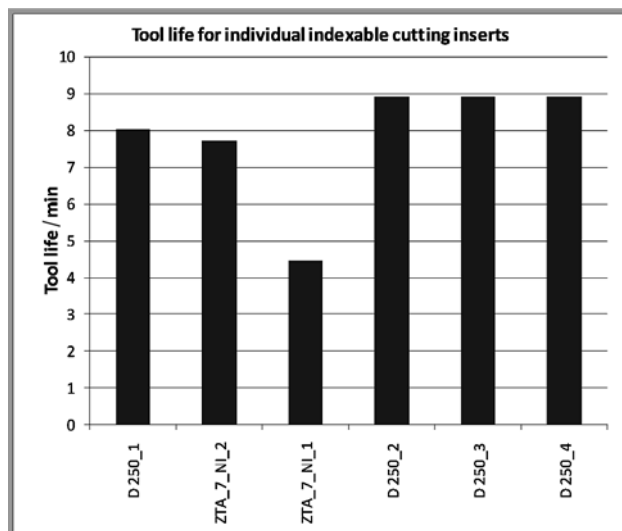
Figure 8 Tool life for individual indexable cutting inserts  
Slika 8. Vijek alata za indeksirane rezne uloške
