Fracture of Jaw Arm Made of Cast Steel GS-42CrMo4

Preliminary note

2. Fracture of jaw arm

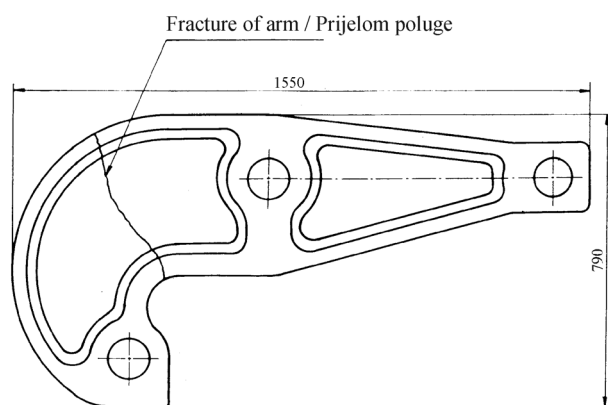
Geometry of fractured jaw arm is shown in Figure 1.

Figure 1. Geometry of fractured jaw arm

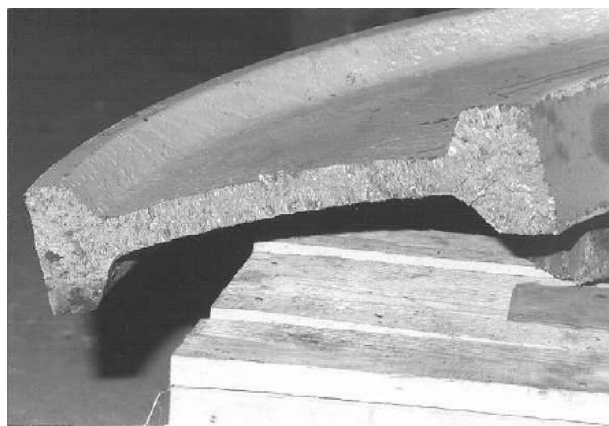
Fracture of the jaw arm takes place in a critical section. Fracture surface and manner of fracture of jaw arm are shown in Figure 2. It can be seen that the character of the fracture was brittle. On the fracture surface there are two distinguishable areas. At surface area of the fracture surface there is 10 to 20 mm depth of coarse-grained area which spreads from surface to core of the casting. At location of the fracture surface which corresponds to the

internal area of the casting there is a less coarse-grained area, in which dendritic solidification is noticeable. Figure 3 shows detail of the fracture surface.

Figure 2. Fracture surface of jaw arm

Coarse-grained microstructure at surface region of fracture indicates that temperature of pouring was too high.

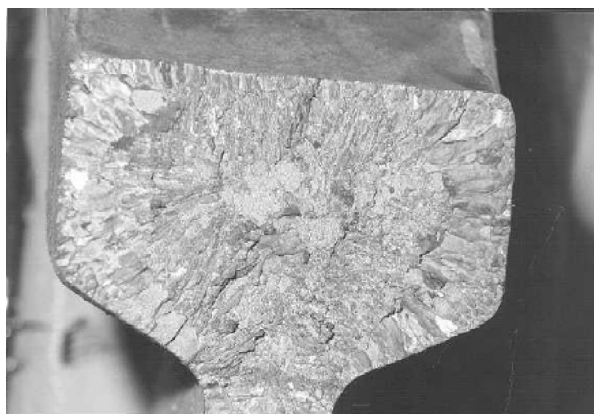
Figure 3. Detail of the fracture surface

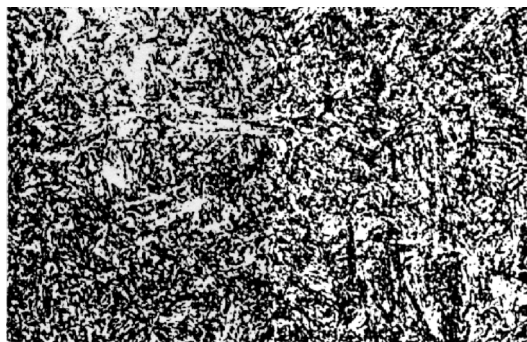
Microstructure of investigated casting is shown in Figure 4.

Microstructure consists of tempered martensite and bainite. Interdendritic segregations, which can be distinguished in the surface and internal area of the fracture surface, are shown in Figure 5. Non-metallic inclusions, which are mainly found on sulphides, are placed in dendrite pockets.

Figure 4. Microstructure of the casting: tempered martensite and bainite, 500:1, nital

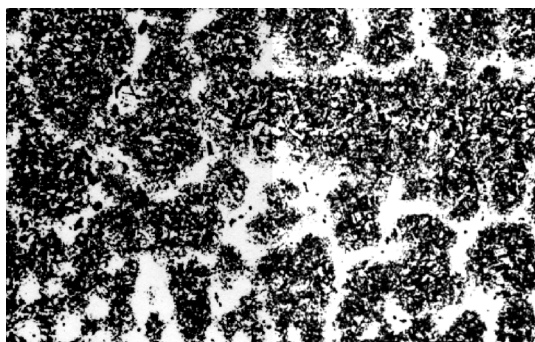
Figure 5. Interdendritic segregations, 30:1, nital

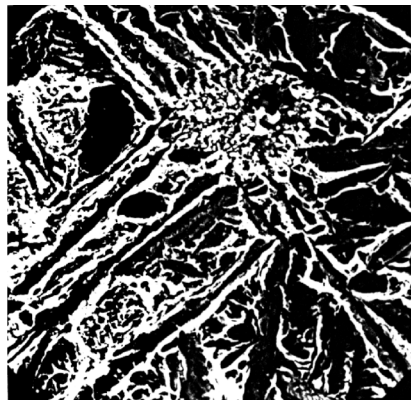
Figure 6 shows intergranular fracture in surface area. Figure 7 shows intergranular part of fracture in internal area.

Figure 6. Fracture surface in jaw arm surface area, 1000:1

By scanning electron microscope analysis of the fracture surface many lamellas on the fracture surface were found. These lamellas indicated that the jaw arm was fractured because of too high content of aluminium nitride, AlN, in the casting. So, the main reason for increased brittleness of the investigated jaw arm is too high a content of aluminium. The aluminium was added in the process of deoxidation of steel casting. An adequate

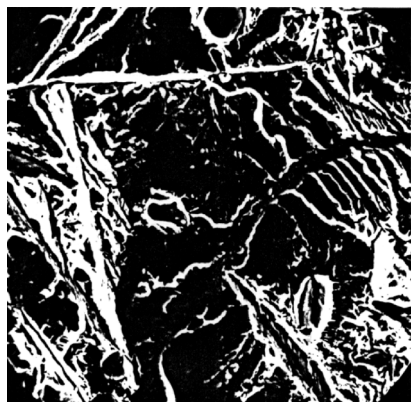
Figure 7. Fracture surface in internal area, 1000:1

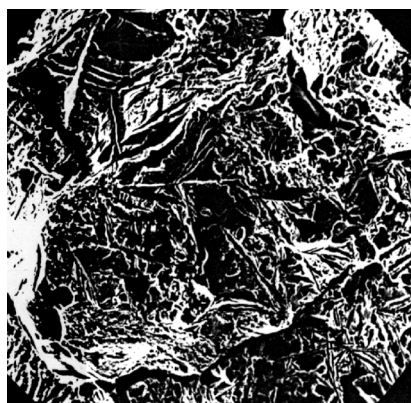
Through microanalysis, it was also found, that in internal area or area near the surface of the fracture, individually fields of ductile transgranular fracture are surrounded by an intergranular part of the fracture. Figure 8 shows transgranular parts of fracture. In fracture dimples, which are characteristic for ductile fracture, there are inclusions which are mainly found on sulphides.

Figure 8. Fracture surface in internal area, 1000:1
