RESEARCHES REGARDING STRUCTURAL MODIFICATIONS THAT APPEARS IN THE MATERIAL OF TOOLS USED FOR RUBBER WASTE ATTRITION

Tools commonly used for shredding rubber waste, currently produced, are made of neatly cast iron in the composite is to avoid the presence of sulfur and phosphorus. In this paper are presented the main structural material changes that occur in different areas, located at different distances from the active surface of tools. Structural changes occurred mainly refers to the transformation of white iron surface layer to gray cast iron and graphite separations appearance, which causes the crack primers and cracking corrosion phenomena in tools material.

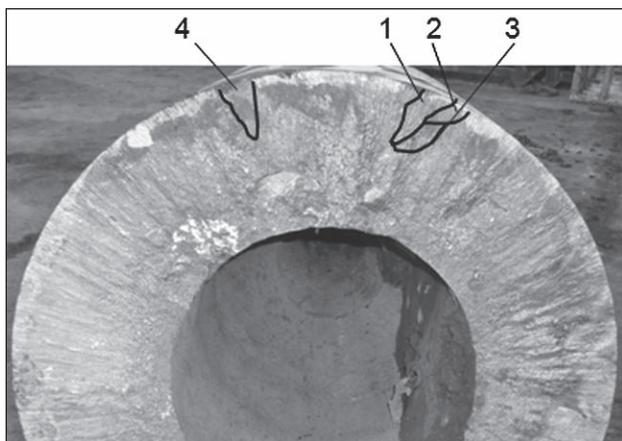
Figure 1 Worn tool and sampling areas

tool from which samples were taken and the sampling areas are shown in Figure 1. When sampling was taken has been considered that they belong to both the surface layer where there is white iron, and core tool, where gray iron can be found.

This used tools material structural analysis is done by four tests conducted in the area of rupture of a used cylinder. Sampling was done in the area of rupture of the cylinder because it was considered that in this place are the most important structural changes. Samples were taken from both cuts from broken tool.

Because on one of the pieces broken cracks were observed, in this area were taken 3 tests and from the other one, just a single sample. In terms of form of used

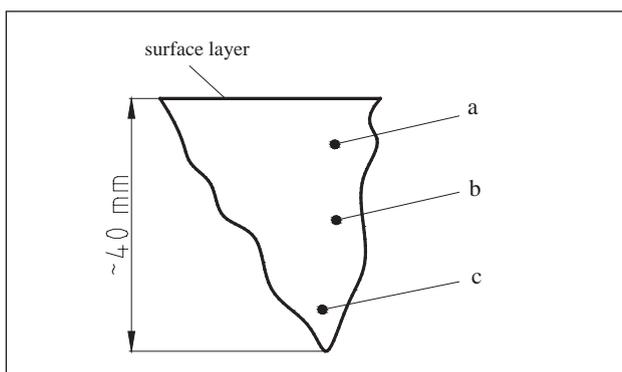
Figure 2 Form sample 1, a, b, c - points of performing the structural analysis

Form of no. 1 sample which was subjected to structural analysis is presented in Figure 2, and to achieve complete structural analysis of the test portion were observed images, on metallographic microscope, of the material structure at different points within a certain distance of the top layer.

Analysis corresponding to the three points will show three different microstructures presented in Figure 3 for point a, Figure 4 for the point b and Figure 5 for point c.

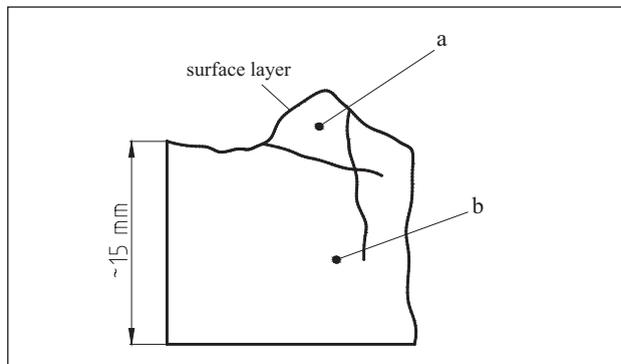
Figure 6 Sample form 2

It was taken and another sample, 2, where small cracks were observed, and the form of sample 2 for

which an analysis of structural changes was made, is presented in Figure 6.

Structural analysis of the sample number two will be made by metallographic microscope, by observation of material microstructure in two different points, (a) or (b).

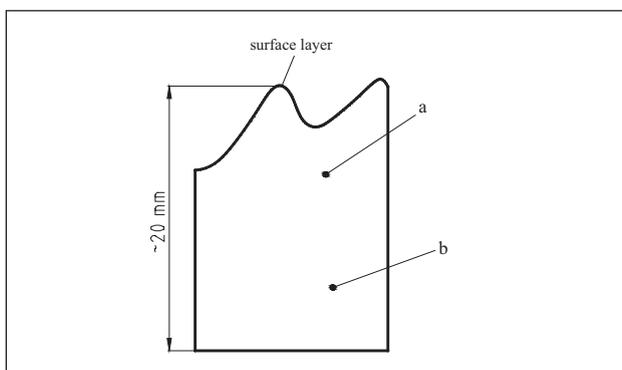
Figure 9 Form sample 3

To analyze the structural changes for sample 3 is shown first in Figure 9 its form. Structural changes in the sample 3 are especially interesting because the position of which it is taken, namely that it is found in the

separate area of white cast iron and gray iron. Structural changes will be observed under the microscope in two distinct points of the sample. Corresponding two points in which the structural analysis is performed are presented in Figure 10 for the point a and Figure 11 for the point b.

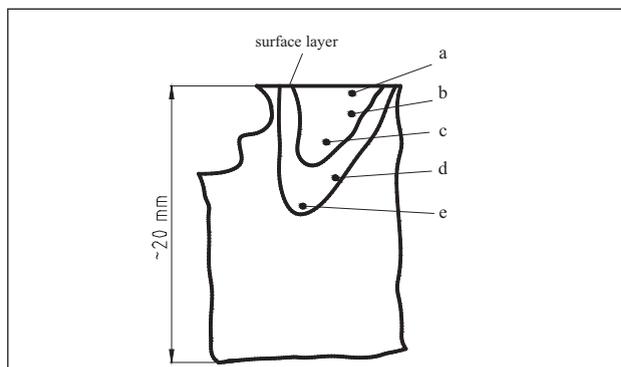
Figure 12 Sample form 4.

Sample no. 4, Figure 12, was taken from another piece released from breaking tool (cylinder).

As shown in Figure 12 are present on the sample surface a series of cracks. Due to the fact that there appeared cracks, areas of structural analysis we have ranged from the surface layer to the last crack. Given that this area could give us very important information on structural changes, analysis was made for five points. Accordingly we have five different structures, shown in
