# Influence of contact stresses on bearing capacity of traditional stone columns

Original scientific paper

Traditional stone columns, built by linking the base, body of column and capital with a dowel in the column axis, are often characterized by typical cracks in connection zones that are continuously propagating. Despite numerous retrofit, this cracking can not be stopped, which points to an intrinsic defect. A systematic study involving a number of numerical models of variable complexity, and laboratory testing of quasi-real size samples, was initiated in order to determine the cause of the problem. Some results describing typical behaviour of columns are presented in the paper.

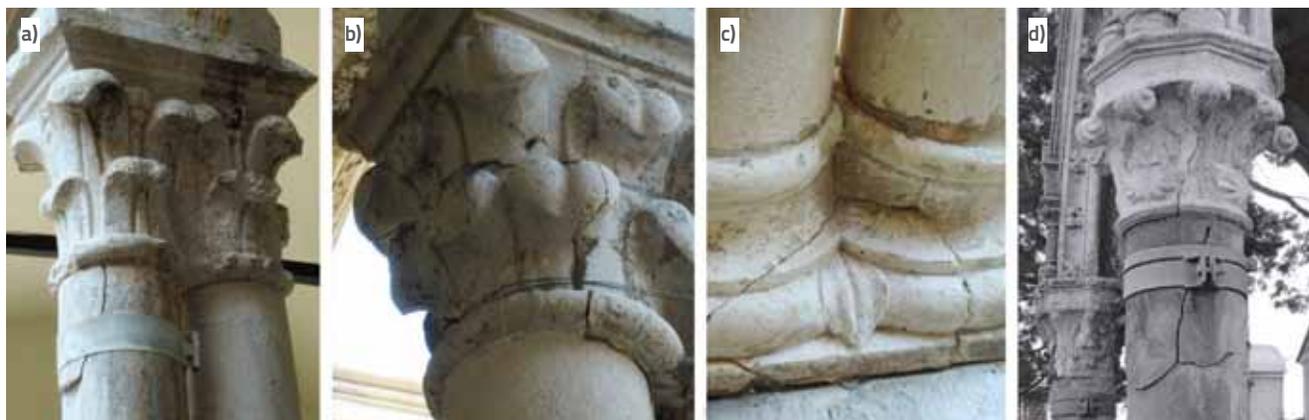
Figure 1. Cracking on traditional stone columns with remains of previous repair work

The testing was continued until the centric force of 200 kN which is in accordance with force values obtained in double columns (Figure 1.a) of the Rector's Palace in Dubrovnik [7]. If the state of sample is analyzed for the force representing

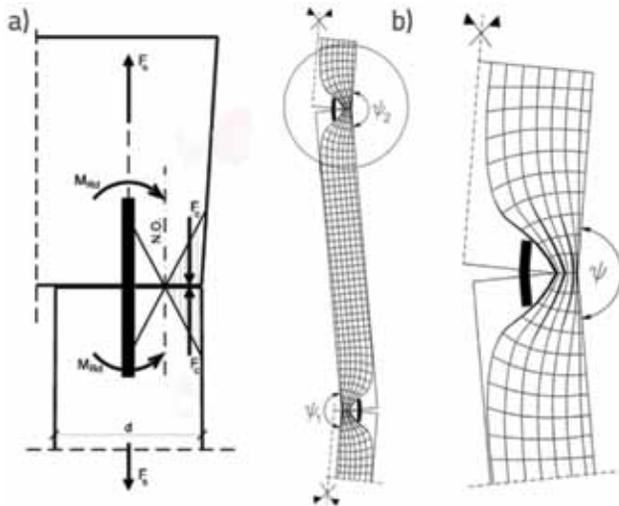
Figure 2. Connection behaviour model: a) internal forces and stress, b) distribution of stress trajectories [8]

details such as the centrically placed peg in the column axis and poor anchoring into the stone (Figure 2.a) [7].

Unfortunately, imperfections during realization, uneven settlement of foundations, earthquakes, stress redistribution in vaults, temperature, and numerous interventions during the life span, cause eccentric load and deviation of columns from the vertical axis. Even at very small deviations the connection elements turn, i.e. the connection opens on one side and contact surfaces are joined on the other side of the cross section. As the contact surface (compression zone) is extremely small (theoretically infinitely small), the occurrence of big boundary compressive stresses becomes inevitable. These stresses result in the opening of typical joints in the vicinity of contacts. The described behaviour is in accordance with the distribution of stress trajectories as it is obvious that the pronounced concentration of compressive trajectories leads to fracturing of material at the edges (Figure 2.b), while

The described problem has often remained undetected as stress trajectories become parallel in zones not close to contacts (Figure 2.b) and measurements reveal low level of stress in columns, i.e. a high safety coefficient (which is in most cases greater than 10 [9]). Investigations have shown that the knowledge of properties or behaviour of contacts is indispensable for a reliable estimation of stress distribution in the structure and for a more accurate estimation of safety coefficients.

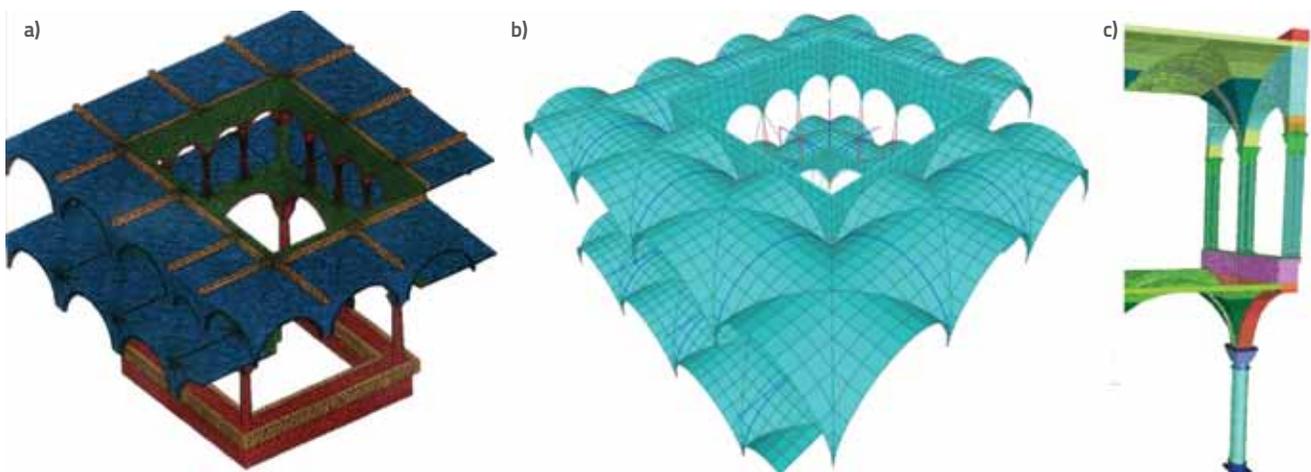
Figure 3. Numerical models of the Rector's Palace: a) by volume elements; b) by bar and plate elements; c) detailed model of a typical part [16]

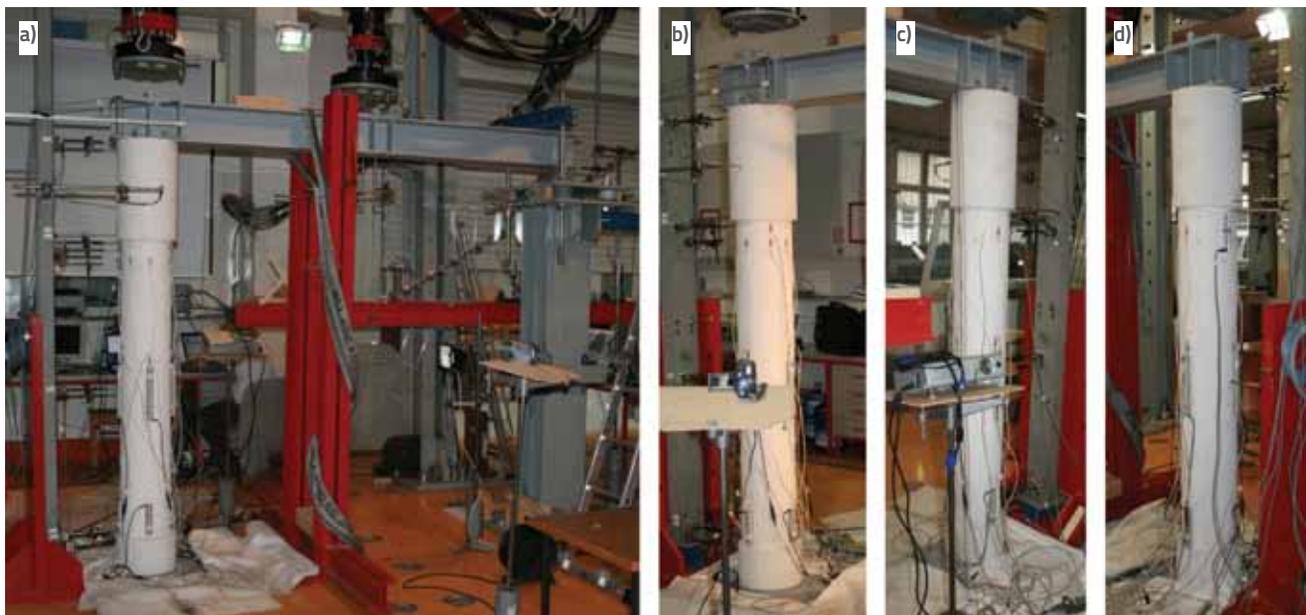
Figure 4. Testing assumption for the sample K2 (stone sample 2)

The testing procedure that closely simulates the behaviour of existing structures was defined (Figure 4). The initially planned alternative with arches or vaults was rejected as it can not be applied for laboratory testing of a set of samples until failure. The solution with horizontally placed steel beam (HEB200 with reinforcements) for load application was obtained after extensive numerical simulations. This solution ensures a good distribution of stresses along the column, controlled application of force, simple assembly, almost full-scale sample dimensions, and safety at cracking. The steel beam was specially adapted for the application of load using the universal compression/tension machine Zwick/Roell with pistons. The main piston with the capacity of  $\pm 600$  kN was placed on the beam above the column (centrally), while the 250 kN piston was placed in the middle of the steel beam span (eccentrically). The pistons can apply load via a force or displacement control, and can monitor the post-critical behaviour of the contact zone, which is crucial for determining the bearing capacity reserve at cracking. During the testing, the force was applied by displacement control, and the increments of 0.01 mm/s were used.

Steel beam dimensions ( $l=2.4$  m) were selected so as to enable controlled bending (deformation) of the beam in an elastic area through application of load in the middle of the span. The angle of beam rotation above the column is transferred onto the capital via the contact with screws in epoxy resin, by which we obtained the desired contact between the capital and one side of the column cross-section. On the other side, the beam leaned onto a separate structure that simulates the fixed bearing of a historic building. Column sample dimensions were selected in accordance with dimensions of double columns situated at the first floor of the Rector's Palace in Dubrovnik. The capital (300 mm in diameter and 500 mm in height) was placed onto the column ( $d=250$  mm,  $h=1500$  mm), and they were linked together with a steel peg ( $d=16$

mm,  $h=150$  mm) placed in openings ( $d=19$  mm,  $h=100$  mm) located in the centre of the cross section. The same method was used to link the column with the base ( $d=300$  mm,  $h=200$  mm) which lies on the steel support which was adequately strengthened to prevent sliding.

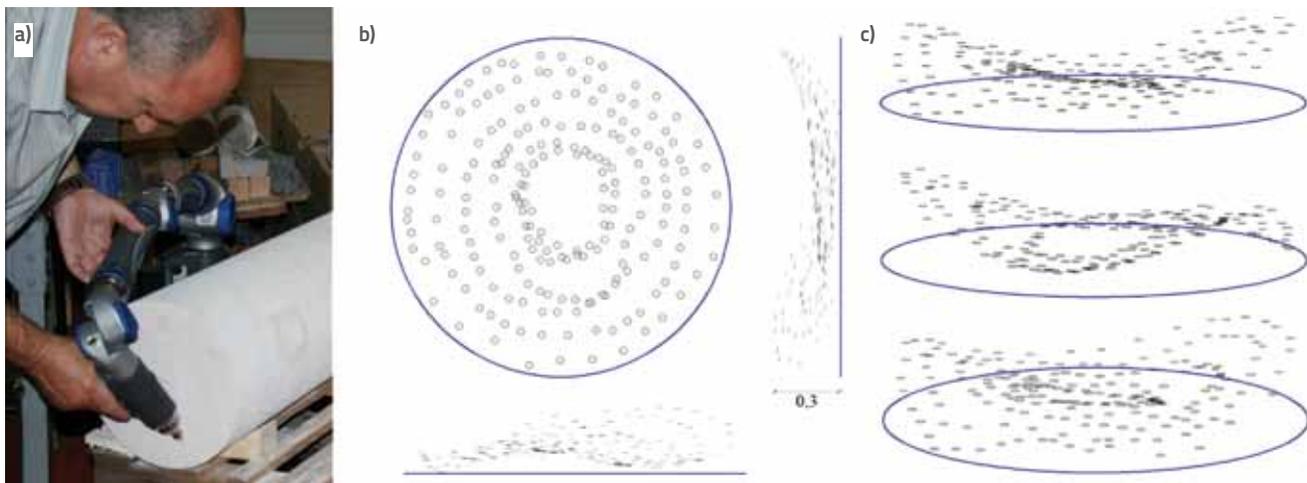
Figure 5. Determining shape of contact faces: a) measurement by FaroArm device; b) in plane presentation of measurement points; c) spatial presentation of measurement points [16]

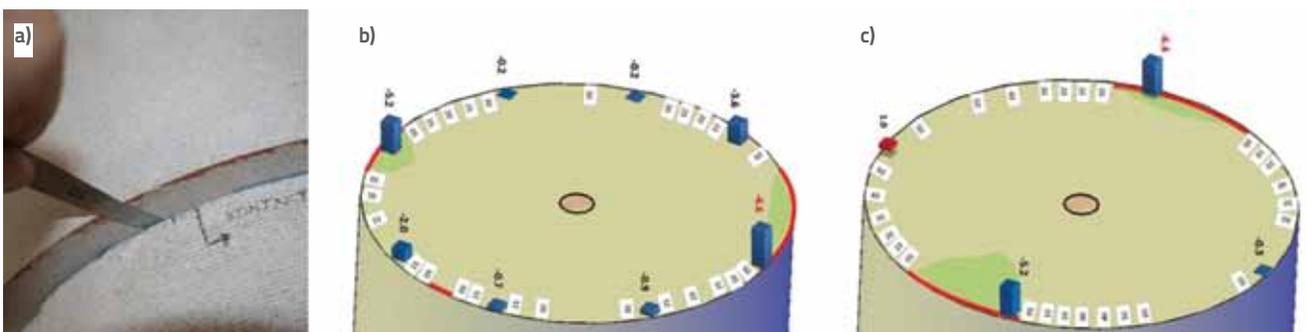
Figure 6. Test phase of investigations (sample K4): a) deviation measurement by measurement sheets; b) stress values at VS; c) stress values at DS

Measured deviations enabled good interpretation of the uneven stress distribution obtained by testing, as can be seen on the results of the sample K4 test phase (Figures 6.b and 6.c). In these Figures, the contact between column elements is marked with red line, while deviation values (1/100 mm) are inserted in between. The three-dimensional schematic presentation of stress results obtained by relative deformation measurements was selected, as it also shows stress relationship in which compression stress is marked in blue, while the tensile stress is marked in red.

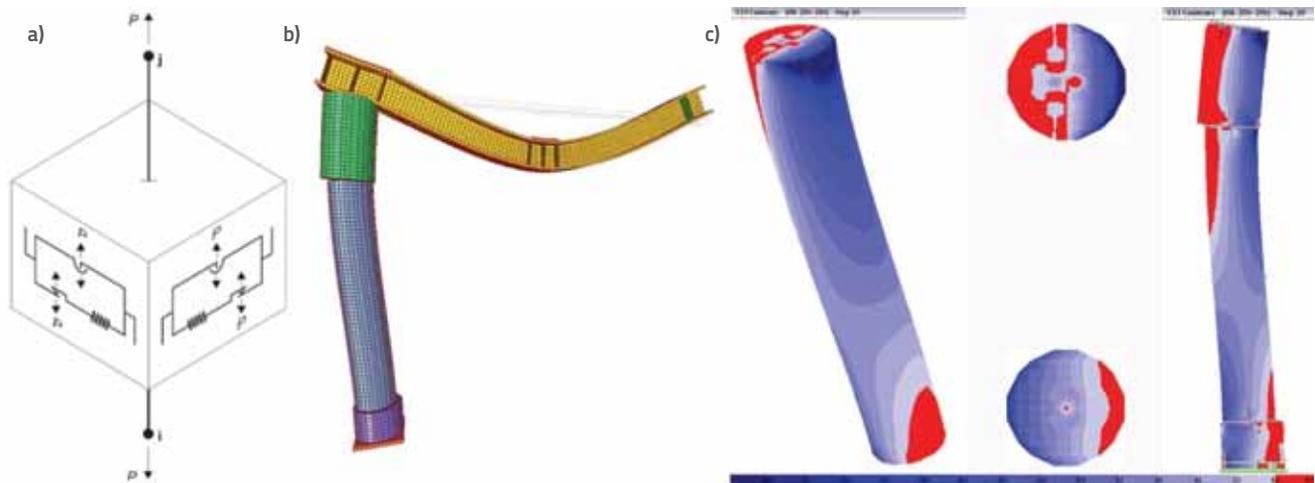
Figure 7. a) Material model of connection elements; b) Numerical model of the testing – deformed state at eccentric load; c) Stress distribution along the column shaft, contact faces and in the vertical cross section through the axis [5]

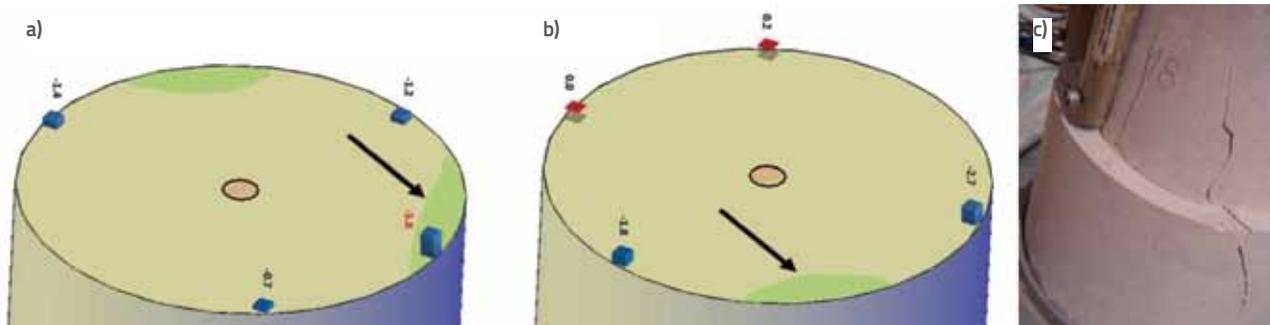
Figure 8. Test phase of investigations (sample K1): stress values at VS; b) stress values at DS; c) occurrence of first visible crack

on real-life structures as it enables a good estimate of critical points even without group testing. For instance, even the test phase results are sufficient for estimating critical points, i.e. the points of application of pressure at contact faces (marked in green) for VS (Figure 8.a) and DS (Figure 8.b).

These assumptions were confirmed after the centric force was increased to 297.6 kN when the crack occurred (Figure 8.c) near the marked place of application of pressure at DS (Figure 8.b). The analysis of results for all MM, immediately before and after crack opening, has revealed the redistribution of stresses or, in other words, the sample has established a new state of balance. This has been confirmed by continued testing when, depending of the newly realized contact, the unloading or increase of stress can be observed at individual MM. By further increase of centric force until 450 kN a crack opened at VS. This crack also corresponds to initial stress concentration from the test phase (Figure 8.a). Just like during the opening of the first crack, the instantaneous change in stress, i.e. new stress distribution, was observed at almost all MM.

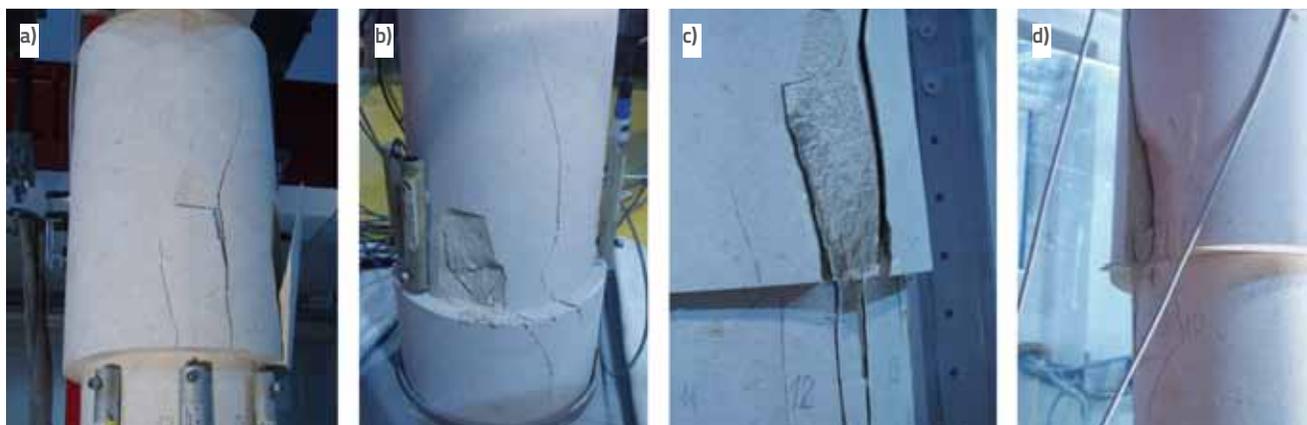
Figure 9. Cracked condition of sample K1: a) and b) VS and DS at centric force of 500 kN; c) and d) VS at centric force of 500 kN and eccentric force of 21.4 kN

At the centric force of 500 kN, the contact zone between the column shaft and capital (VS) is already pervaded with cracks (Figure 9.a) and the crack opened at the base has spread high into the shaft of the column (Figure 9.b). The centric force of 500 kN represents only 11 % of the ideal bearing capacity (bearing capacity of an ideal cross section subjected to centric pressure, assuming an uniform distribution of stress) which corresponds to the assumed usability of traditional stone

According to testing objectives defined in advance, in the next phase, the sample was subjected to eccentric load by means of the piston placed in the centre of the steel beam and thus the capital pressure was moved to the edge of the column. As could have been expected, even a negligible eccentric load of 21.4 kN caused a significant cracking at the capital level (Figures 9.c and 9.d) but, due to redistribution of stresses, the

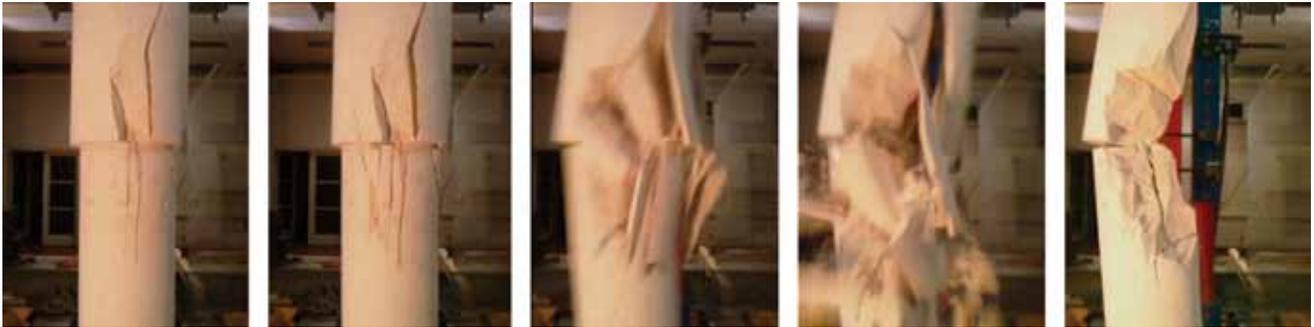
Figure 10. Splitting of sample K1 (VS) in the last phase of testing

sample retained its load bearing capacity. The testing was then resumed and, with a continuous piercing sound of crack propagation, the full sample splitting and failure occurred at the eccentric force of 140 kN (Figure 10).

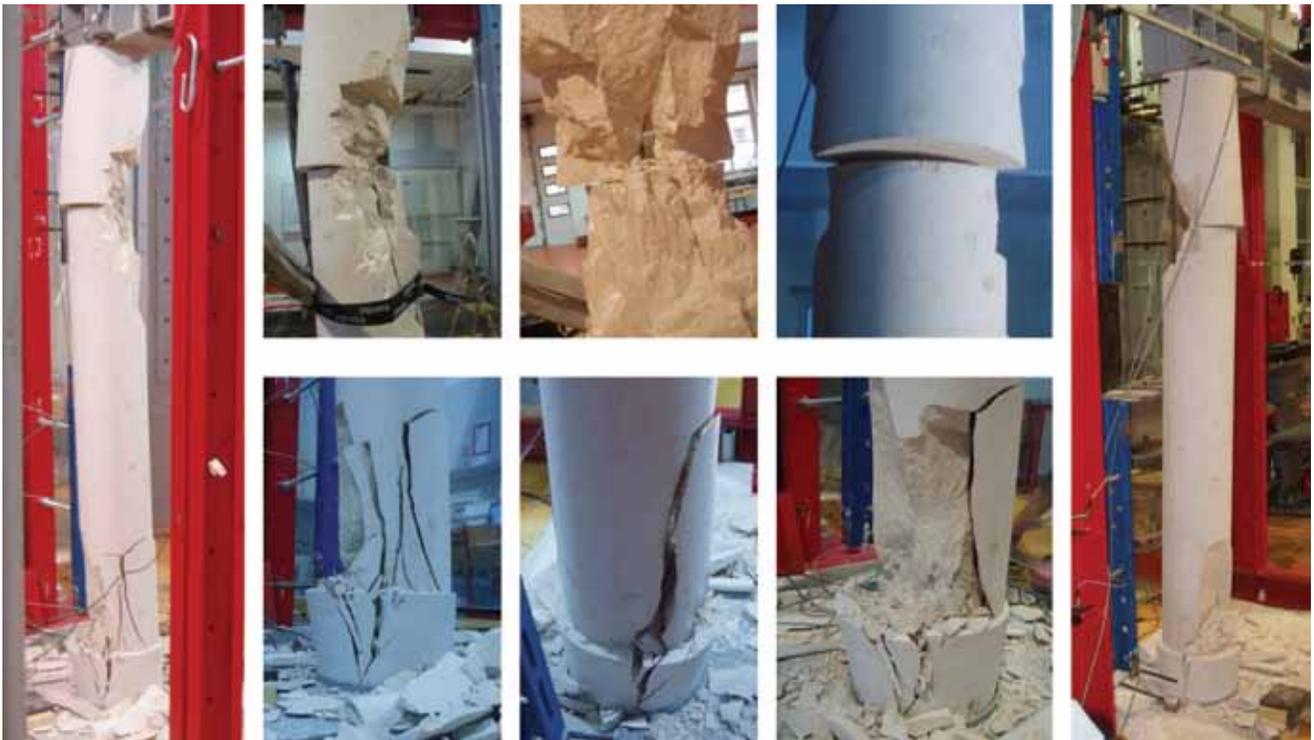
Figure 11. Sample K1 after failure [18]

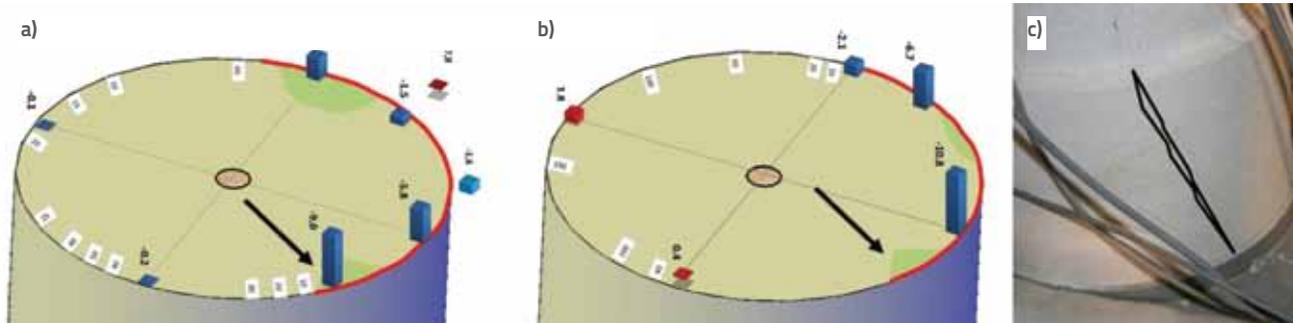
Figure 12. a) and b) Stress distribution in test phase of investigations for VS and DS (sample K3); c) First visible crack at the column base

in MM positioned 10 cm away from the contact face. In addition, the position of MM does not have to correspond to the position of the maximum concentration of stress. For instance, the position of stress concentration for DS (Figure 12.b – marked in green) is not located immediately below the MM. It is obvious that stress distributions obtained by numerical models (Figure 13.a) and laboratory testing (Figures 12.a and 12.b) correspond to each other. However, the importance of numerical calculations lies in the fact that they provide data about stress distribution in the entire sample, while extrapolation of stress onto contact faces is especially significant. Thus, according to numerical calculations for the critical position in DS, the stress concentration at the contact face greatly exceeds 10.8 MPa which has also been confirmed in the course of subsequent testing. The slight increase of centric force to 137 kN resulted in the opening of the first visible crack (Figure 12.c) in the vicinity of the marked stress concentration (Figure 12.b).

only 4.5% of the ideal bearing capacity, we can notice the propagation of the joint at the base and, at the place marked at VS (Figure 12.a), the stress value rises to 34.9 MPa. According to stress increase and numerical results, the strength at VS has already been exceeded, but the crack itself is not visible. After that, the eccentric load was applied and a new crack was registered at the centric force of 184.5 kN and at the eccentric

force of 66.8 kN (Figure 14.c). The crack occurred at VS near the marked position of stress concentration that was already noted in the test phase (Figure 12.a), and also in numerical models (Figure 13.a). As the position of the initial stress concentration was located on the side of the cross section influenced by capital weight, an additional increase in stress due to capital weight was too great, and the appearance of a

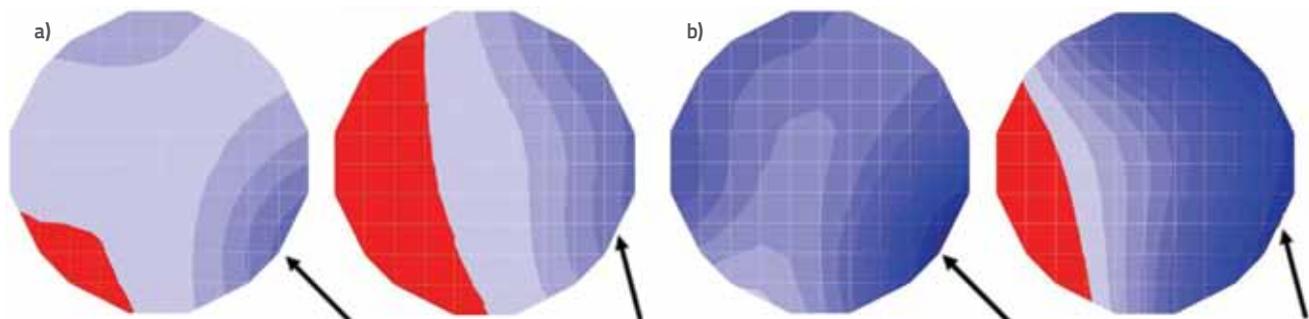
Figure 13. Redistribution of normal stress values at MM: a) 100 kN centric load (test) – VS and DS; b) 500 kN centric load – VS and DS [5]

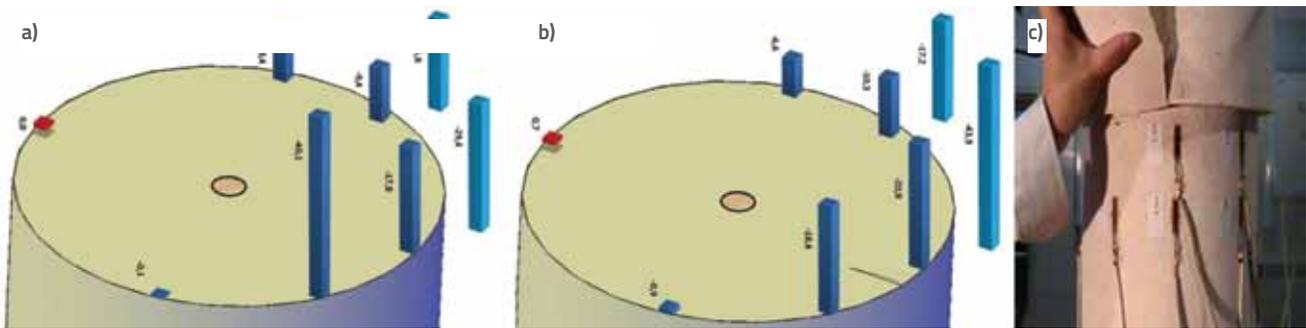
Figure 14. a) and b) Distribution of stress prior to and after crack opening at VS (sample K3); c) crack in capital (VS)

It is significant to note that eccentric load caused change in the angle of capital rotation with respect to column shaft for negligible  $0.033^\circ$ ! Similar values were also obtained for other samples, and all this corresponds well with current research results [7]. After the crack opening the described process is repeated, i.e. a new redistribution of stresses around the crack and a new state of balance is registered (Figure 14.a and 14.b).

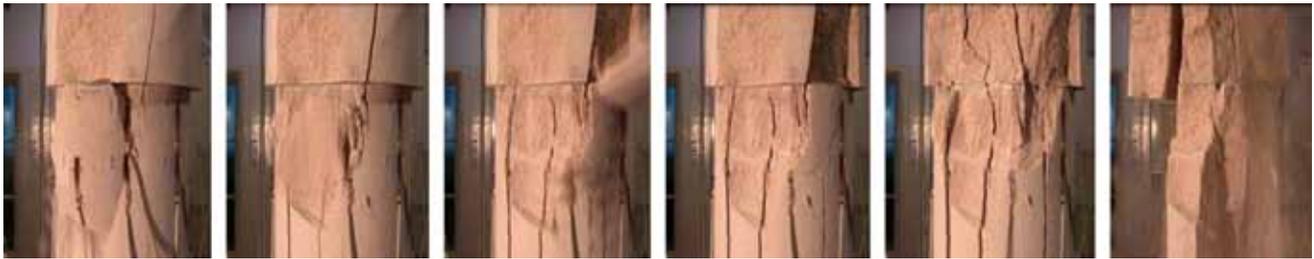
Figure 15. Sample K3 splitting until failure (VS) [5]

Subsequent testing and an additional increase in load resulted in a pronounced increase in stress in the vicinity of the capital positioning zone which points to propagation of existing cracks, but also to the opening of new ones. Unfortunately, all testing phases and results at all measurement points can not be described in the paper, and so the accent is placed only on typical behaviour of samples: establishment of stress concentration, crack opening, and redistribution of stress until the bearing capacity at the cross section is exceeded. The failure of the sample K3 occurred only after failure of a major part of the cross section, when the redistribution of stress was no longer possible (Figure 15).

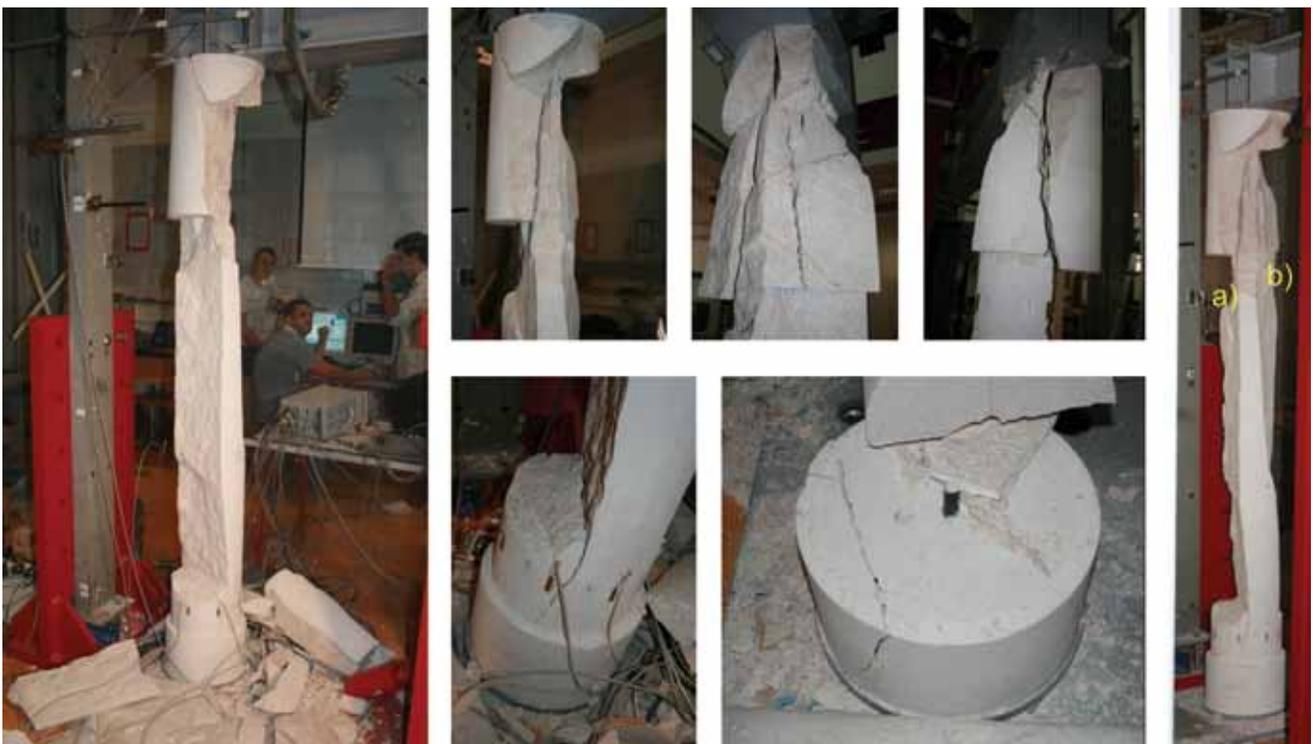
Figure 16. Sample K3 after failure [5]

Photographs of the broken sample (Figure 16) confirm the described course of testing, as the column splitting is visible at two points. The first failure surface is near the first crack in VS (marked with a), while the other one (marked with b) is situated in the part of the cross section that has assumed load after redistribution of stresses (Figure 14.b). In addition, the propagation of the first crack at the base was registered during sample disassembly. Results obtained for the sample K3 have confirmed some basic assumptions of this research, such as the significant damage to column even at a very low centric load, and pronounced susceptibility to eccentric load, i.e. relative rotation between column elements.
