Pregledni članak
Review article

OPTIMIZIRANJE BRODSKOG VIJKA S KONSTANTNIM USPONOM¹

OPTIMIZATION OF MARINE PROPELLERS WITH CONSTANT PITCH²

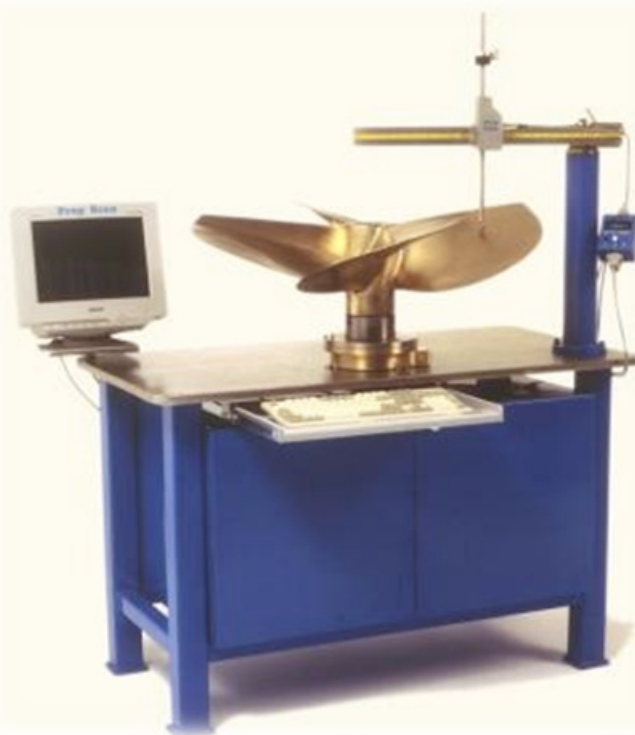
The Prop Scan system for the testing and diagnostics of propellers is shown in Figure 2. The system is made up of a work bench with a base for the propeller, and a crane with a measuring rod and sensor. The measuring rod with sensor extends over the propeller blade face going from the leading to the trailing edge according to the marked radii. The sensors gather information from the blade face for each degree of the propeller rotation on the base of the work bench, sending the data to the computer.

Slika 2. Prop Scan sustav za ispitivanje vijka
Figure 2 Prop Scan system for testing propellers

Prop Scan sustav za ispitivanje i dijagnostiku vijaka prikazan je na slici 2. Sustav se sastoji od radnog stola s postoljem za vijak, te od kрана s mjernom šipkom i senzorom. Mjerna šipka sa senzorom prelazi preko lica krila vijka u smjeru od ulaznog prema izlaznom bridu po označenim radijusima. Senzori prikupljaju podatke s lica krila za svaki stupanj okretaja vijka na postolju radnog stola i te podatke šalju u računalo.

The second part of the Prop Scan system consists of a computer equipped with programmes that analyze the data received. The measurement results are shown on the computer screen. The measurement is carried out by turning the propeller on the work base by 360°, which is the equivalent value of one complete pitch. Radii are marked by first placing a radius labelling spike on the measurement rod by

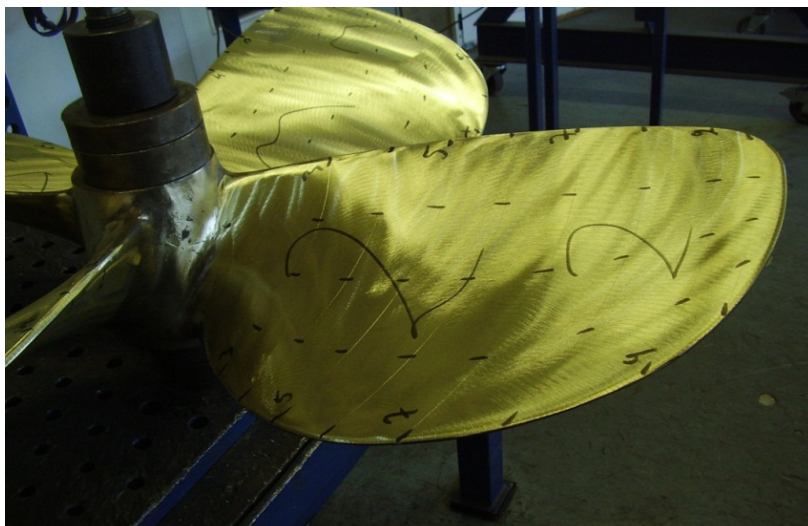
Slika 3. Mjerna područja lica krila vijka ribarskog broda
Figure 3 Measurement areas of the propeller blade face for a fishing ship

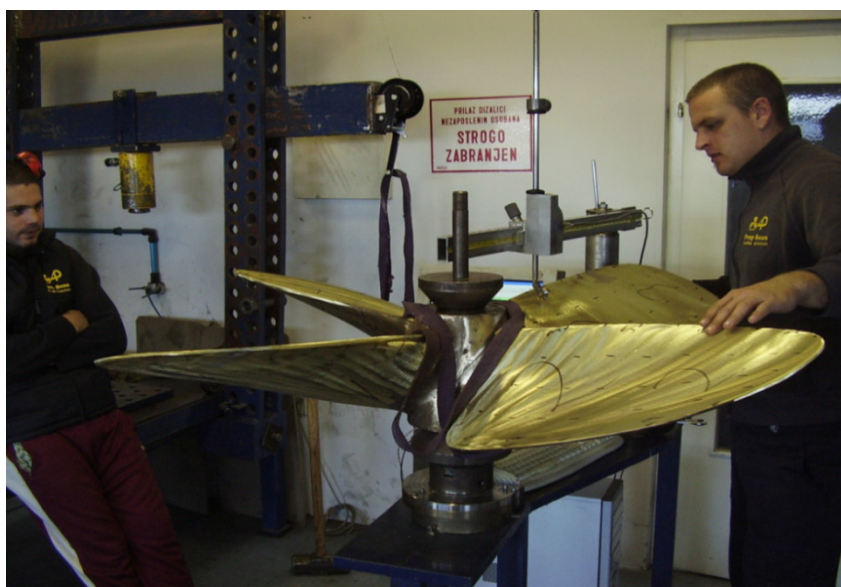
Slika 5. Postupak mjerenja vijka Prop Scan tehnologijom [1]
Figure 5 Procedure for measuring a propeller using the Prop Scan technology [1]
