GEODETTIC WORKS IN RESEARCH AND DEVELOPMENT PLAN IN REMEDIATION OF LANDSLIDE KOSTANJEK

KEYWORDS: City of Zagreb, landslide Kostanjek, surveying methods, high-risk areas

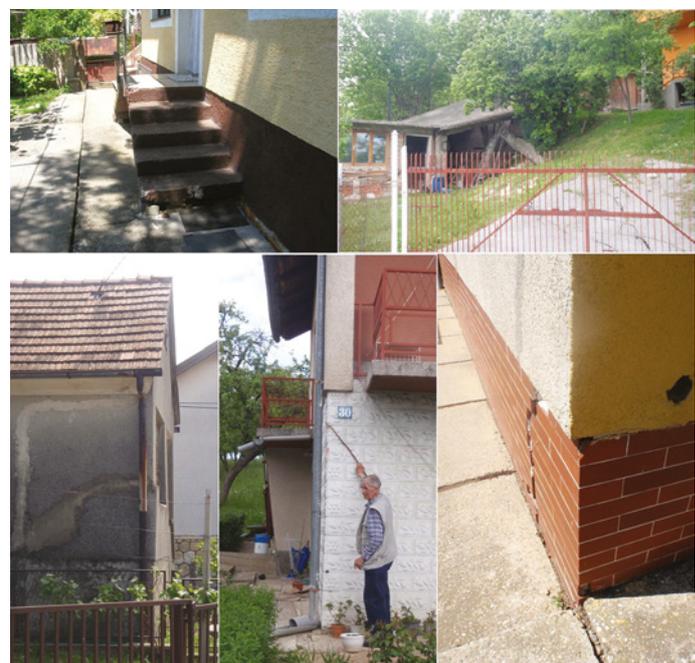
Slika 4.1. Monitoring plan for landslide Kostanjek

Within this project five houses with evident deformations, cracks and tilt caused by land sliding were measured (figure 4.1).

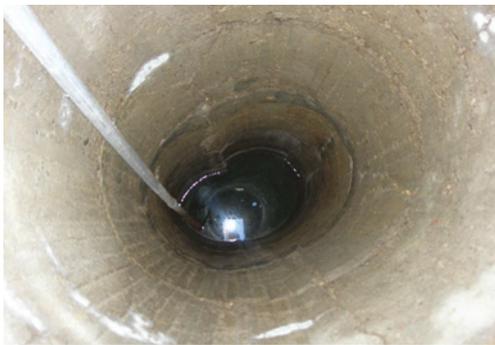
Slika 5.1. Analysed well

Primary objective of this research was measurement of shift and deformation of particular well (Figure 5.1) near north western border of landslide, while the final goal was to determine the direction and displacement of landslide movement in the vicinity of the well to develop landslide model for the particular well.

Analysed well is located right by the house which also shows visible shifts and deformations due to landslide movements. It is important to note that shift and deformation of this well represent landslide movement probably better than displacement and shifting of the house, because damaged zone in the well is located near the sliding surface, while the house which behaves as one solid body, does not necessarily move as the landslide moves.

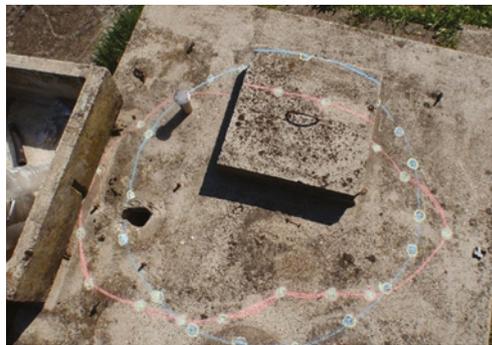
Slika 5.2. Cross sections on the upper side of the well

the well. Water level of analysed well was 5.57 m below the top of the well. First cross section of the well (blue) was determined for the top of the well, beneath the concrete plate (Figure 5.2), using direct method with measuring tape and wooden rod with centimetre scale. Second cross section of the well (red) was measured right above the water level, using plumb on the wooden rod with centimetre scale. However, it was impossible to place the plumb on the very inner side of the well due to the deformation and the outward shift of the well, so an estimation of the shift was made. Due to measurement technique and working conditions accuracy of the estimated shift was 0.10 m. After the cross sections were drawn out on the upper side of the plate, they were measured using total station (Figure 5.3). Cross sections were used for creation of 3D model of the well, which is the best way to present the size of the shift and shape of deformation (Figure 5.4, 5.5).

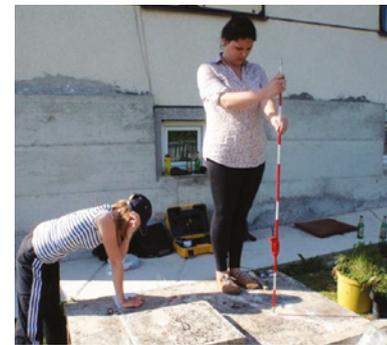
Slika 5.3. Measurement of cross sections
