Pozzolanic mortars for the conservation of old masonry structures

Professional paper

The design of repair mortars started from the characterization of the original mortar samples preserved in small areas in the floors of the Dungeon Tower, Bač Fortress. Two materials (waste brick and clay material) were investigated in order to select the pozzolanic material which later was a component of the repair mortar. Based on the compatibility test of the examined old mortars and of the newly developed mortars, slaked lime based, the mortar with the ground waste brick as a pozzolanic material was selected for the conservation treatment of the Dungeon Tower.

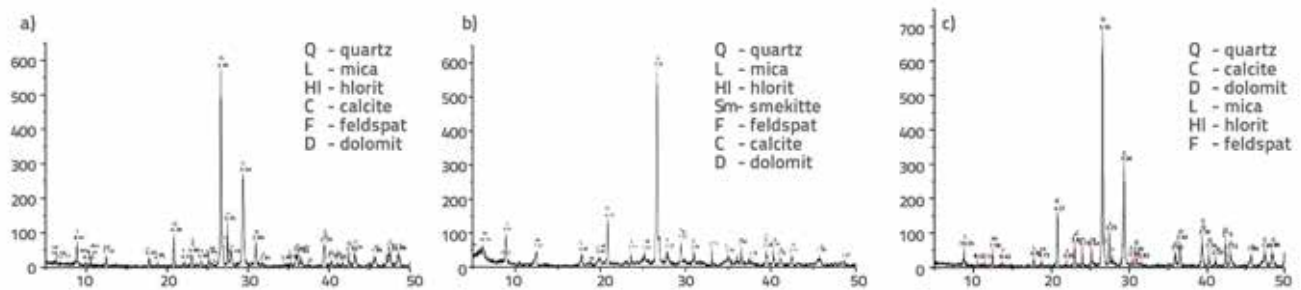
Figure 5. XRD analysis: a) local clay (used for the production of Pozz1 and Pozz2); b) crushed old brick (Pozz3); c) crushed brick fragments from the historic mortar sample TBM1

An important starting point for the design of repair/replacement mortars was the characterization of the old mortar and its historical context [7]. Based on results obtained by examination of the historical mortar TB M1 sample, and taking into account the fact that the lime mortar was the most widely used material in historical-artistic constructions, the newly designed mortars (DM1, DM2 and DM3) are lime-based materials [8]. These samples, Table 2., were prepared by mixing the aggregate (local sand) and a commercial hydrated lime with potentially pozzolanic materials (crushed old bricks and local fired clays), Figure 5.

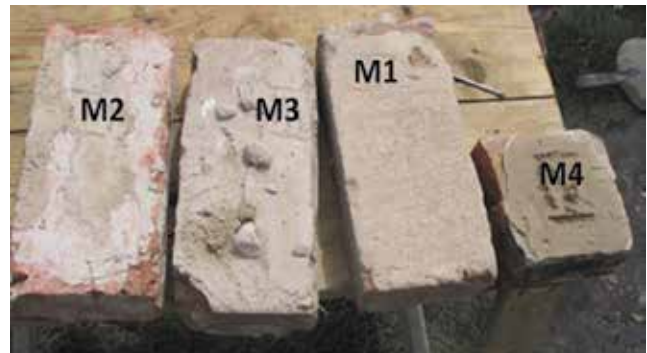
Figure 8. Testing workability and consistency of prepared mortars

Besides chemical, esthetical, physical or mechanical characterization that is generally made in the case of the newly developed materials, the conservators are also concerned about workability aspects [13]. The workability of a chemically compatible mortar can not be guaranteed in advance. Therefore, one or more application tests are often decided upon on site. Some in situ tests were performed to study workability and consistency of prepared mortars (Table 6). Prepared mortar samples were placed on glass plates in form of a truncated cone (cookies of about 9 cm in diameter) by manual vibration in order to assess volume consistency [14]. These steps were significant for defining aesthetic, adhesive, and mechanical properties of the newly designed samples M2, M3 and M4, which were to be used as finishing floor mortars. The mortar sample (M1) with the binder/aggregate ratio 1/5 was planned to be a base mortar that would be used together with M2-M4 finishing mortar samples. Some observations considering the differences between the applied mortars M2-M4 were made after 24 hours of drying in the shade, Figure 8. In the case of the mortar sample M2 the surface was cracked and rough with spots. The mortar sample M3 also had a rough

surface, but of a lesser intensity and with fewer crumbles. The last sample, the mortar sample M4, did not have visible cracks, and the surface was smooth as an adequate plasticity with the desired tonal effect was achieved.

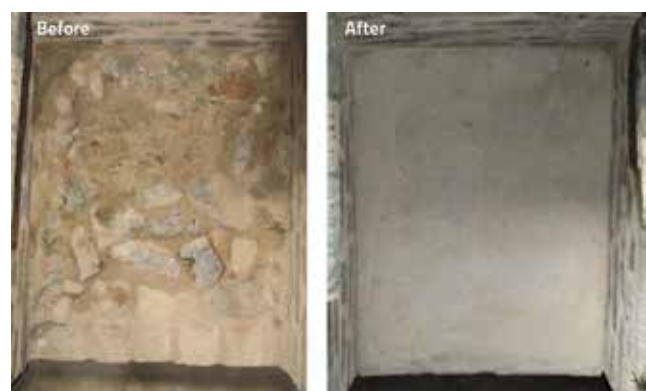
Figure 9. Appearance of the floor area before and after conservation treatment [4]

Taking into consideration laboratory results and results obtained by in situ testing of mortar samples, the M4 sample was finally selected for the conservation treatment of the Dungeon Tower floor area. This mortar satisfied numerous required properties such as: good hardening time and adhesion properties, good aesthetic appearance (colour, texture, surface finish), similarity to the authentic finishing mortar, and good workability without any cracks during the hardening process. After the mortar production and selection, the conservation treatment of the floor was performed. The following procedures were applied: the joints were carefully cleaned (by washing with water, and by removal of all loose parts of the bricks and mortars) and the base mortar M4 was applied, Figure 9.
