BASIC ASSUMPTIONS FOR THE RESEARCH OF STRESS-DEFORMATION STATE OF DAMAGED REINFORCED CONCRETE COLUMNS OF CIRCULAR CROSS-SECTION

Matija Orešković

Review article

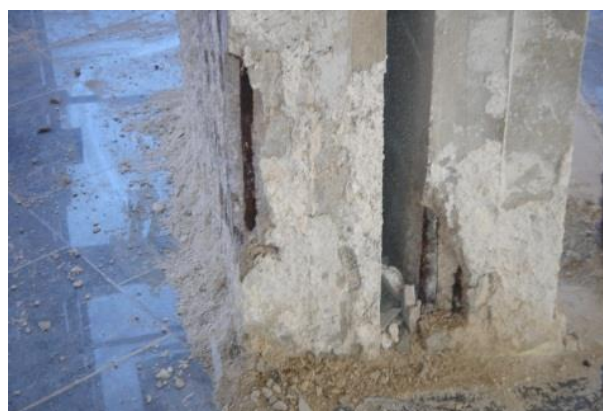
Figure 1. Examples of types of damage noticed in old buildings

When we compare this pattern of damage to the samples from the beginning of the article which were noticed in the buildings from the previous century (age 40 and over), the similarity is clear and unambiguous. We can conclude that the columns of the buildings suffered not only from the deterioration of the structure (and everything that this cause carries), but also from long-term or short-term loads. The basic features of this type of damage are the following:

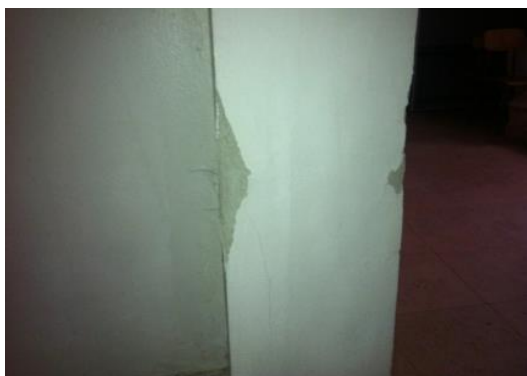
Figure 2. Repair of column damage caused by long-term exploitation

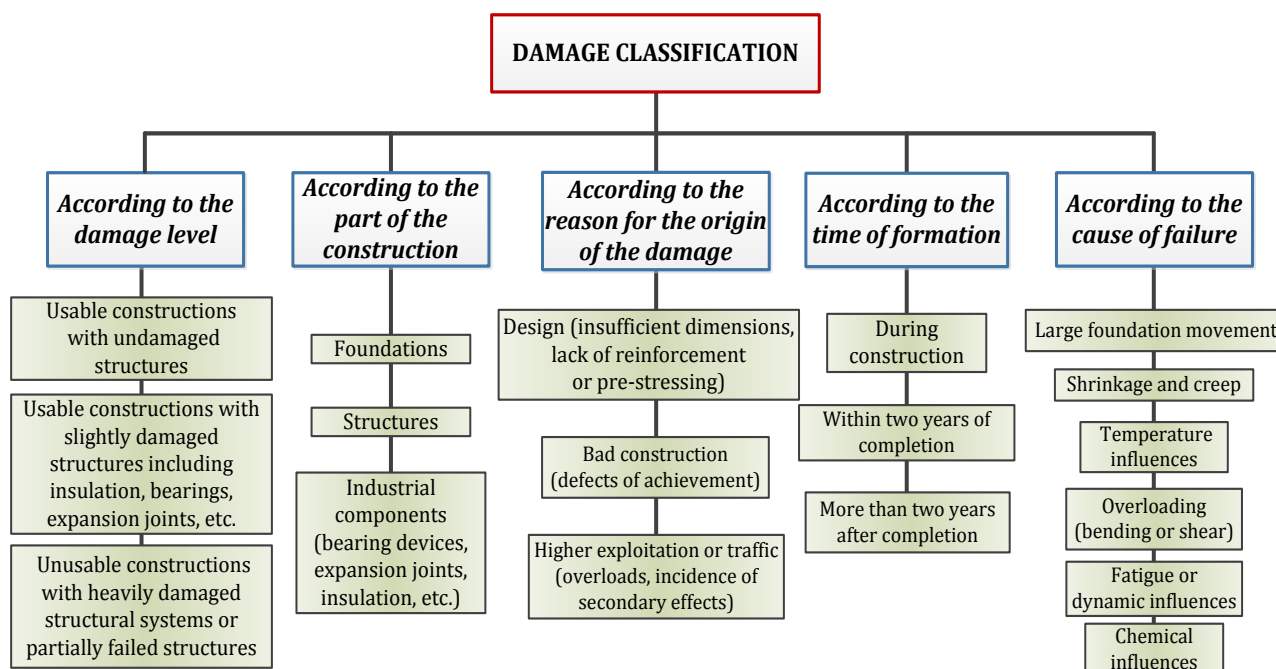
Figure 3. Damage classification scheme

The RILEM (International Union of Laboratories and Experts in Construction Materials, System and Structures) technical committee DCC-104 in 1991, after a three-year work brought out a state-of-the-art report on the classification of damage in concrete structures [3]. In summary, it can be said that most of the damage to concrete structures originates due to the generally poor design (design phase of construction), poor technology and poor quality of construction materials (construction phase), overloading of the structure (exploitation phase, but also the design!) and from a variety of atmospheric and chemical influences. The actual classification can be illustrated by the following picture:

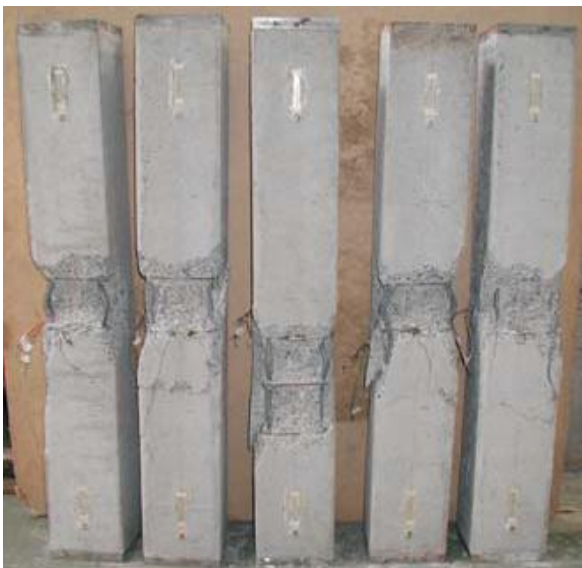
Figure 4. Characteristic damage of columns subjected to axial force (J. Němeček et al.)

The type of damage of the tested samples after their fracture was particularly noted during the review of the research. It has been noticed that the fracture is locally oriented, of certain "wedge" type/appearance, that it is placed on or around the middle of the column, and that the length of the damaged part is 20-30% of the total column length. This is particularly noticeable in research by Němeček J. et al. [19], Rabie M. [20] (Figure 4 and 5).

- they appear near the center of the column,
- identical “wedge” shape,
- damage depth is between $R / 2$ and R (radius),
- height of the damaged section is between 20-30% of the total column height,
- strong deformation of reinforcing bars in the damaged part (though still plastic).

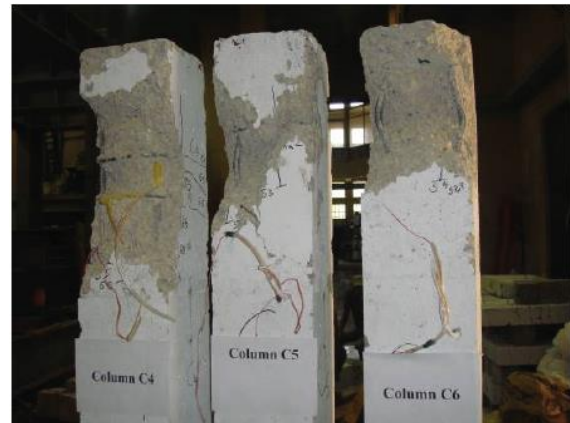
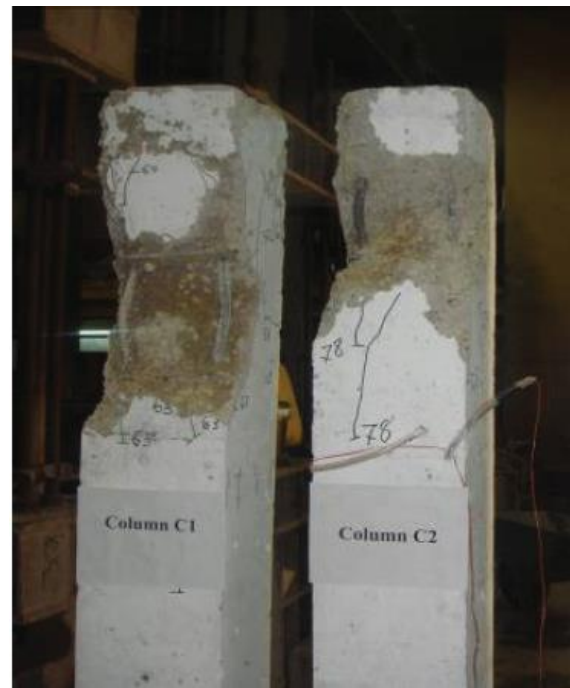
Figure 5. Characteristic damage of columns subjected to axial force. Columns damaged in the upper zone because that part of the column was made from poor concrete (Rabi M.)
