## RESEARCH ON DEFORMATIONS WHICH APPEAR IN WITHIN THE METAL STRUCTURES OF MINING EQUIPMENT

Preliminary Note – Prethodno priopćenje

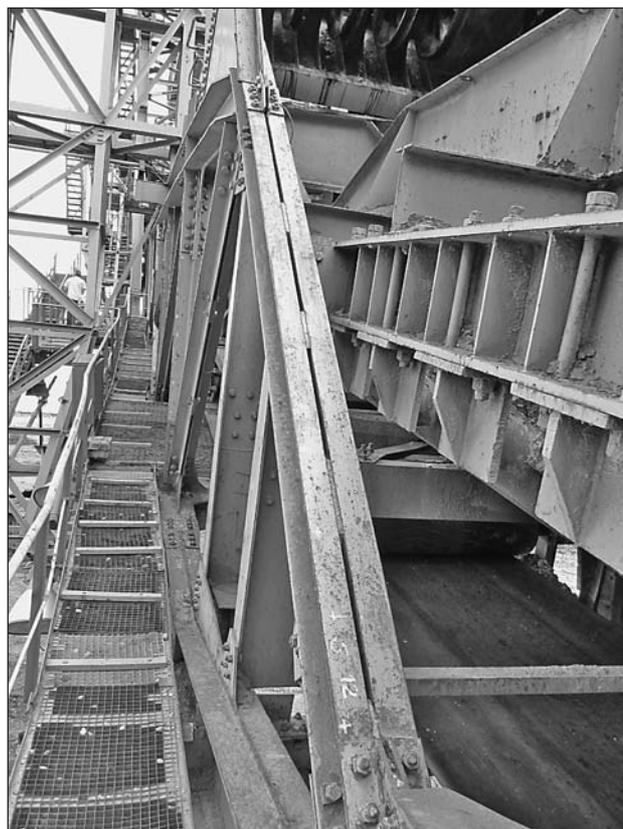
Figure 2 The deformed element of the excavator arm

intergranular corrosion phenomena and high mechanical requests. Thus in the first phase of experimental research it was visually analyzed the deformations area and were not found superficial corrosion areas where is currently a continuously coating layer Figure 2. Also, the method of deforming the excavator arm element is shown in Figure 3.

From the results shown in Table 2 it can be observed the fact that the thickness of the KL element is approximately 10,9 / mm, and this size is formed from a layer of paint and oxide plus the thickness of the metal part. After the measurements was found that in the area of points 9 ÷ 11 is the thickest layers of paint and oxides, and in this area there is the smallest thickness of the metal layer, namely the thickness is reduced by 5-6 / % in relation to the new state. In these conditions it was observed that in this area the maximum deformation which extend and has an increasing length.
