CONTRIBUTION TO THE STUDY OF EFFECTS OF SURFACE STATE OF WELDED JOINTS IN STAINLESS STEEL UPON RESISTANCE TOWARDS PITTING CORROSION

Received - Priljeno: 2006-03-14
Accepted - Prihvaćeno: 2007-02-20
Preliminary Note - Prethodno priopćenje

I. Juraga, V. Šimunović, Đ. Španiček, Faculty of Mechanical Engineering and Naval Architecture University of Zagreb, Zagreb, Croatia

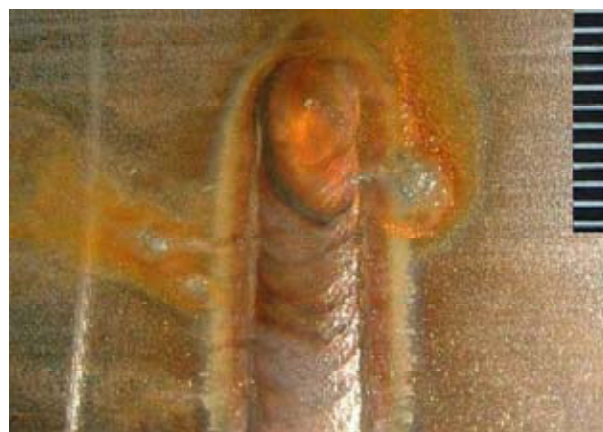
Figure 4. Results of field test of resistance towards microbiologically influenced corrosion on a welded joint
Slika 4. Rezultat terenskog korozijskog ispitivanja otpornosti na mikrobiološki poticanu koroziju na zavarenom spoju

Selection of results of conducted pitting corrosion testing is shown in Figure 3. Comparison with results of field-testing of untreated welded joint to the microbiologically influenced corrosion in raw water is presented on Figure 4. It can be noted that even to the microbiological colonies inhomogeneity of surface is highly attractive as a location for their habitat and initial point of damaging that will develop as a product of their metabolism.

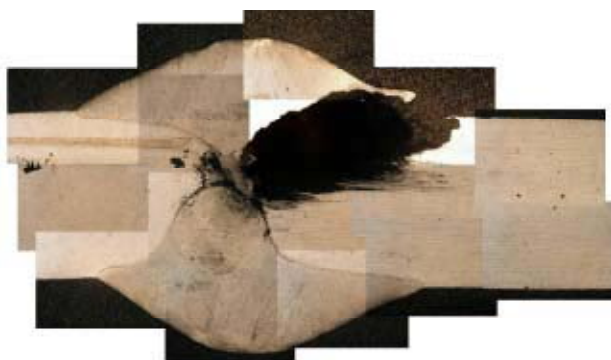
Figure 6. Presentation of a real corrosion damage initiated at the fusion line of AISI 304L welded joint caused by microbiologically influenced corrosion in form of pitting (water tank, 3 months in use, thickness of the base material: 4 mm)

of aggressive particles, mainly chlorides, within the pit has been established. Results of conducted tests and comparison with real corrosion damages are given in Figures 5. - 8.

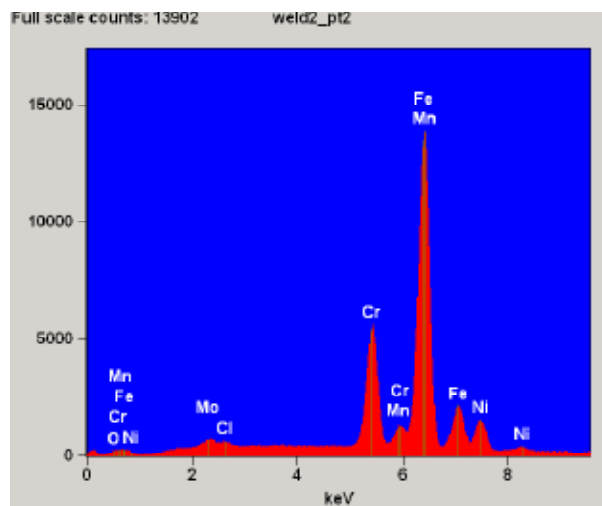
Figure 7. Presentation of EDX analysis of non damaged metal - outside pit

Testing has been done on characteristic surface areas, i.e. at the fusion line and heat tint zones on all samples. Testing results confirm that significant changes in content of major alloying elements which are necessary for corrosion resistance of stainless steels can be found on the “as welded” surface close to weld bead.

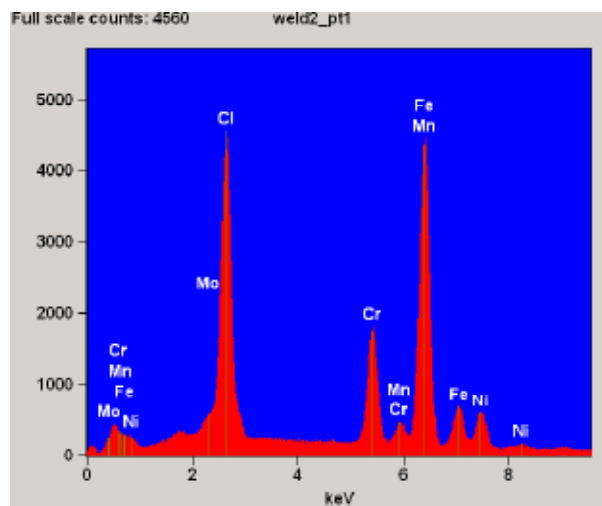
Figure 8. Presentation of EDX analysis of deposits within pit

Moreover, numerous inhomogeneities enhance initiation of corrosion deterioration. Additionally, accumulation
