GOMABN 53, 3, 248-260

Stručni rad / Professional paper

EXAMINATION OF CORROSION CAUSE OF WELDED PIPES

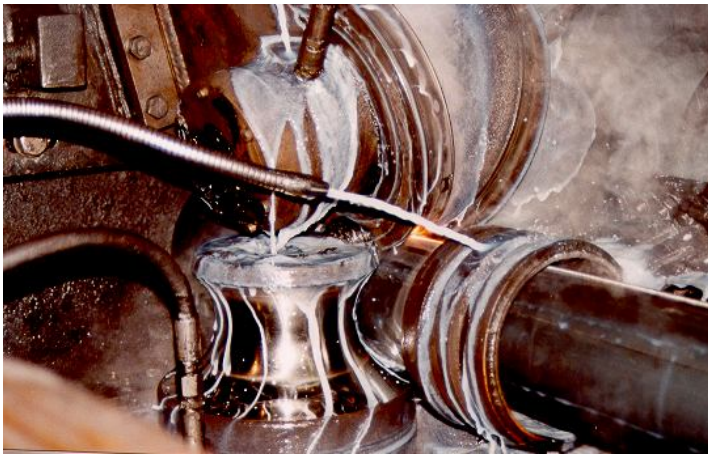
Figure 1: Cooling of an impeder with a cooling emulsion during pipe welding

After the heat processing, the pipes are cut to the proper length, cooled and examined in accordance with current standards, packed and stored [5-7]. During the manufacturing process of both precise and hot-rolled pipes, in several process phases the pipes come in the contact with the emulsion Fig. 1.

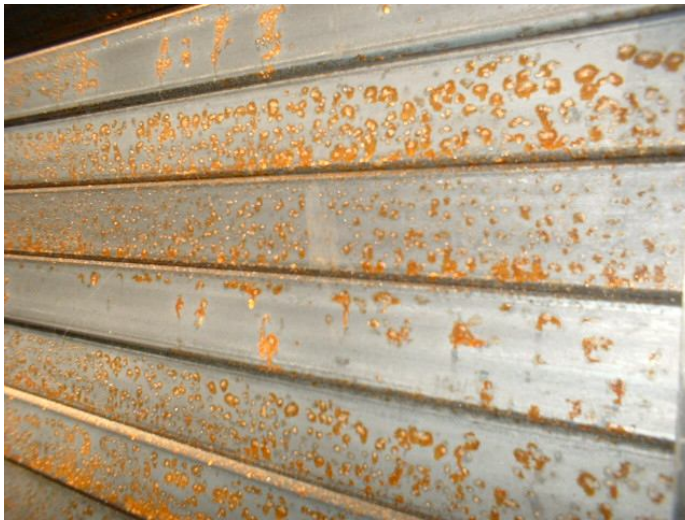
Precise welded pipes, size 25 mm x 25 mm x 2 mm were rolled from hot-rolled steel band of S240 quality, thickness 2 mm. Hot-rolled welded pipes, size 12.7 mm x 2.65 mm and 38.1 mm x 3.25 mm were rolled from hot-rolled band of S240 quality, thickness 3.8 mm. The corroded precise welded pipes in the rolling mill storage are shown on Figure 2.

Figure 2: Corroded precise welded pipes 25 mm x 25 mm x 2 mm

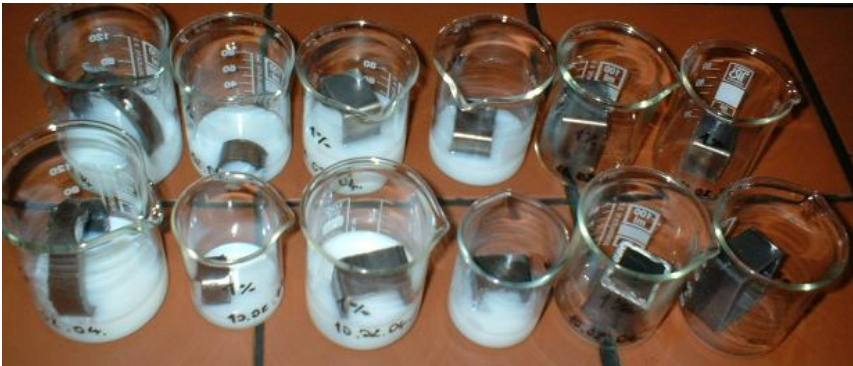
The pipes which were immersed in the emulsion and exposed to different temperatures did not corrode, not even in traces. In the conditions of increased humidity there was no corrosion on the pipe surface. The results of all examinations have shown that there was no corrosion in any of the tested emulsions of different quality, even with the smallest portion of concentrate i.e. 1 %. Slight corrosion that appeared on a cut while cutting the pipe samples for dry testing did not spread while treated in the emulsion containing 1 % EM-BU. In the pipe production process the emulsion comes in contact with the pipe surfaces. The task of the working emulsions for metalworking is the protection during the process and in interphase times. To protect the materials against the corrosion, especially the sensitive ones, during their storage or transport the additional protective agents are required [18].

Figure 8: Corrosion examination on pipe samples in 1 % emulsion, immersed and coated only, without immersing

Based on a suspicion of insufficient working emulsions EM-BU anticorrosion properties, the detailed examinations of the emulsions in the absence and in the presence of the cut parts of the pipe were carried out. There was no evidence of any corrosion on the pipe surface. Therefore it can be concluded that the emulsion did not cause the pipe corrosion during storage.
