MOZAIK “KAŽNJAVANJE DIRKE” U PULI, KONZERVATORSKO-RESTAURATORSKI OSVRT

“THE PUNISHMENT OF DIRCE” MOSAIC AT PULA, A CONSERVATION-RESTORATION REVIEW

Nastavljajući projekt Arheološkog muzeja Istre kojim se želi dokumentirati stanje i planirati budućnost pulskih spomenika, obavljena je analiza antičkog mozaika s prikazom kažnjavanja Dirke, zajedno s okolnim zidovima i freskama. Analiza je uključila sakupljanje dokumentacije o mozaiku od vremena njegova otkrića, izradu fotogrametrijskih snimaka, laboratorijske analize te mapiranje prisutnih degradacija. Ovim se člankom želi sažeto prikazati rezultat tih radova, uz osrv na moguće potrebne konzervatorsko-restauratorske zahvate te one usmjerene na ponovnu valorizaciju lokaliteta.

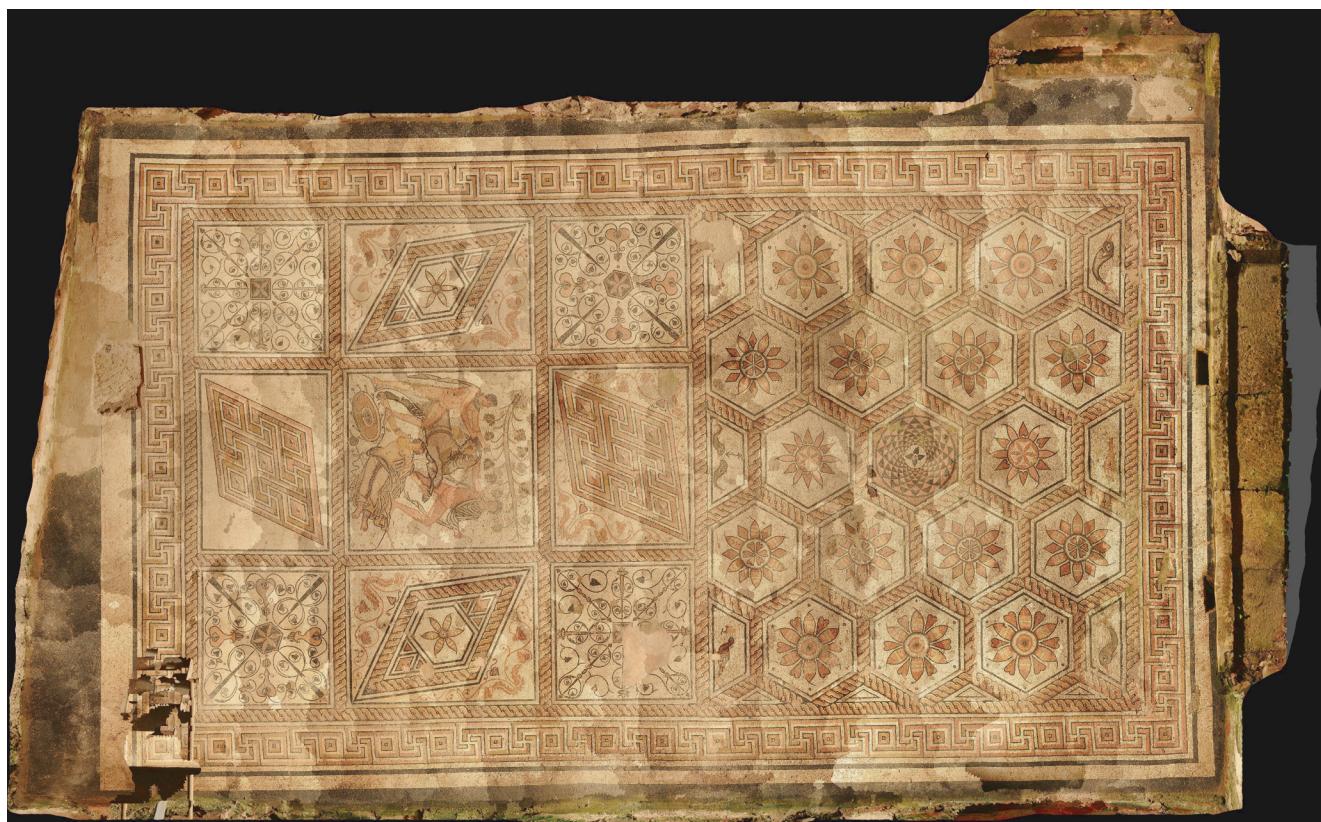
Sl. 1 Mozaik s prikazom kažnjavanja Dirke.
Fig. 1 The mosaic showing the punishment of Dirce.

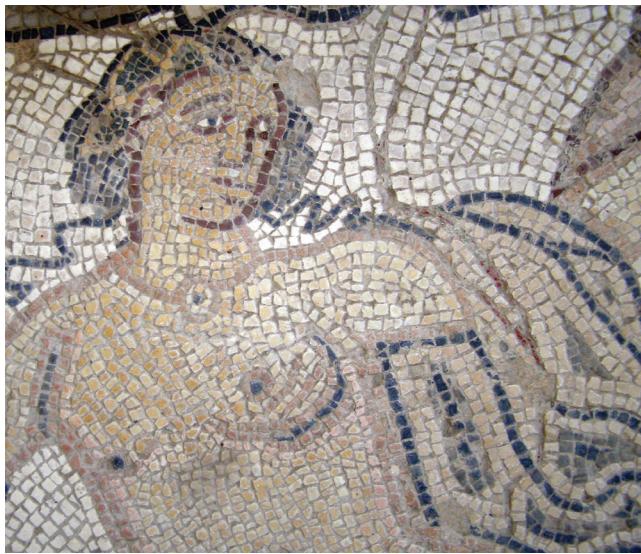
Sl. 2 Detalj motiva s Dirkom, desno od lica vidljivi su tragovi biča s ostacima tesera od staklene paste.

Fig. 2 A detail of the motif with Dirce, visible to the right of the face are traces of a whip with remnants of tesserae made of glass paste.

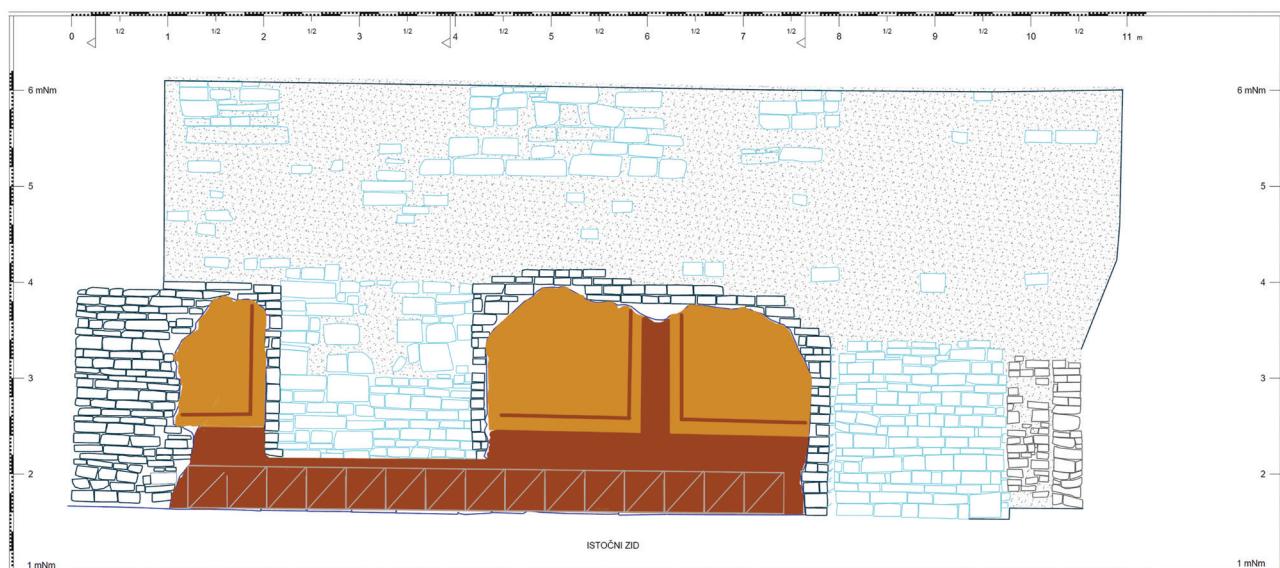
Sl. 3 Idejna rekonstrukcija slikanog sloja istočnog zida (izradila L. Milotić Bulić).

Fig. 3 A conceptual reconstruction of the painted layer on the eastern wall (made by L. Milotić Bulić).

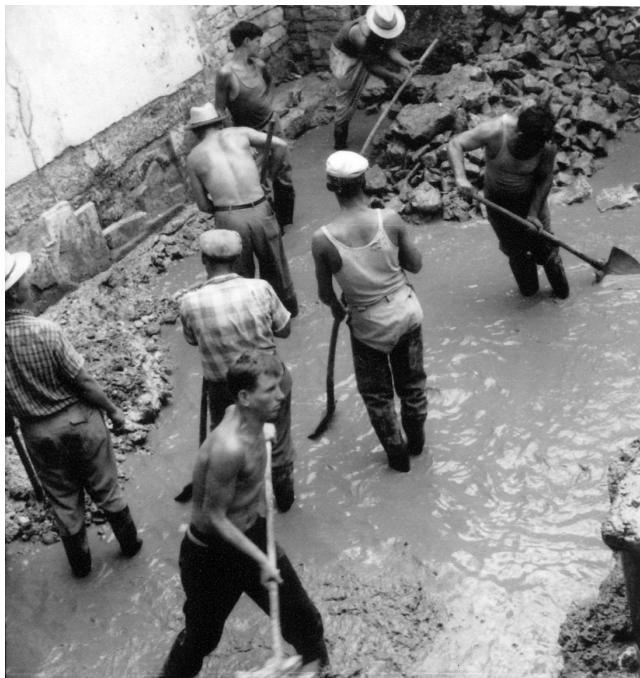
Sl. 4 Pripreme za novu podlogu, vidljiva je linija do koje se podiže razina vode (Fototeka AMI-ja, fotonegativ 25866).

Fig. 4 The preparations for a new substrate, visible is a line that marks the level to where the water rises (Photo archives of the Archaeological Museum of Istria, photo-negative no. 25866).

Godine 1964. mozaik je odvojen od originalne podloge koja je zamijenjena novom, vjerojatno od armiranog cementnog morta. Glavni razlog podizanja mozaika bila je činjenica da je često poplavljivao zbog prodora podzemnih voda na njegovu površinu. Prilikom podizanja, a vjerojatno i prije toga, mozaik je oštećen⁸.

In 1964, the mosaic was separated from its original substrate that was exchanged with a new one probably made of reinforced cement mortar. The main reason for the raising of the mosaic was the fact that it was frequently inundated with subterranean waters. During this process, and probably even before that, the mosaic was damaged⁸.

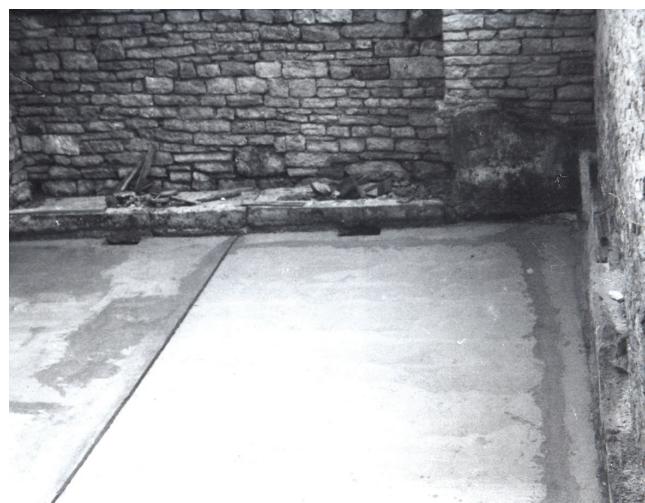
Sl. 5 Nova cementna podloga i odvodi vode za budući mozaik (Fototeka AMI-ja, fotonegativ 25873).

Fig. 5 The new cement substrate together with the drainage channels of the future mosaic (Photo archives of the Archaeological Museum of Istria, photo-negative no. 25873).

The conservation-restoration interventions on the mosaic began in 1964. Before this, in 1962, M. Medić requested the Museum to perform a systematic measurement of the subterranean water level in the area of the Roman mosaic. In accordance with the results of this measurement, M. Medić would then make a study for the conservation of the mosaic⁷. We are not aware of any data that came from these measurements, nor do we know if the water was fresh, salty or brackish. In any case, a drainage channel was erected on the southern side of the mosaic, which resolved the problem associated with water (Fig. 5).

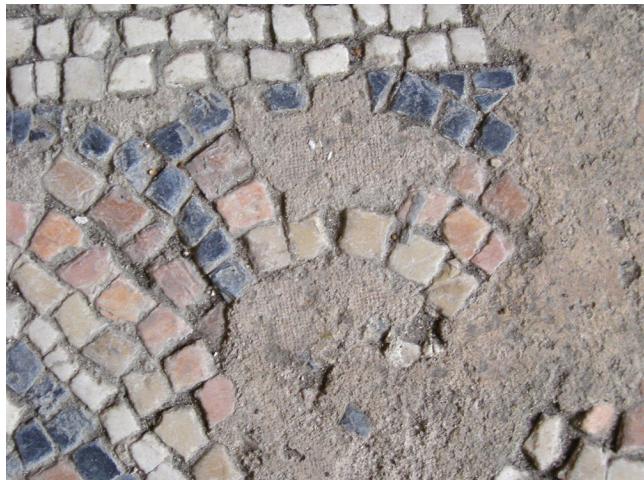
Sl. 6 Mozaik sa žbukom na kojoj su vidljivi tragovi tkanine korištene pri podizanju.

Fig. 6 The mosaic together with mortar that bears visible traces of a textile fabric that was used to raise the mosaic.

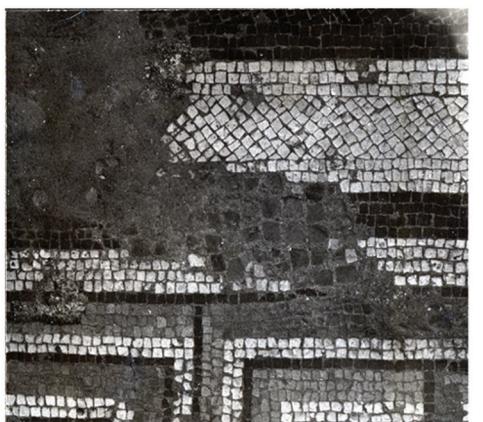
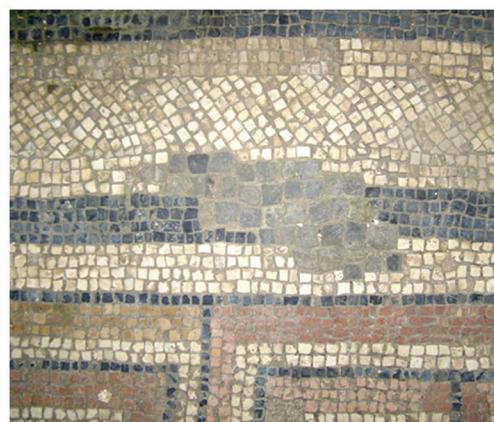
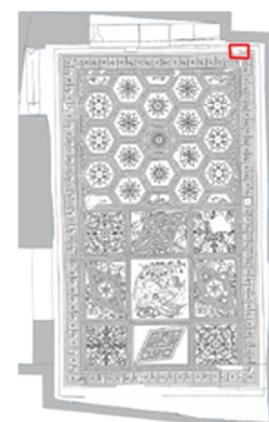
1958.-59. Dokumentacija AMI-ja. Fn. 9332 03.01.2013.

Sl. 7 Usporedba degradacija pri pronalasku mozaika i nakon zahvata 60-ih godina.

Fig. 7 Comparison of degradations at the time of discovery of the mosaic, and after the intervention in the sixties.

² See figure 7 further on in the text, showing a reconstruction that differs from the original as far as size, material type and quality of workmanship are concerned.

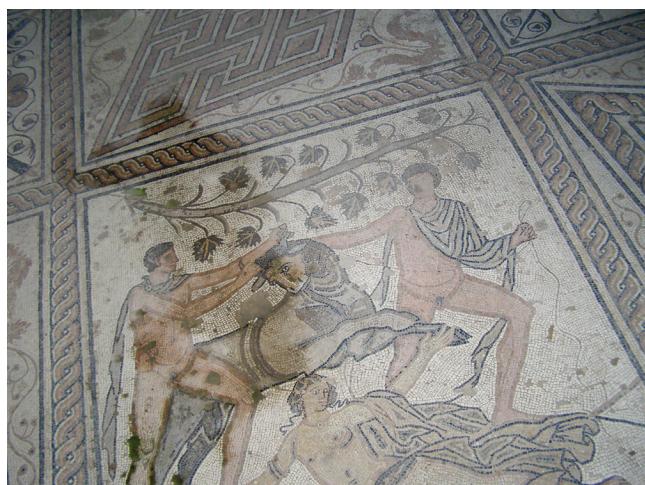
Sl. 8. Centralni motiv mozaika - vidljive su mrlje vlage i zelene cementne površine prekrivene kolonijama algi.

Fig. 8 The central motif of the mosaic - visible are stains caused by humidity, as well as the green cement surfaces covered by colonies of algae.

Dust and earth are deposited on the mosaic, frescoes and walls, and with the presence of water, vegetation develops there (Gobić-Bravar 2011, 184). There is an active biological patina on the mosaic, which can be identified as algae (Malinar 2001, 38–42). Not only does it negatively affect its appearance, but it also penetrates and expands into the already damaged surface of tesserae. Their surface is damaged when common microorganisms through metabolism secrete sulfuric acid ($2 \text{SO}_2 + \text{O}_2 + 2 \text{H}_2\text{O} \longrightarrow 2 \text{H}_2\text{SO}_4$) that when in contact with calcium carbonate transforms into calcium sulfate ($\text{H}_2\text{SO}_4 + \text{CaCO}_3 \longrightarrow \text{CaSO}_4 + \text{H}_2\text{O} + \text{CO}_2$) (Fiorentini Roncuzzi, Fiorentini 2001, 191), salt that is dissolved in water, which affects tesserae with cavities and flakiness. The presence of algae has been noticed mainly on the cement fillings of the mosaic. There are only two areas of the mosaic, where algae are also spreading onto the surface of tesserae.

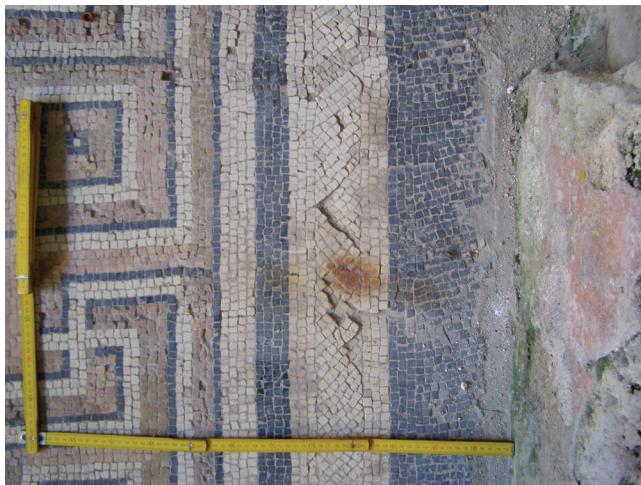
Sl. 9 Mrlja od hrđe.

Fig. 9 A stain caused by rust.

Some of the stains on the mosaic cannot be removed, but an attempt should be made to remove at least those that were created after the discovery of the mosaic - stains made with rust particles and ink, as well as scale.

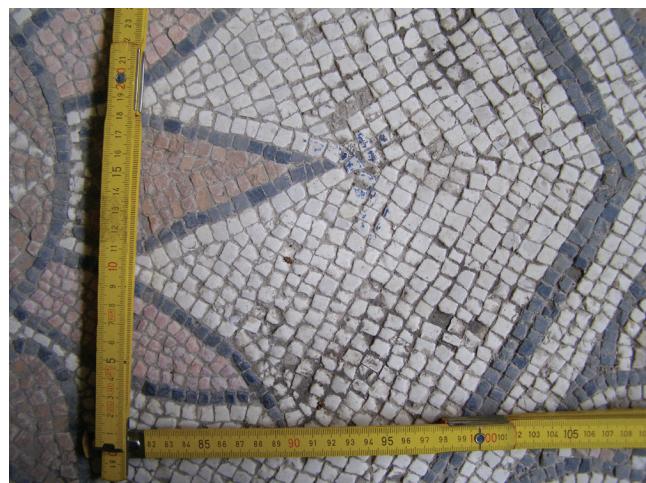
Sl. 10 Plava mrlja, vjerojatno od tinte.

Fig. 10 A blue stain, probably spilled ink.

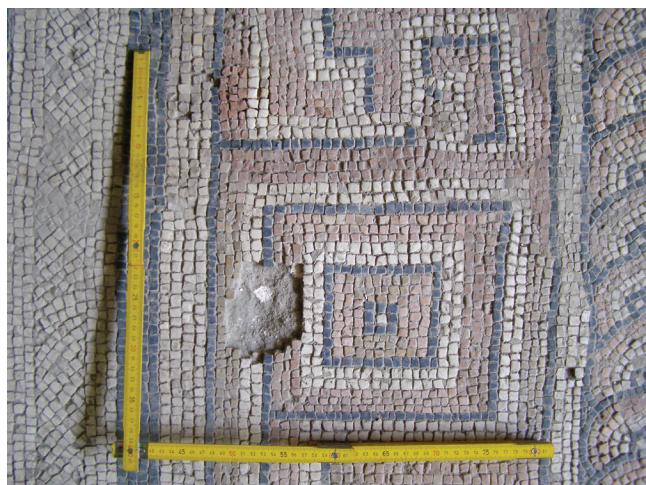
Sl. 11 Primjer nedostajućih tesera i površine bez opšava.
Fig. 11 An example of missing tesserae, and an area devoid of bordering.

Some tesserae are not protected with a bordering and that could result in their loss when cleaning and/or walking over them. On a certain spot alongside the threshold that separates rooms 3 and 4¹³, vegetation caused some tesserae to separate from the substrate.

The areas lacking a bordering should be grouted. Although cement was used for the interventions carried out on the mosaic to date, a responsible conservator-restorer cannot recommend a cement mortar for this kind of intervention. Irrespective of the fact that this means the introduction of yet another material, the fillings should be made with a lime mortar. This mortar can be removed without damaging the mosaic if such a move is ever required, and that is not the case with a cement mortar.

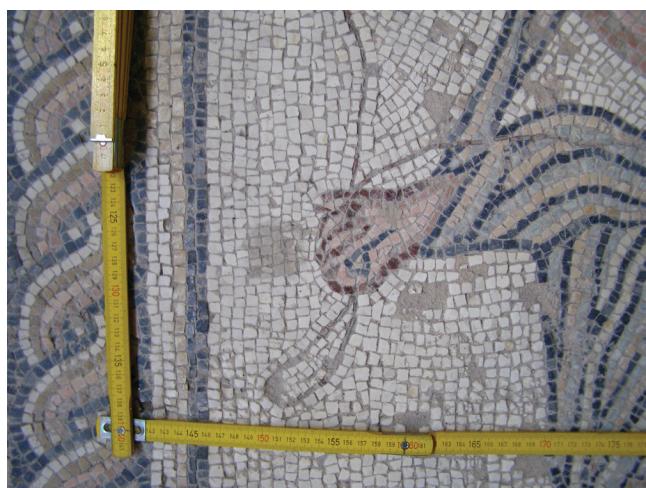
Sl. 12 Detalj bića s nedostajućim teserama od staklene paste.
Fig. 12 Detail of the whip with the missing tesserae made of glass paste.

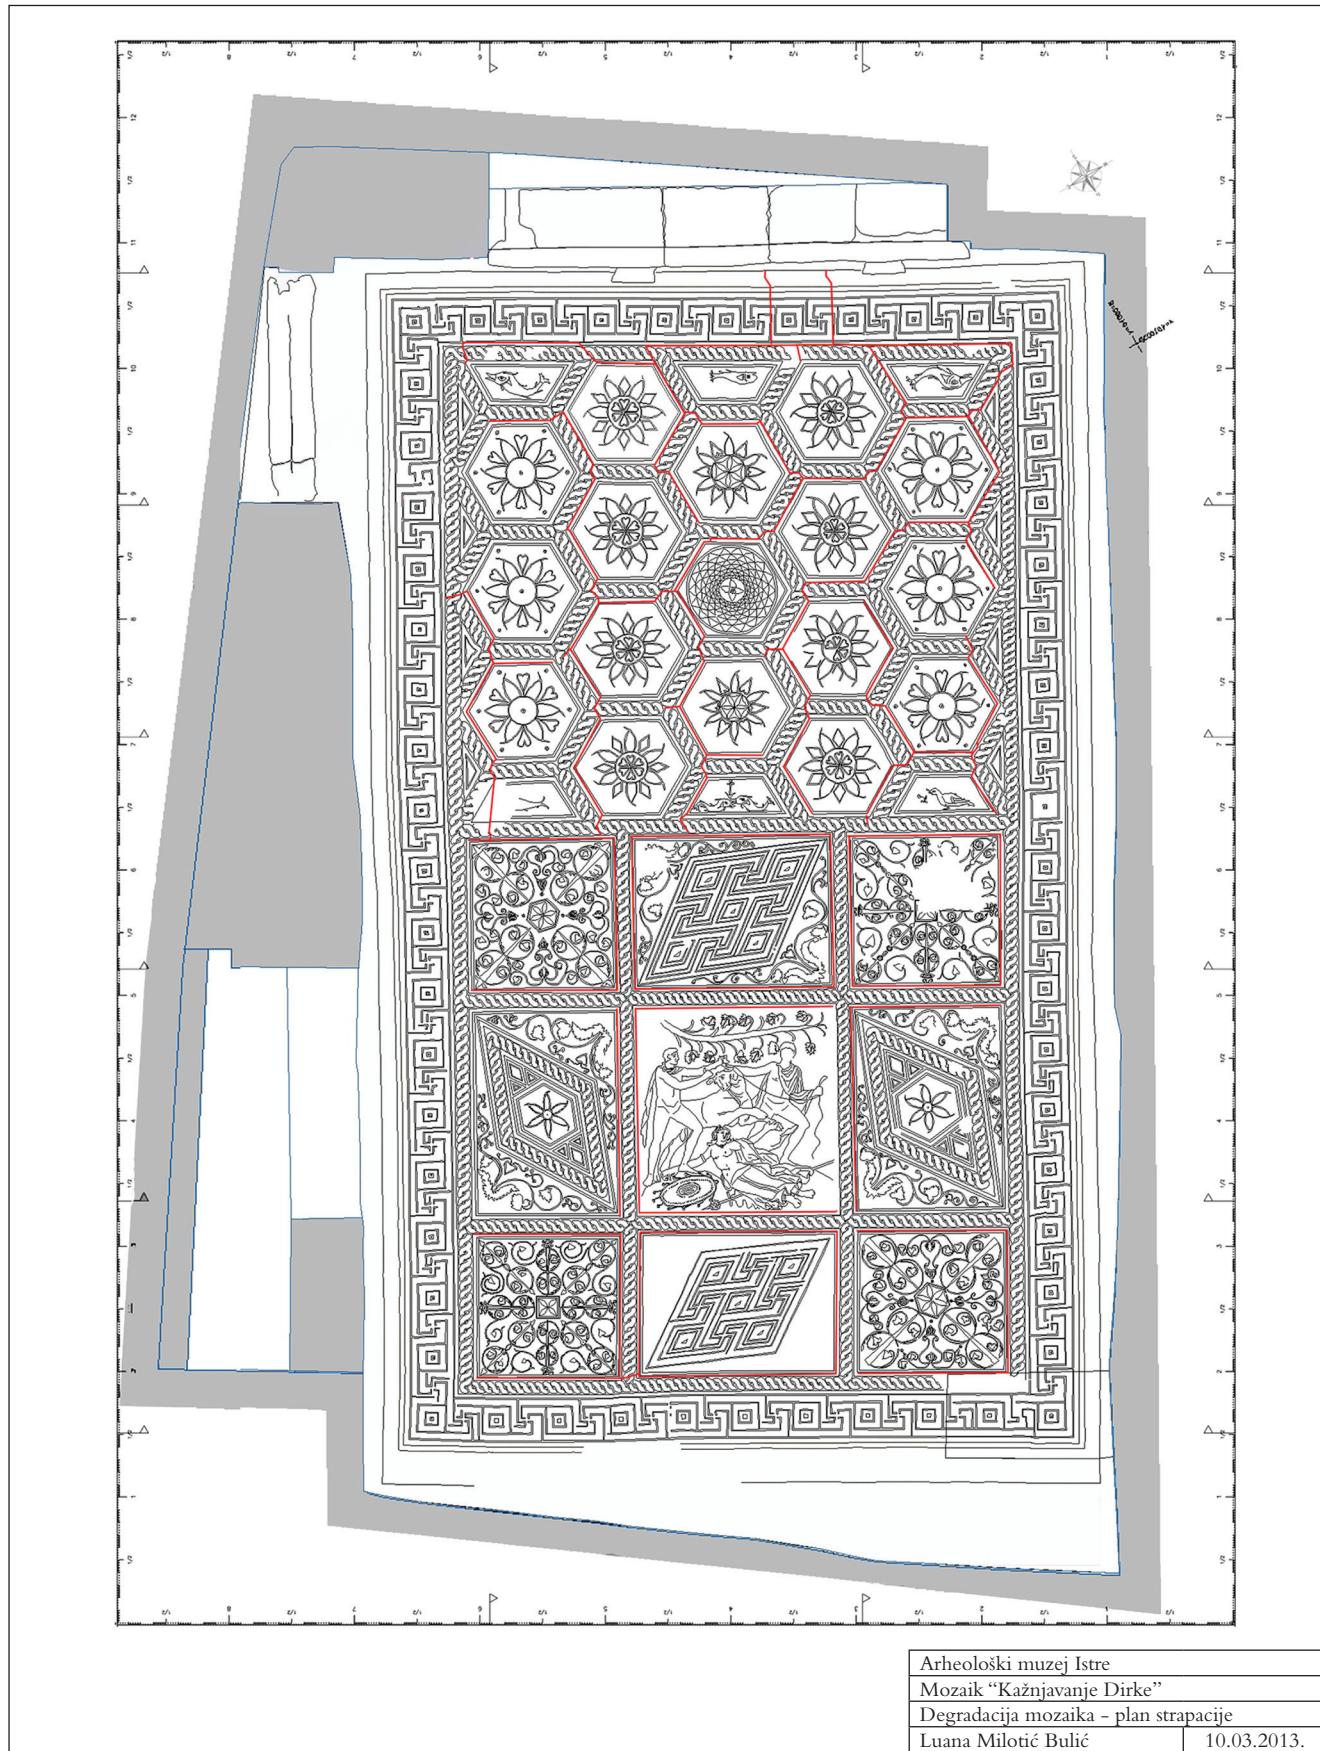
T.I Grafički prikaz idejnog plana podizanja mozaika.

P.I Graphic display of the preliminary plan to raise the mosaic.

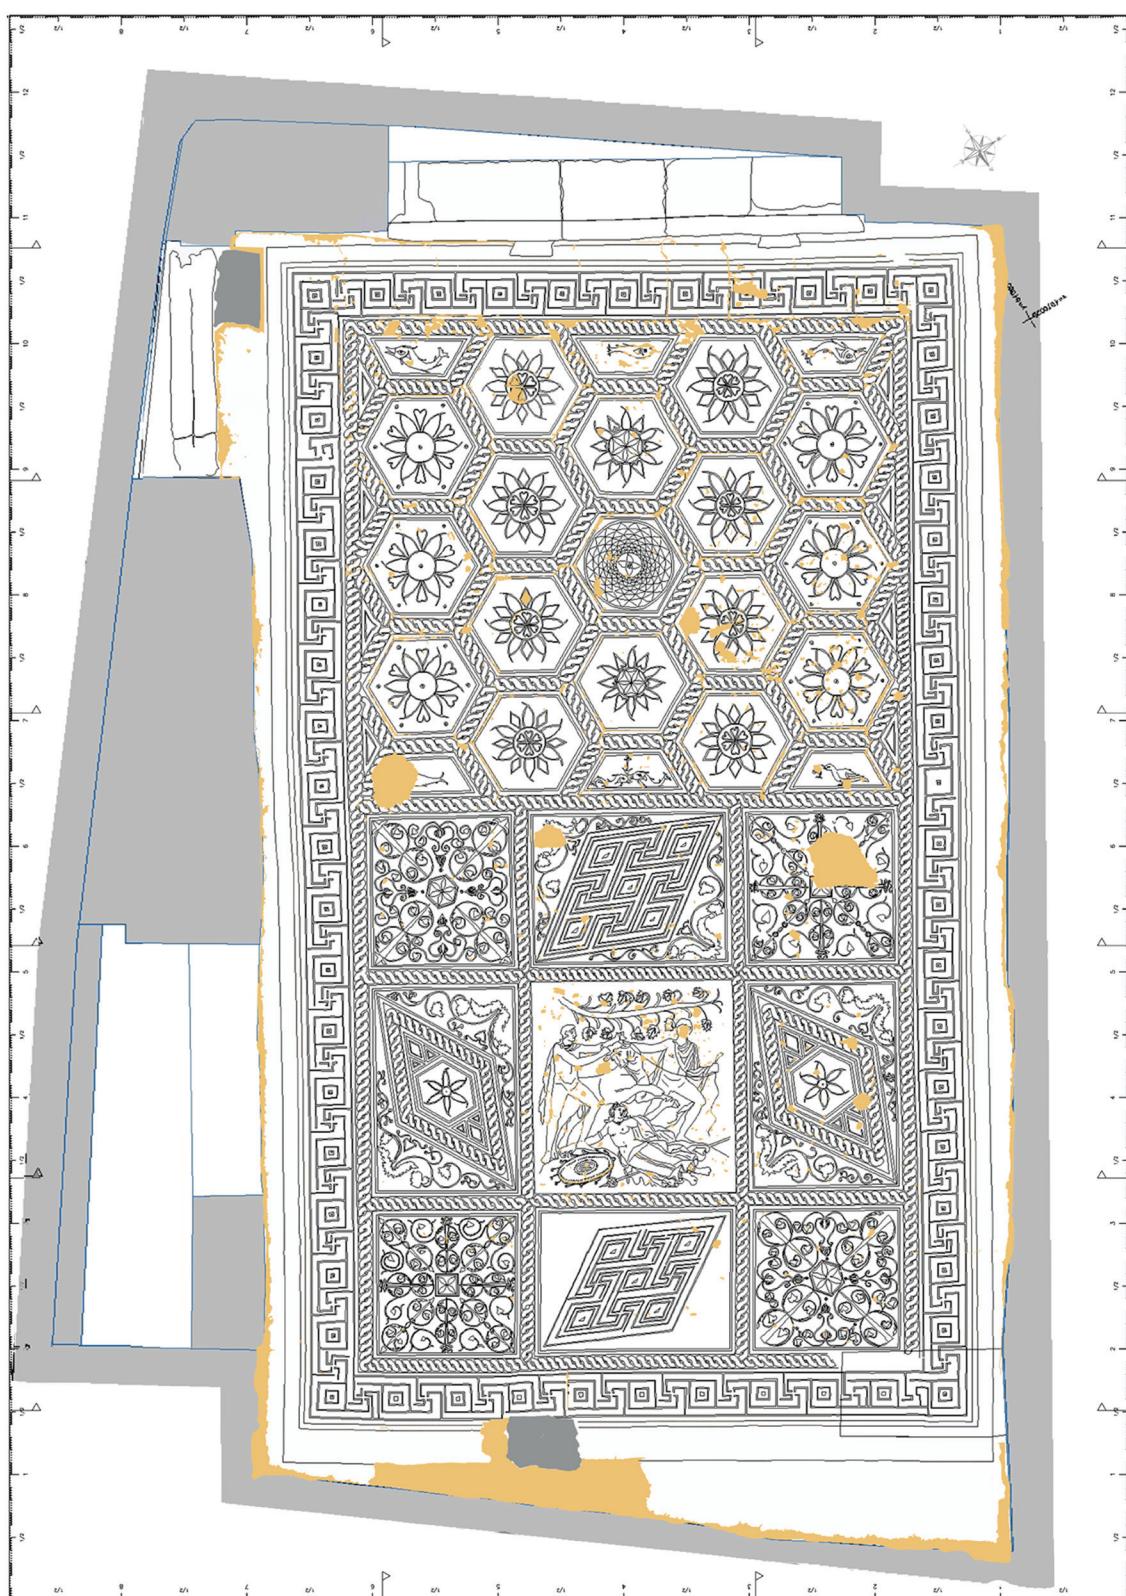
The mosaic is very compact nowadays because it adheres to its substrate in its entirety. When it was discovered it was likewise in an excellent state, it only had some minor flaws – *lacunae* that, however, did not disturb the overall image of its surface (Brandi 1977, 21). If we compare the photographs taken at the time of its discovery, and compare them with the surface of the mosaic as it is today, we can detect a much larger number

century (Nardi 2004, Carta del restauro 1931, Article 5, Carta della conservazione e del restauro degli oggetti d'arte e cultura 1987, Article 7d). The fillings in lacunae are very compact and solid, and have a grayish-white color. There is a widely accepted opinion today, in accordance with which cement does not represent a good choice for repairing cultural monuments, because of the inherent incompatibility of two binding materials (Malinar 1996, 37–40). After the mosaic was raised, some damaged areas were repaired using a neutral cement mortar, while others were reconstructed using new tesserae, but there are also reconstructions that were executed with original tesserae, which are very hard to detect (Brandi 1977, 26 Fiori, Vandini 2002, 87). Nowadays it is not possible to understand the criteria used in the selection of the different methods employed to fill the missing parts.

T. II Grafički prikaz cementnih nadopuna.
P. II Graphic display of cement fillings.

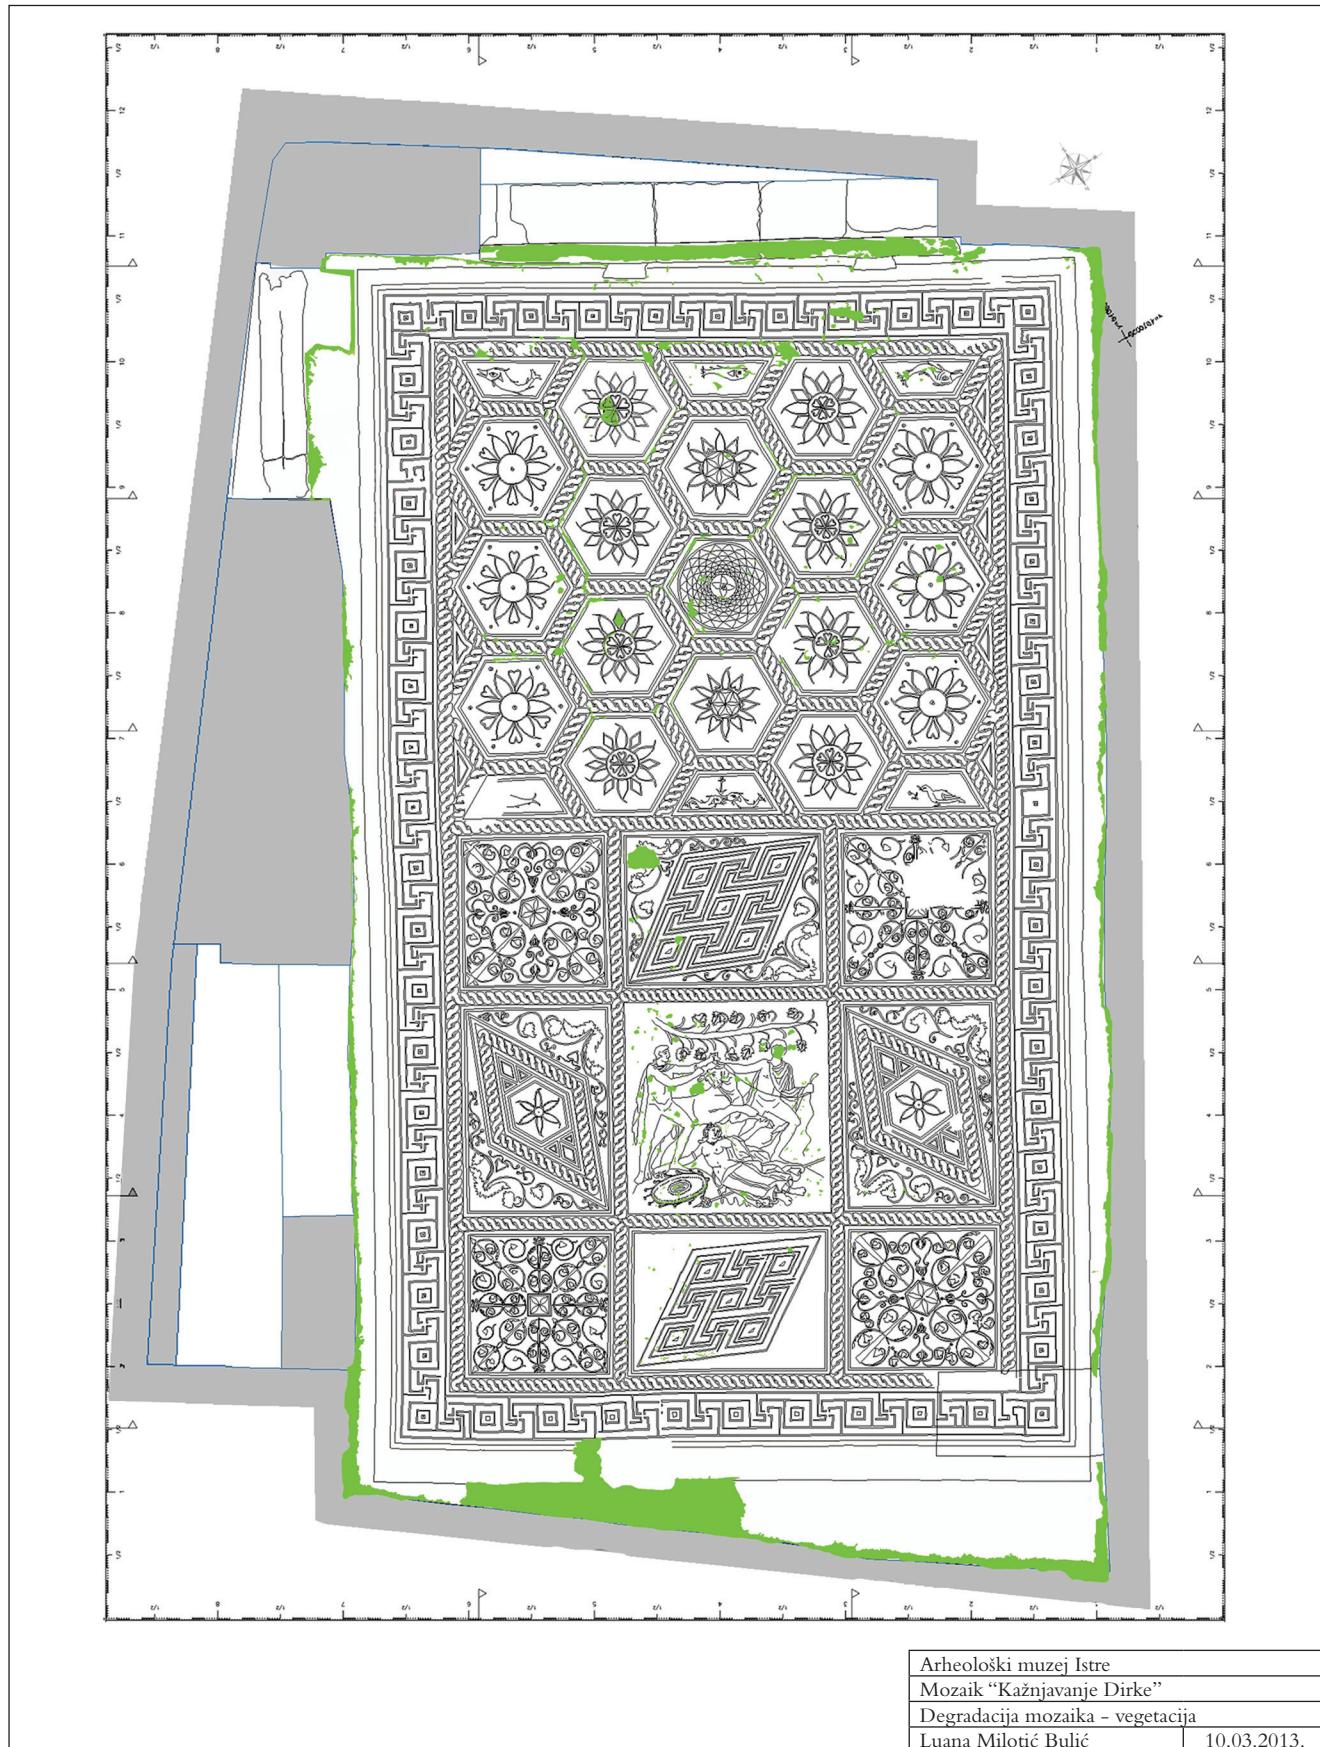
T. III Grafički prikaz vegetacije.
 P. III Graphic display of vegetation.

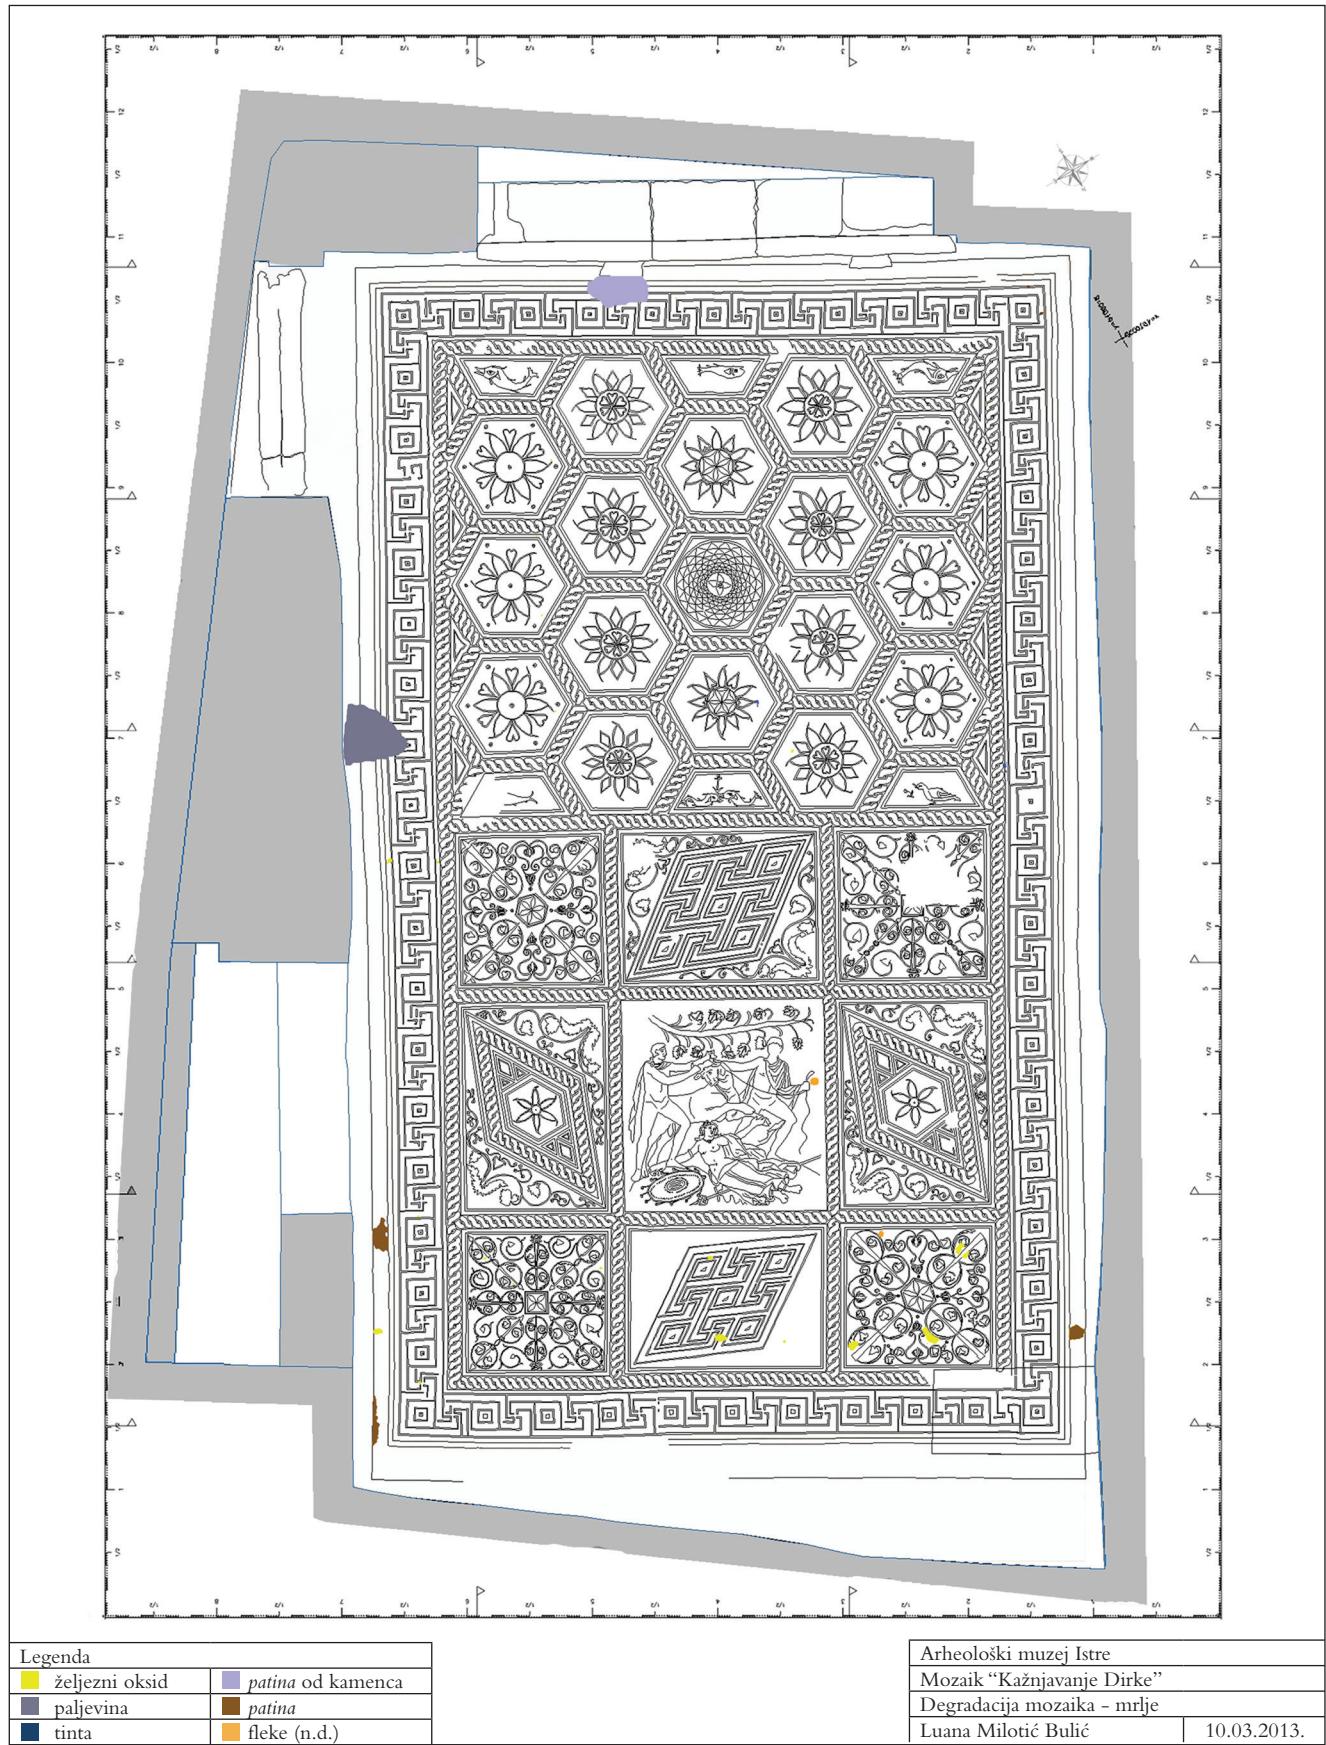
The graphical presentation of stains on the panels shows the different varieties that were created on the surface of the mosaic over the years. Some of these stains will be very difficult to remove, perhaps even impossible, as the surface of the tesserae is damaged. The roof leaks on several spots during rainfall and that creates humid stains on the surface of the mosaic, which were small puddles of water before that. The rain, in places, also dissolves iron oxide from the supporting structure of the roof, which then falls on the surface of the mosaic and penetrates into tesserae. These stains are the most difficult to remove because they were created together with water

T. IV Grafički prikaz mrlja.
P. IV Graphic display of stains.

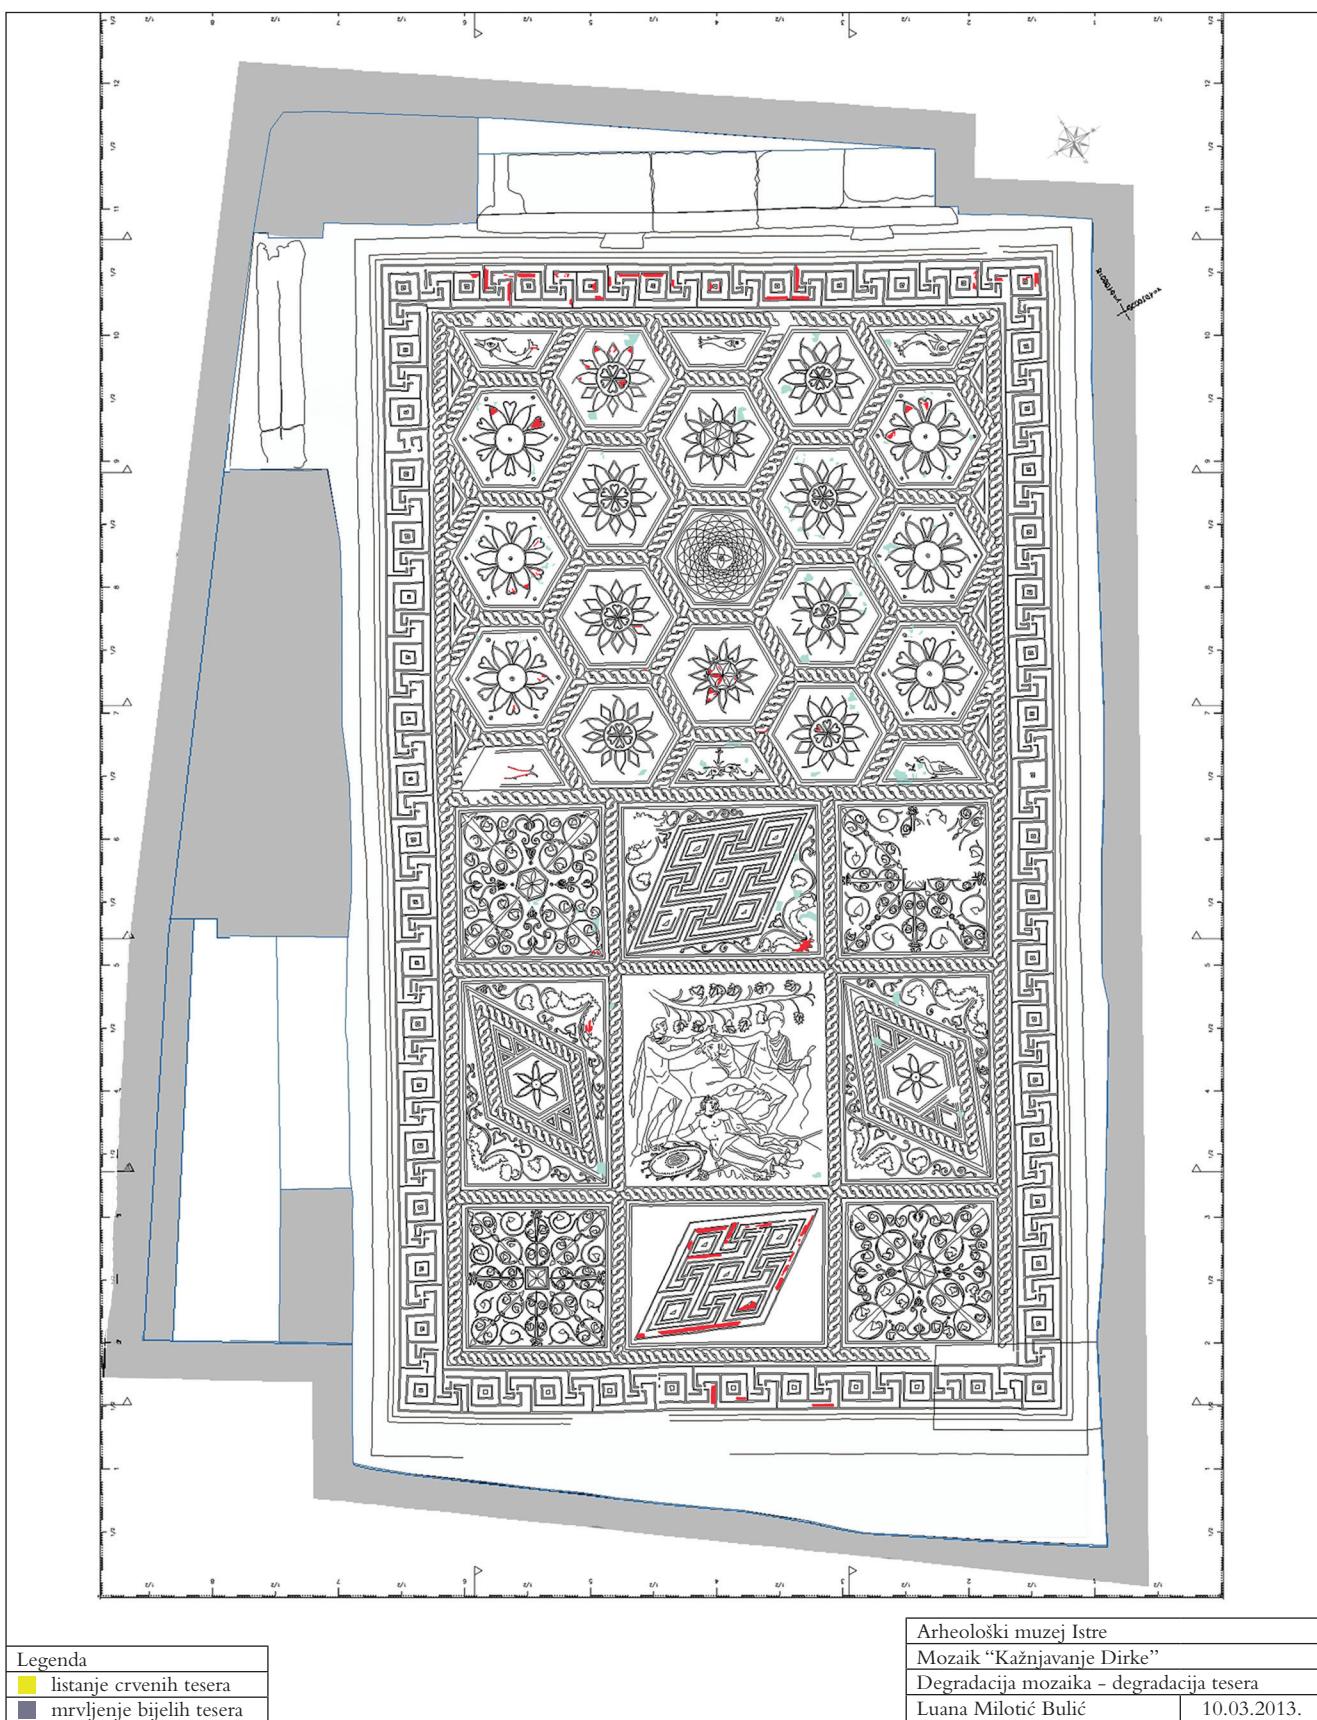
The degradation of tesserae is the most important type of damage because it undermines the very structure of the mosaic. It is easiest to see on tesserae of white and red limestone. Over time, water and with it salt penetrated the thin tesserae pores. The latter, through crystallization, caused the rock structure to flake. White tesserae began to crumble and some of them were utterly fragmented as a result of this. In some parts, red tesserae also began to flake, creating thus one or more thin, parallel portions that fall off in layers. The mosaic also includes red tesserae made of glass paste, which were used to portray the ropes with which the bull is tied. They are harder to perceive nowadays as they are completely covered by the effects of calcification. For the most part they have fallen off

One of the causes of degradation may also be the salts that were proven to exist on the surface of the mosaic after some laboratory analyses were performed. Even though these salts are not present in larger quantities, they can nevertheless cause smaller damages. Besides sodium chloride, whose presence is associated with proximity to water, there are also sulfates that can access the mosaic by means of the atmosphere and the surrounding land, or from the cement that was used during the various interventions (Malinar 1996, 37-40).

T.V Grafički prikaz degradacije tesera.
 P.V Graphic display of degradations on tesserae.

To conclude, the degraded tesserae should be consolidated, uniting them into a single whole. Given that the problems facing the mosaic are often associated with water, it is preferable to choose a consolidating agent that at the same time protects the surface of the mosaic from water (hydrophobic but breathable characteristics). The mosaic surface would in this manner become more compact, and at the same time it would be protected from the negative consequences associated with water.
